Reductant Tank Temperature Sensor Troubleshooting Guide (UQLS) - US17 Emissions And Newer

Trouble shooting guide for diagnosing the Reductant Tank Temperature Sensor (UQLS), commonly referred to as the DEF Level Sensor.

25068-9 FSB 258-040, Aftertreatment Diesel Exhaust Fluid (DEF) Tank, Level Sensor, Replacement

On certain Volvo Truck models built before October 21, 2019, equipped with Diesel Exhaust Fluid (DEF) tank, the vehicle may experience water intrusion into the level sensor protection tubing. This may be due, in part, to kinking of electrical routing protective tubes. The solution is to replace the existing level sensor assembly with new level sensor assembly and follow improved electrical routing.

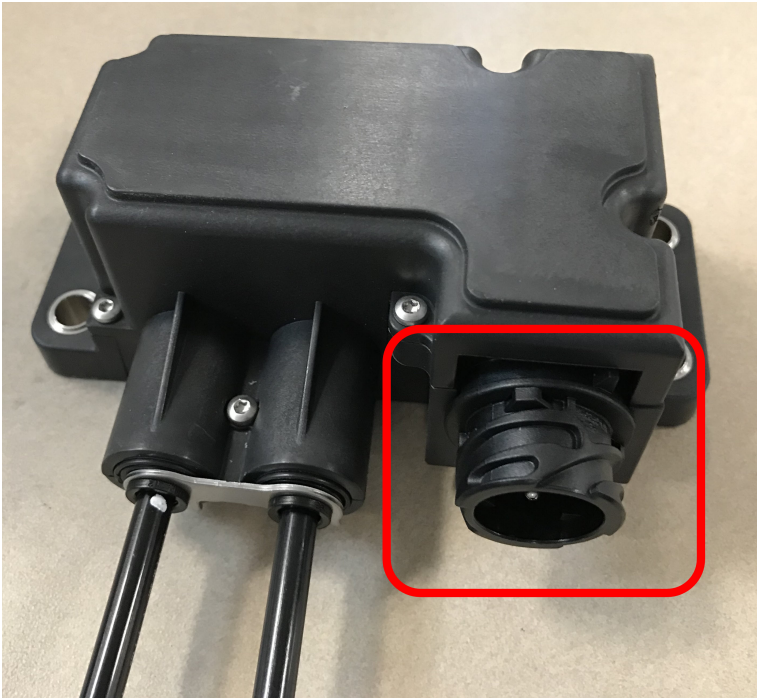
1. Check the sensor wiring harness connection.

- Disconnect the harness and make sure there is no damage to the wires or pins, corrosion, or water ingress in either of the connectors. If damage is found replace in accordance with FSB 258-040.
