Particulate Matter (PM) Sensor Troubleshooting **Guide - US14+OBD16 And Newer Emissions**

25074-9 FSB 258-039, SCR Fittings, One Box, Replacement

FSB 284-069, Exhaust Particulate Sensor, Repair (2017 Vehicles)

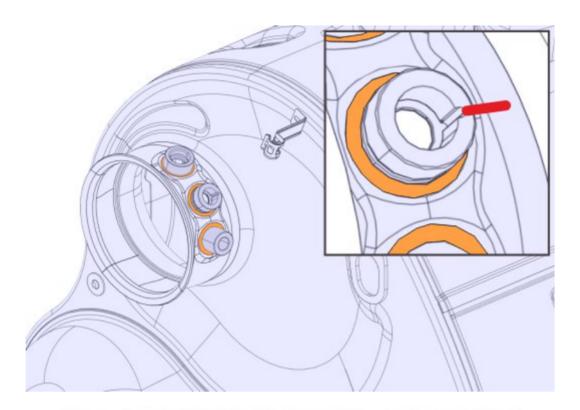
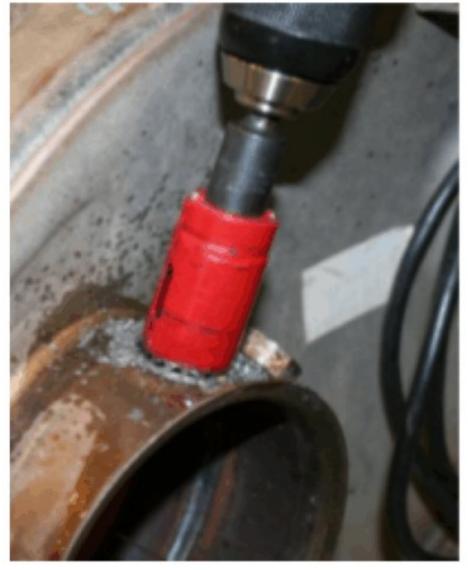
Note: If the PM sensor boss is damaged as shown in the illustration mark the position of sensor boss notch before removing the boss welding. The notch of PM sensor boss is always set in the 3'o clock position.

Note: When removing the sensor boss weld, check the depth frequently to prevent the damaged sensor boss from falling inside the aftertreatment muffler. Also ensure that the notch mark is not removed.

1. Remove the damaged boss welding.

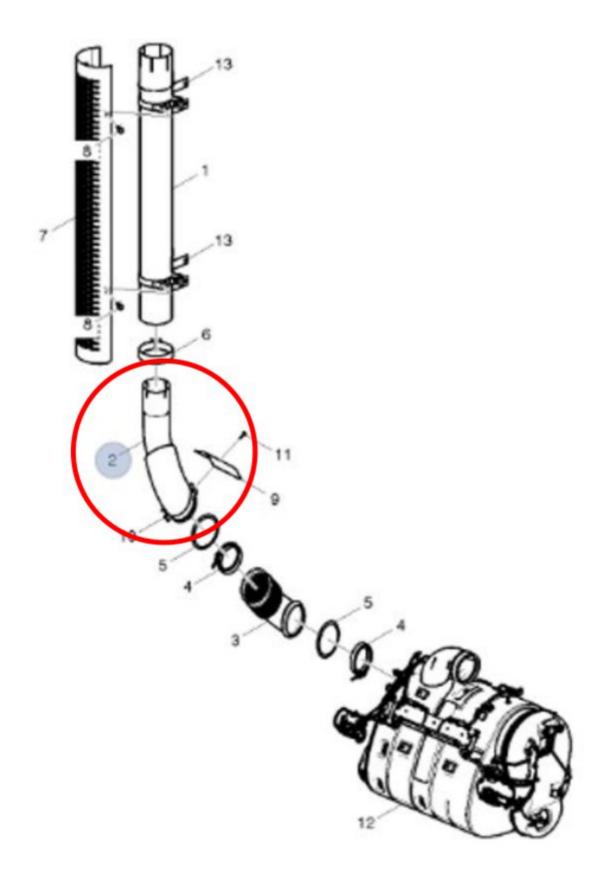
Repair 1

Some trucks built between 1/1/2017 and 11/15/2017 may experience a Particulate Matter (PM) Sensor fault that can result in the MIL lamp illuminating. These faults may be P24DA, "PM Sensor Exhaust Sample Error," or P24D1, "PM Sensor Regen Incomplete." These faults may be caused by contamination of the PM sensor. In order to reduce the likelihood of sensor contamination, new exhaust pipe parts are being made available that contain an internal water management feature along with an integrated drain that will prevent contamination of the sensor. If either of these two faults occur, follow the instructions outlined in this bulletin to clean the exhaust pipes and install a new exhaust pipe with the new contamination prevention measures.

VNL	Cab	Single Outlet Right Side	23873123	22181981	25172497
		Outboard			x 2
