## Mack Chassis - Anthem (AN) Water Leak Around Door

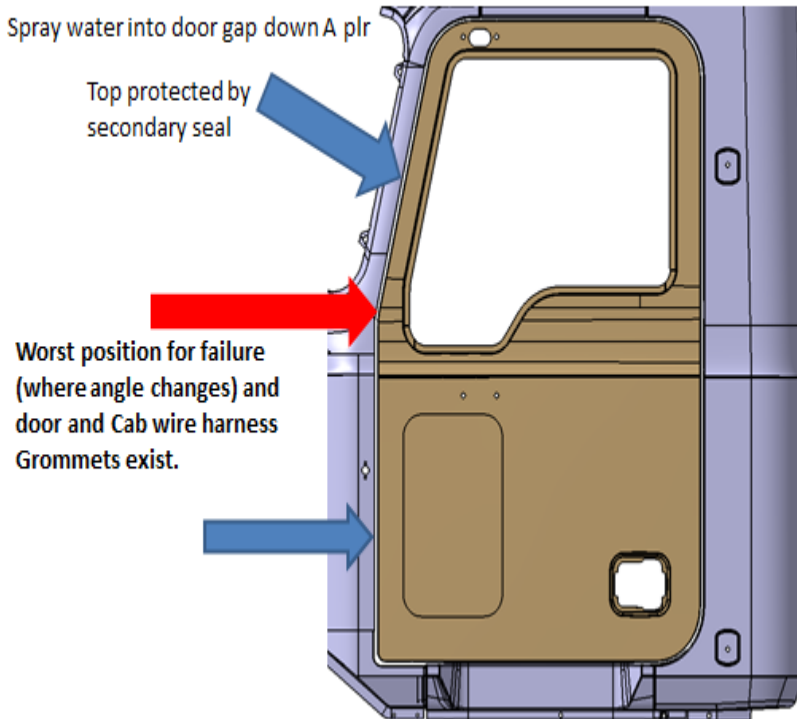
#### Door seal water test evaluation

Mack Anthem models may experience water intrusion through the door seal. The likely source of intrusion can be found in the area around the bottom of the A pillar trim panel.

Spray water into door gap down A pillar

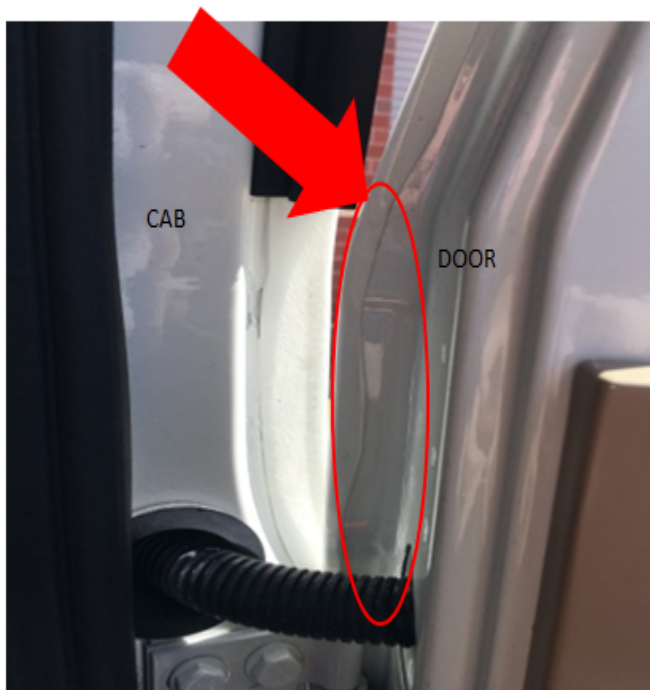
Clean Area Circled

1. **Clean and prep the door hem flange where the seal tape will meet the door flange.**
