FIELD SERVICE CAMPAIGN – 21112

Grid Heater Relay

Certain International® MV™ Series and DuraStar® models with Cummins® ISB engines only.

The grid heater relay may stick closed resulting in battery draw.

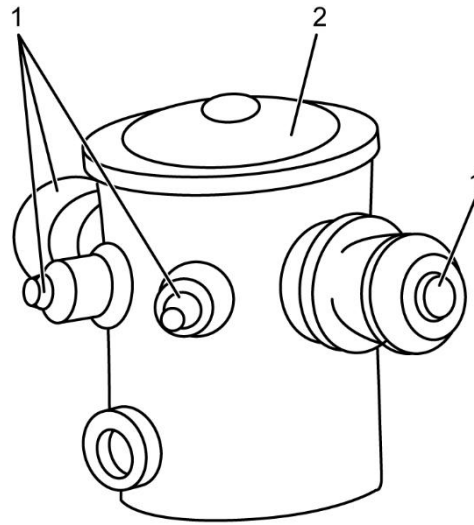
Figure 1. Grid Heater Relay

- 1. Grid heater relay terminal (4)
- 2. Grid heater relay

7. Remove grid heater relay terminals (Figure 1, Item 1).

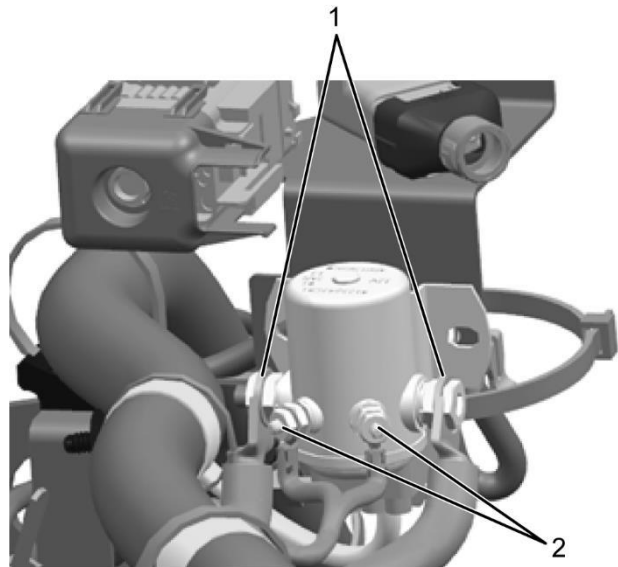
Figure 4. Grid Heater Relay

1. Terminal and nut (2)
2. Terminal and nut (2)

10. Install grid heater relay terminals and nuts (Figure 4, Items 1 and 2). Using torque wrench, tighten terminals and nuts (Figure 4, Item 1) to 59 lb-in (7 N•m). Using torque wrench, tighten terminals and nuts (Figure 4, Item 2) to 20 lb-in (2 N•m).

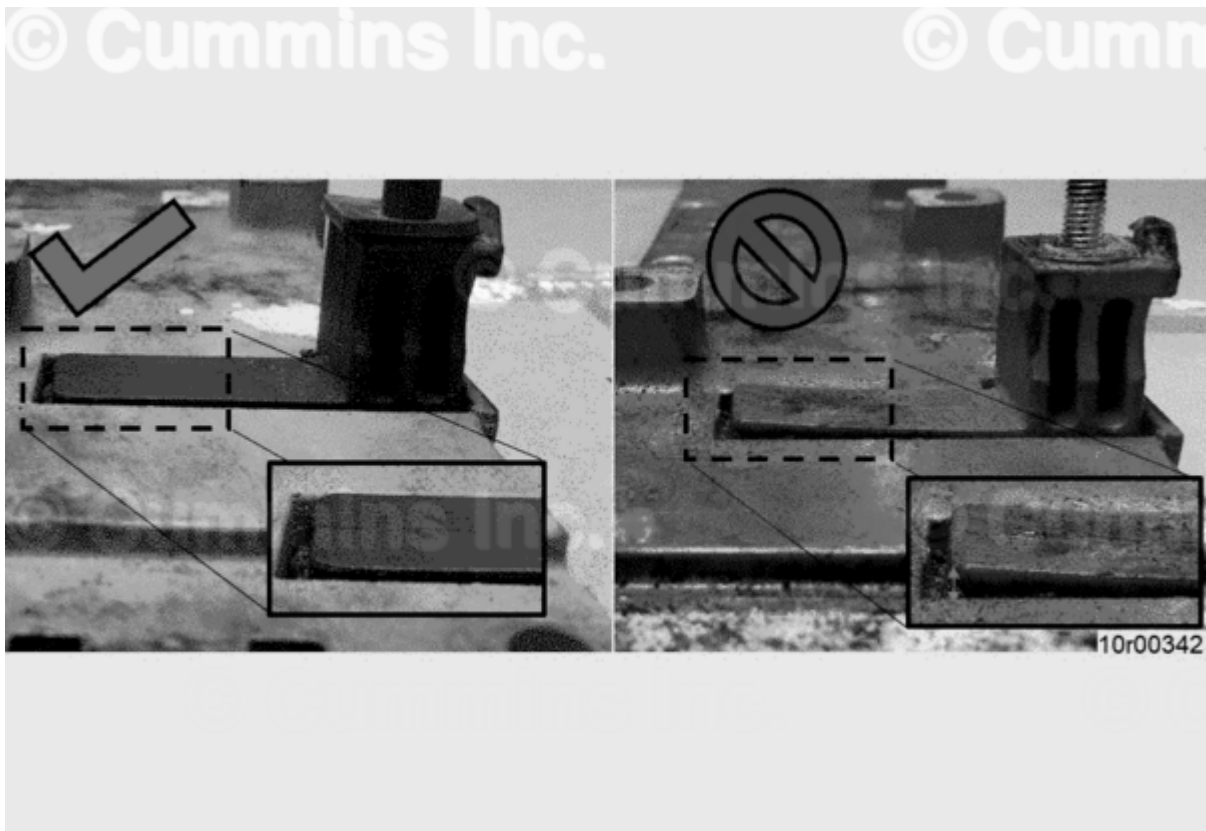
- Intake air heater relay stuck closed leading to extended on-time of the heater. Units experiencing Fault Code 383 may have experienced extended on-time of the intake air heater with no air flow entering the system caused by a stuck relay, causing the air heater to overheat. The isolated power connection bar may expand and lift from the top surface of the intake manifold cover due to extended on-time (Figure 1). The isolated power connection bar may also become loose. The issue may progress and exhibit electrical arcing damage to the intake air heater internal joints (Figure 2), with potential for arcing to cause debris to drop into the intake system.

Figure 1, Example View of Power Bar Deformation from Top Surface of Intake Manifold Cover.

- Intake air heater damage that exhibits power connection bar deformation or movement of the terminal back and forth is due to intake air heater relay failure and is **not** covered under Cummins ® warranty. Repair locations are to contact the OEM for further repair direction.
- For Navistar® and IC Bus applications reference iKnow article IK1201457.

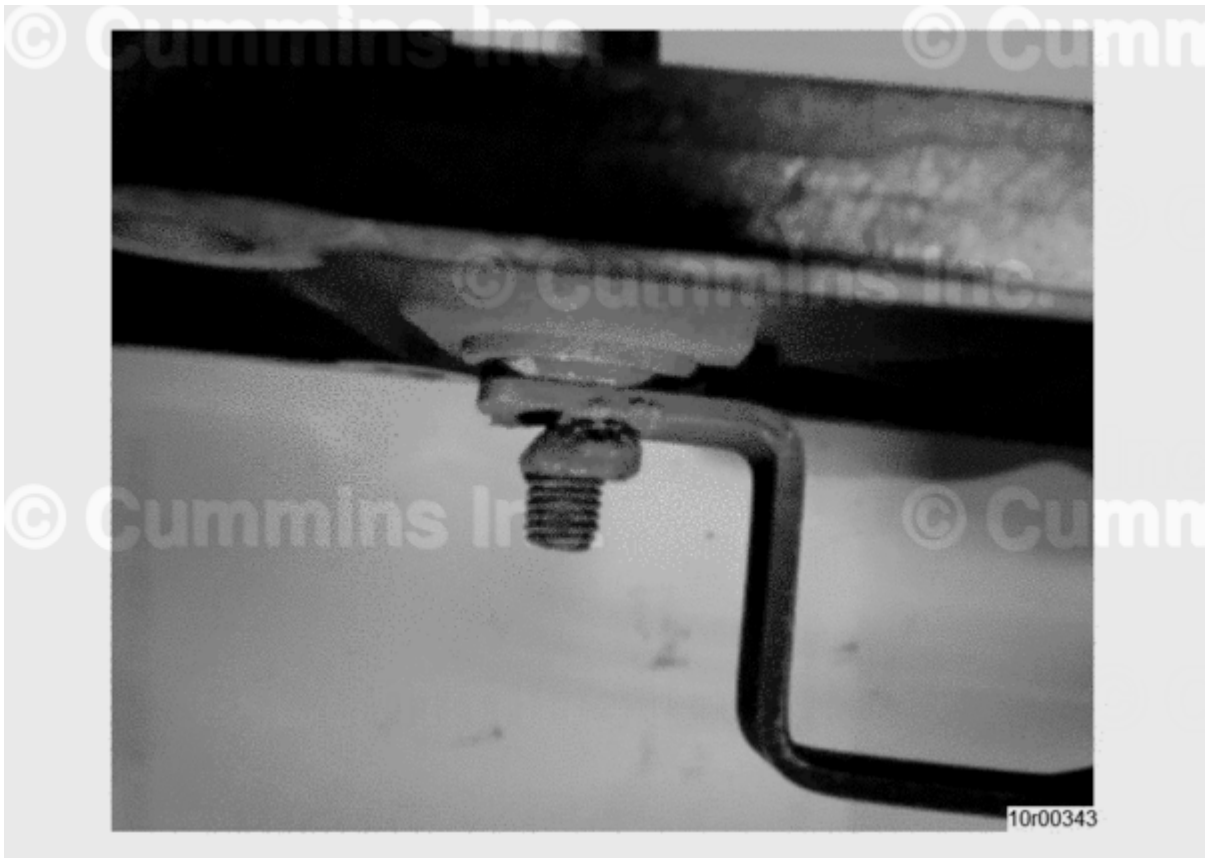
Figure 2, Example of Arcing Damage on Internal Joints of Intake Air Heater.

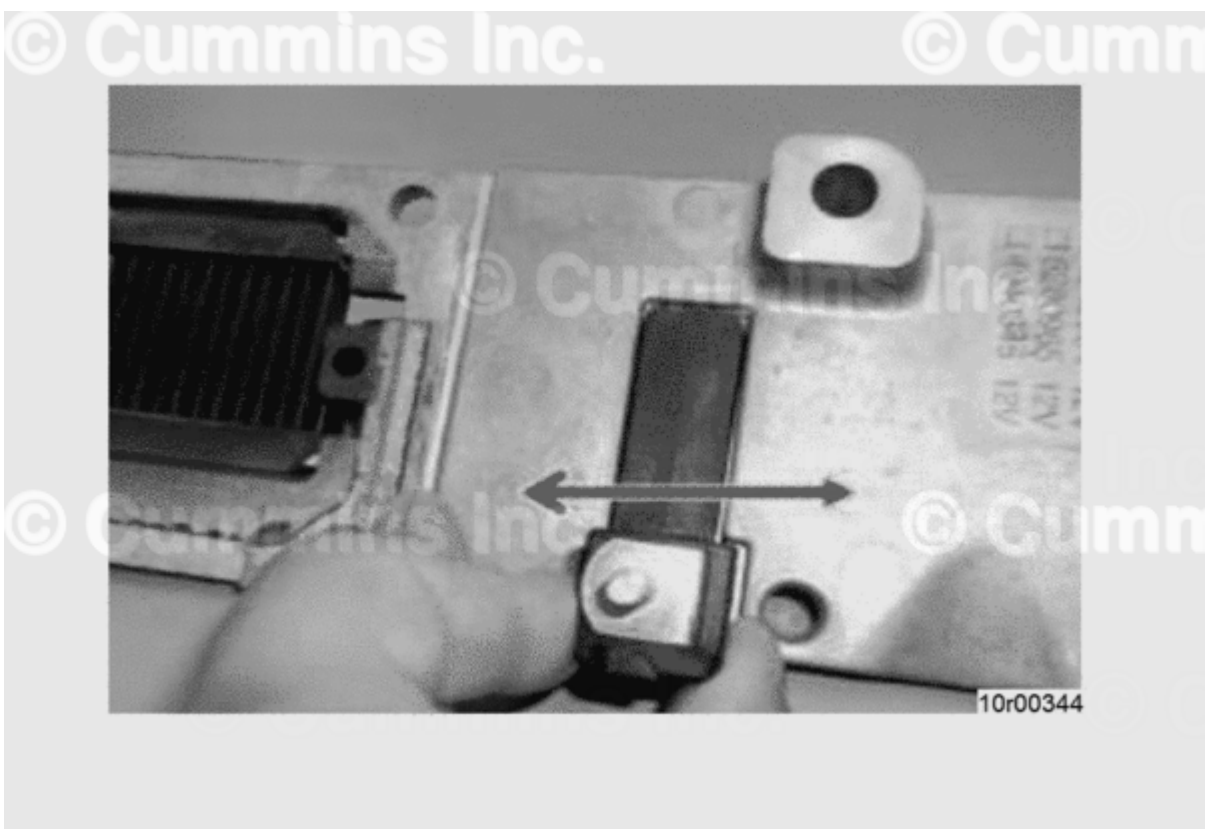
Figure 3, Any Movement of The Terminal Back and Forth As Shown is Unacceptable.
