Title: QLS Emergency Calibration

Applies To: EPA 2017 and Newer X15 / L9 / B6.7 Engines

This document is intended for information purposes only to inform the user about an emergency calibration release that has been approved by the EPA and CARB to help provide relief from the global supply shortage of electrical components.

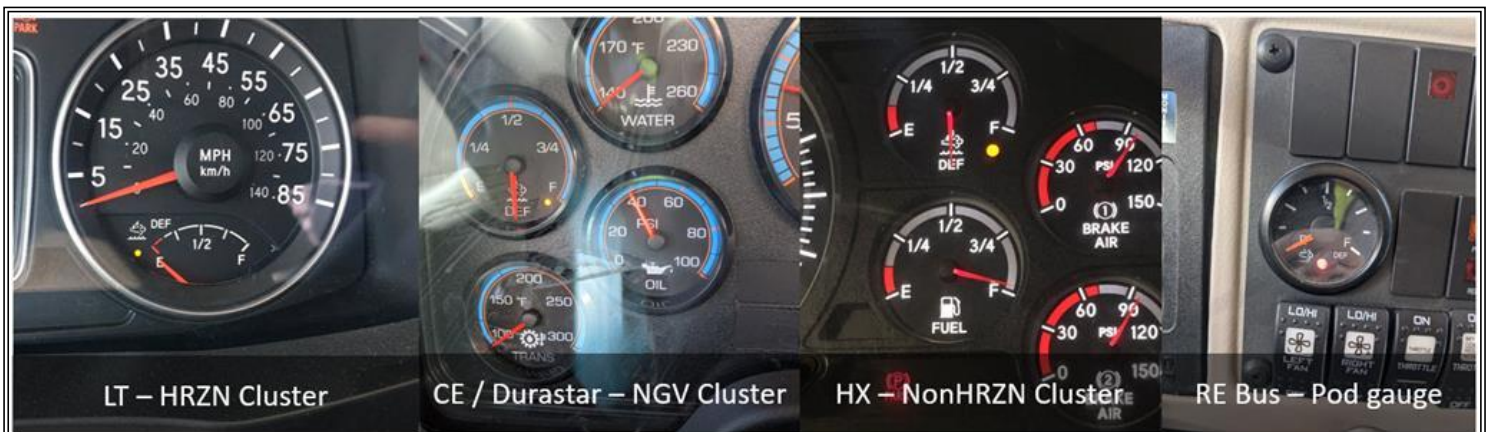
Figure 1: DEF Level Gauge Reaction

The DEF tank level gauge will NOT function with the QLS emergency calibration. It may show incorrect or empty at all times.

Item 1: DEF Level Gauge

With the DEF gauge not functioning the DEF Tank Miles to Empty will not read correctly or read N/A. It is strongly recommended that the vehicle be filled with DEF at every full stop to ensure the tank stays topped off.

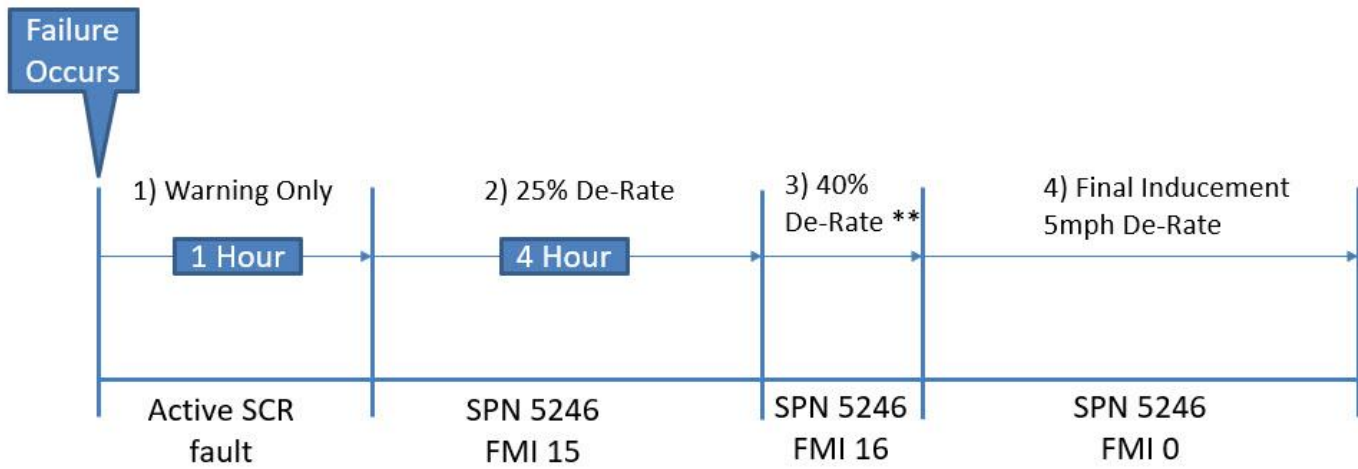
Figure 2: SCR System Tampering Inducement Faults

Item 1: For the first hour after a failure or tampering occurs there is a warning only, with no de-rate.

Item 2: Hour 1 to hour 5 there will be a 25% de-rate accompanied with fault code SPN 5246-15 AFT SCR operator inducement severity - Least severe.

Item 3: After 5 hours from initial awareness the vehicle will ramp to 40% de-rate and will search for the final inducement trigger accompanied with fault code SPN 5246-16 AFT SCR operator inducement severity - Moderately severe.

Item 4: Once final inducement is triggered the vehicle will ramp to a 5mph de-rate accompanied with fault code SPN 5246-0 AFT SCR operator inducement severity - Most severe.

Note: **The time between stage 3 and 4 will be determined based on the fault code and triggers. If repeated tampering occurs the time window between stages will be reduced.

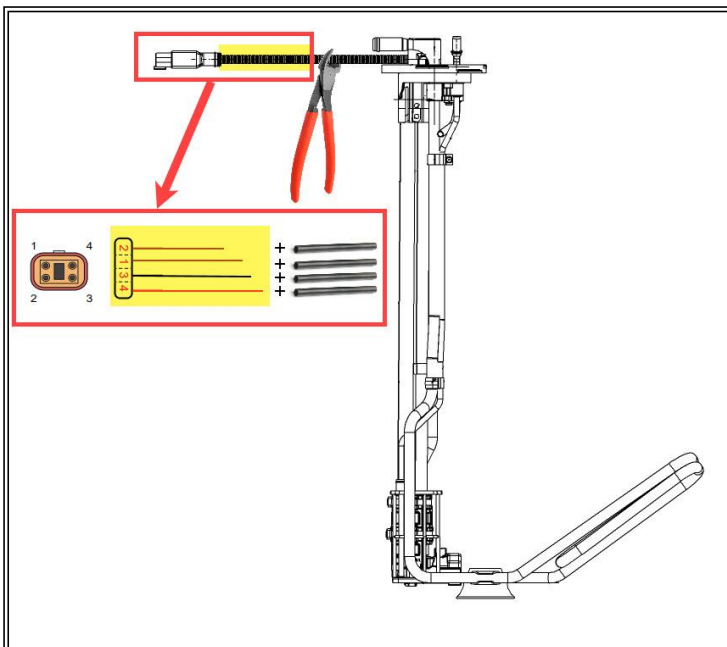
Figure 5: QLS Pigtail Modification

Item 1: QLS Pigtail

1. Ensure the QLS is disconnected from the chassis harness. **If the sensor is still connected it could result in shorting of the power circuit.**
2. Using wire cutters, cut the QLS pigtail harness as least four inches from the connector (Refer to figure #5). Once cut the pigtail can be moved to a bench for ease of installation.

Note: At no point is the QLS removed from the DEF tank during this procedure.

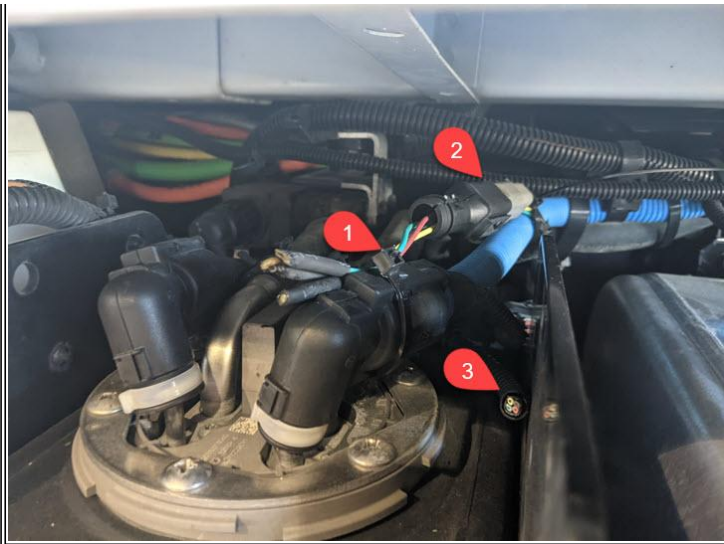
Figure 8: QLS Pigtail Installed

- Item 1: Zip tie securing the harness
- Item 2: Pigtail connected to chassis connector
- Item 3: Harness to QLS left unsealed

7. Once all four wires are sealed, reconnect the pigtail to the chassis harness connector.
8. Secure the harness using a zip tie (Refer to figure #8).
