Title: MV A/C Condenser Hose Interference with Inner Hood

Applies To: MV

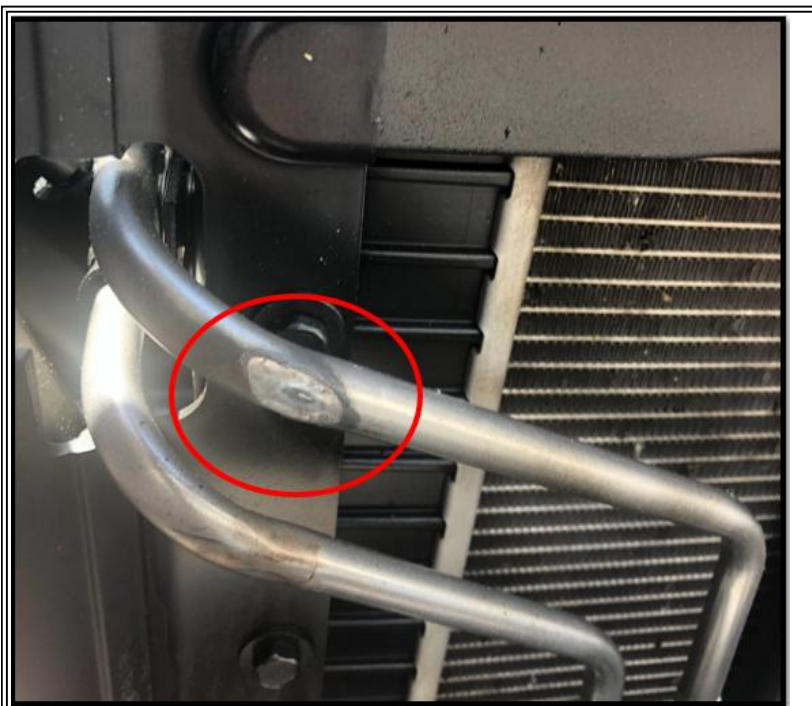
Figure #1: Inspect upper hose for signs of a rub through

condition.

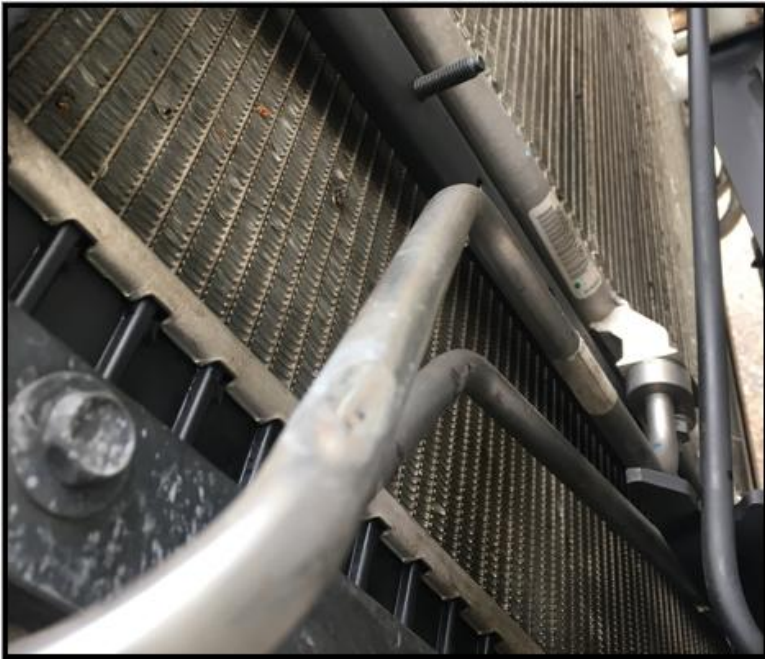
Figure #2: Upper hose has contacted hood assembly.

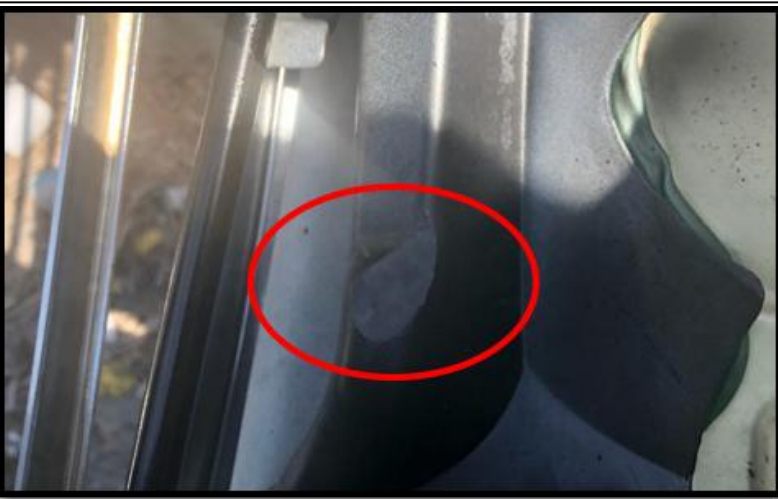
Figure #3: Inspect inner hood for signs of contact.

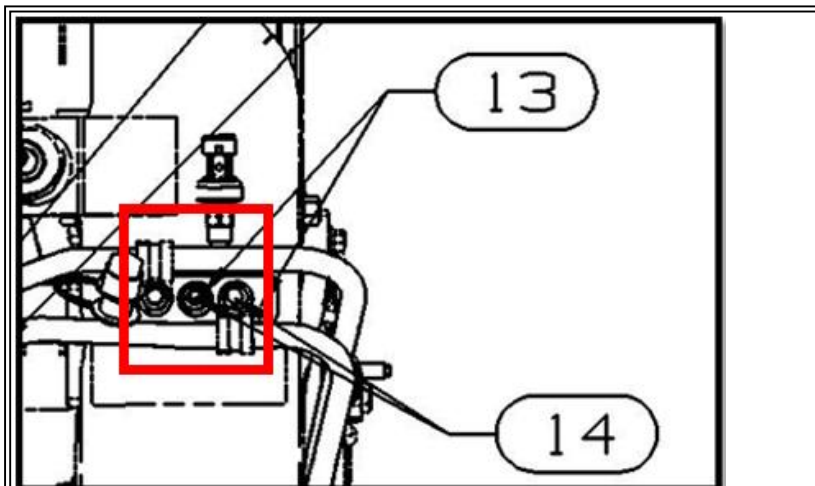
**Figure #4: Original design:** Note clamp location prior to disassembly.

1. During installation of a new hose(s), relocate both clamps during assembly see figure #2.
2. Secure each hose properly by ensuring there are no contact points with the inner portion of the hood assembly.
3. Complete repairs by correcting oil and charge levels listed within the **2017 - 2020 MV Technician Manual (Service and Diagnostic) 0000993280 (HVAC testing)**.

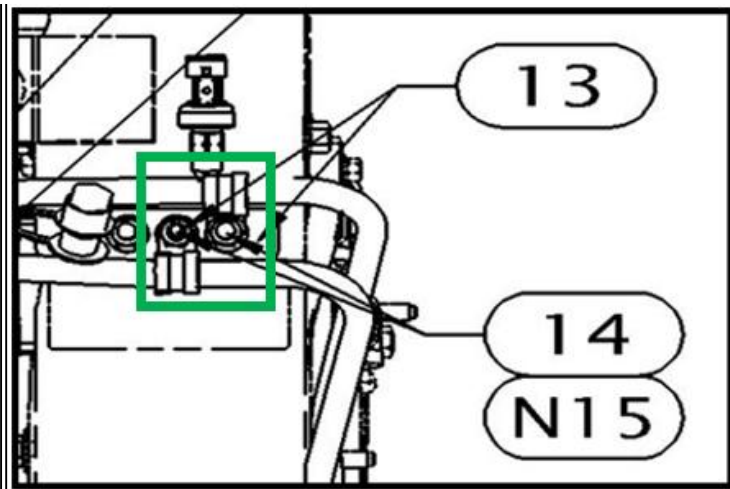
Figure #5: **Updated design:** Relocating both clamps will prevent the upper hose with further contact of the hood.
