Technical Service Bulletin

Mazda North American Operations
Irvine, CA 92618-2922

Subject: CHECK ENGINE LIGHT ON WITH DTC P0126:00	Bulletin No.: 01-011/21
	Last Issued : 09/27/2021

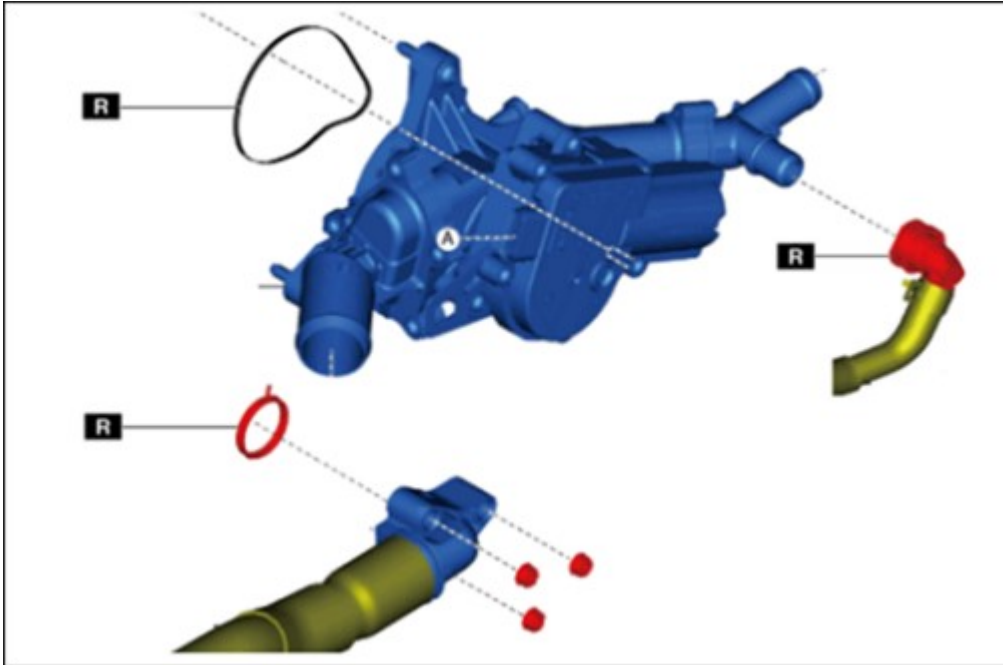
Replacement parts locations

- O-ring
- Gasket
- Connector

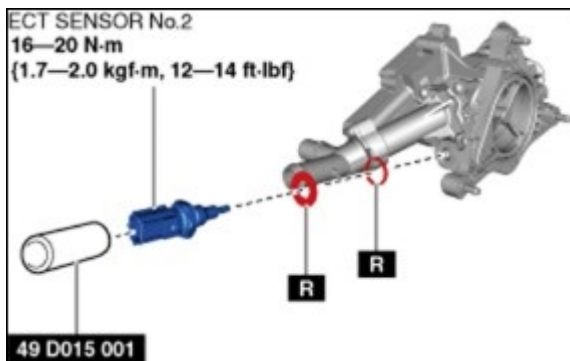
- O-ring and washer for ECT sensor No.2

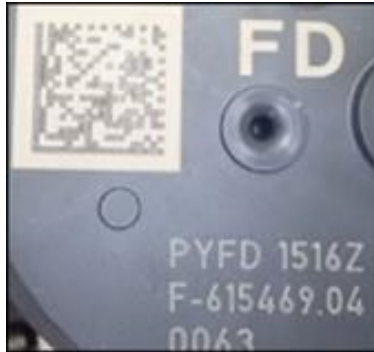
1. With a smart phone, scan the two dimensional code on the water control valve.
2. The code consists of three blocks of codes where the sample picture is read as PYFD1516Z 171115 0000063 and the second block of the code is the production date in YYMMDD format.

- If the second block of the code is 201116 or greater (meaning November 16, 2020 or later), the coolant control valve is modified.
