Subject: SQUEAKING NOISE FROM BLOWER MOTOR	Bulletin No.: 07-003/21
	Last Issued : 09/10/2021

2017-2020 Mazda6 with VINS lower than JM!GL*****521431 (produced before December 27, 2019)
2017 (US spec)/2018 (Mexico spec)-2020 CX-5 with VINS lower than JM3KE*****776608 (produced before December 27, 2019)

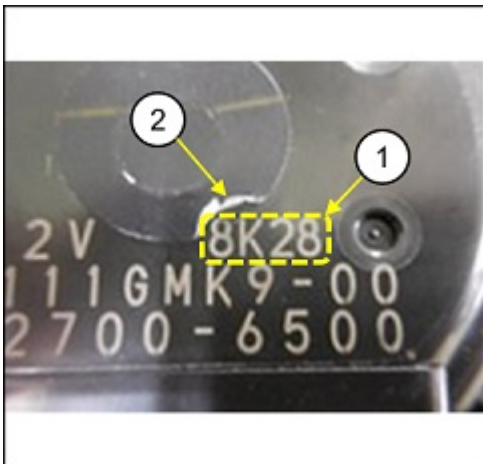
1. Verify the customer's concern.
2. Check the lot number (1) on the bottom of the blower motor.

- The part number has not been changed for the modification.
- If you find a sticker (2) covering the lot number when checking it, remove the sticker partially. The sticker may be left partially removed.

NOTE: The lot number is in YMDD format. The sample above (8K28) means “November 28, 2018” and lot numbers of “9K13” and later are modified parts.

- If the lot number is “9K12” (Nov. 12, 2019) or earlier, replace the blower motor with a modified one according to the instructions on MGSS using TSB warranty information.
- If the lot number is later than “9K12” (Nov. 12, 2019), replace the blower motor according to the instructions on MGSS using normal warranty information.
 - Mazda6 (BLOWER MOTOR REMOVAL/INSTALLATION)
 - CX-5 (BLOWER MOTOR REMOVAL/INSTALLATION)
