Technical Service Bulletin

RUST OR PAINT PEELING AT INSIDE EDGE OF FRONT DOOR(S)

Bulletin No.: 09-016/21

Last Issued : 09/13/2021

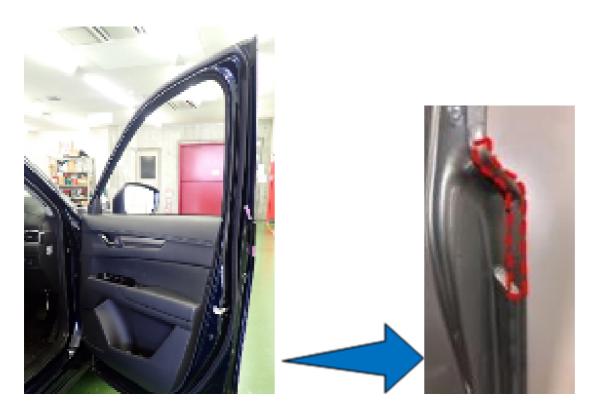
Some vehicles may exhibit rust or paint peeling at the inside edge of the front door(s). This may be caused by dust adhering between the front door edge and the rear door weatherstrip, which rubs/damages the paint during vehicle operation (door opening/closing and vibration while driving).

- 1. Verify the customer concern.
- 2. Repair the paint peeling and/or rust on the vehicle according to normal body shop procedures.
- 3. Attach the protector tape to the front door(s) according to "Procedure to attach the protector tape" below. **NOTE:** Replace both rear door weatherstrips as necessary.
