**WHISTLING NOISE FROM FRONT WINDOW GLASS WHEN  
DRIVING AT HIGHWAY SPEED**

**Bulletin No.: 09-028/21**

**Last Issued : 09/17/2021**

2017-2021 CX-5

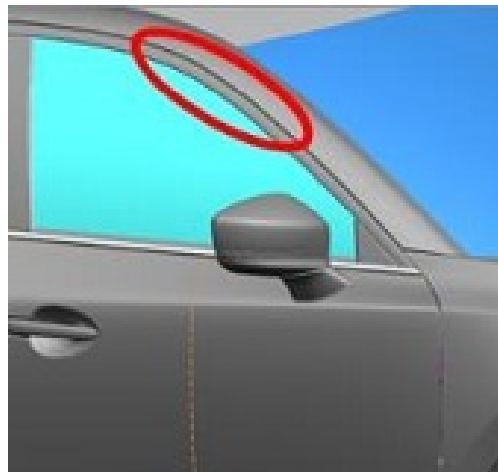
Some customers may complain about a whistling noise heard from the top of the A-pillar area when driving at highway speeds.

When driving under following conditions, a negative pressure is generated on the doors pulling them outward and resulting in weatherstrip vibration.

- The vehicle is exposed to a side wind while driving at highway speeds.
- The vehicle is exposed to a strong side wind while driving at a speed slightly higher than highway speed.
