# Technical Service Bulletin

<b>Subject:</b>  <b>BLIND SPOT MONITORING (BSM) FALSE DETECTION AFTER COLD START</b>	<b>Bulletin No.: 15-003/21</b>
	<b>Last Issued : 09/24/2021</b>

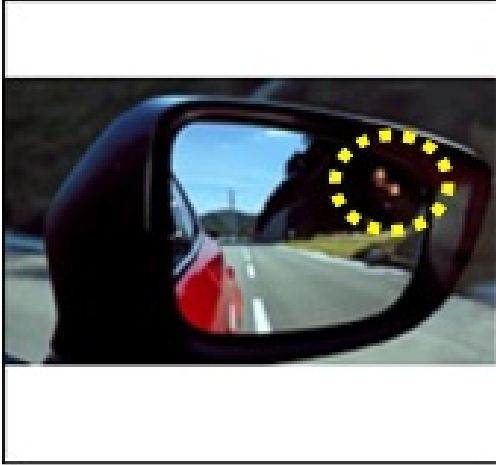
Some vehicles equipped with Blind Spot Monitoring (BSM) may experience a BSM indicator light on the outer door mirror, even if there is no vehicle in the alert (blind spot) area.

**NOTE:** This concern occurs only after a cold start. As the BSM control module temperature rises, the BSM system returns to normal operation.

Due to BSM control module production variances, a false detection may occur in some units when the BSM temperature in the control module has not yet reached normal operating temperature. To eliminate this concern, the control logic of the BSM control module has been modified.

1. Verify the customer concern.
2. Replace the BSM control module of affected side with a modified one according to MGSS online BLIND SPOT MONITORING (BSM) CONTROL MODULE REMOVAL/INSTALLATION.

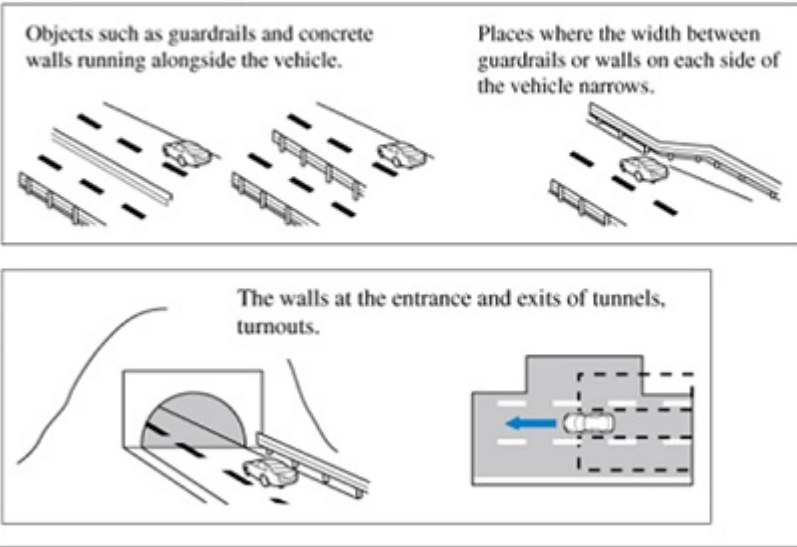
**ATTENTION:** This Service Information is **NOT** applicable to the following situations described in the owner's manual (below).

The BSM warning indicator light may turn on and the vehicle detection screen may be displayed in the display in reaction to stationary objects (guardrails, tunnels, sidewalls, and parked vehicles) on the road or the roadside.
