**SERVICE INFORMATION BULLETIN**

**APPLICABILITY:** 2020-2021MY Outback  
 2019-2021MY Forester  
 2019-2021MY Ascent

**NUMBER:** 07-199-21R

**SUBJECT:** Measurement of Dark Current  
 (Standby Current Draw)

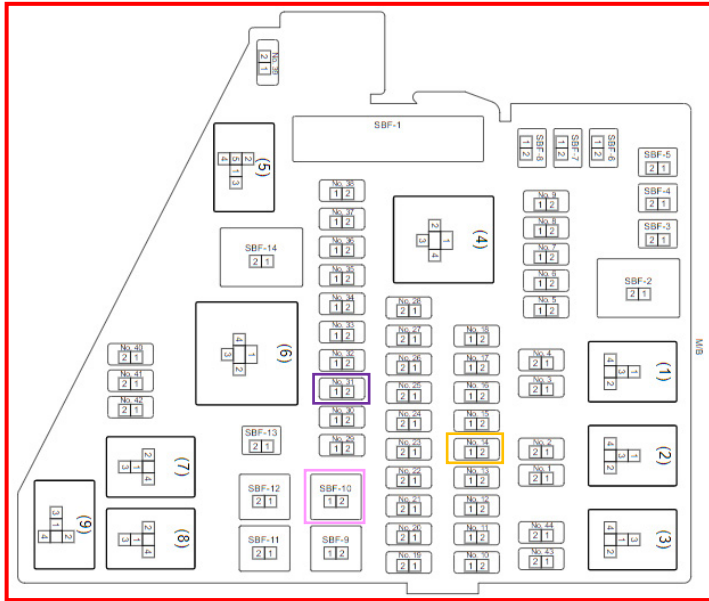
**Ascent & Forester**

**VDC Fuse**

Fuse No.31

SBF No.10

**Power Rear Gate Fuse**

Fuse No.14

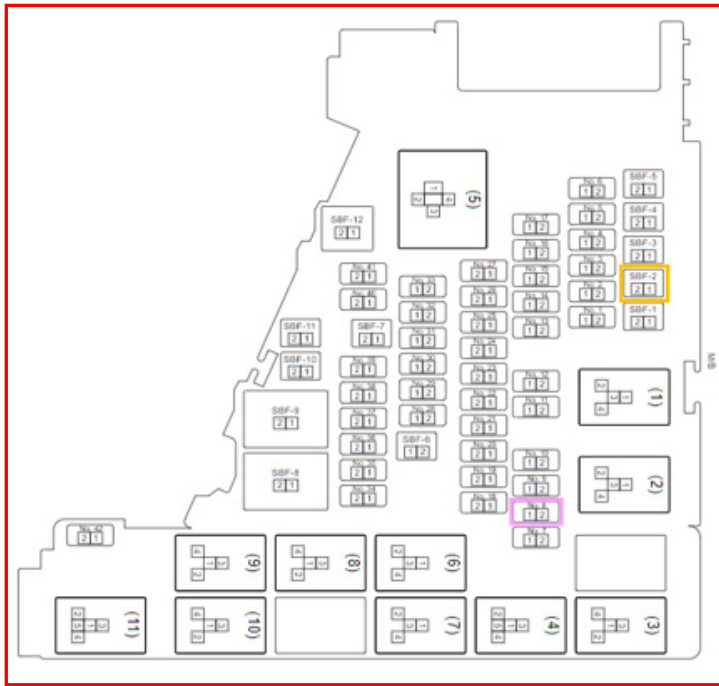
**Outback**

**VDC Fuse**

Fuse No.8

**Power Rear Gate Fuse**

SBF No.2

Fuse No.37

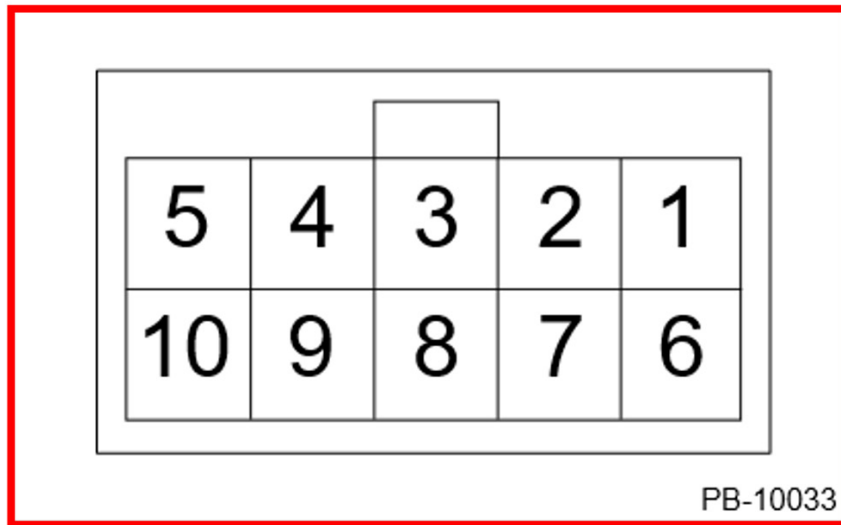
**NOTE 2)** How to check resistance between EPB switch terminals.

- Confirm the ignition is switch OFF:
- Disconnect the EPB switch connector, and check if Dark Current decreases. If Dark Current decreases by disconnecting the EPB switch connector, replace EPB switch and continue diagnosis.
- Check resistance between terminals per the illustrations below.

Switch Position	Terminal No.	Standard
Neutral	1-2 4-5	1MΩ and higher
	1-5 2-4	Less than 1Ω

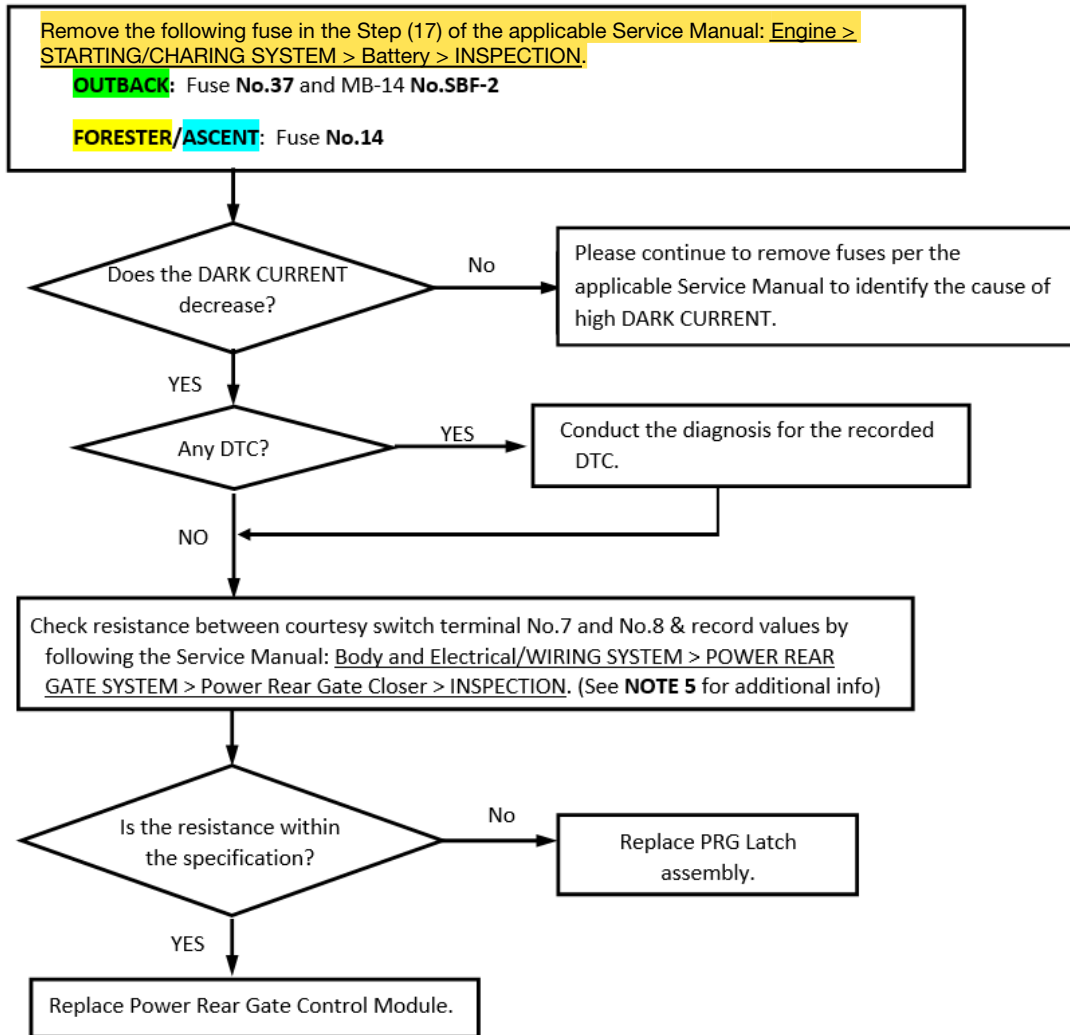
**NOTE 4) Troubleshooting Tree for excessive Dark Current draw from Power Rear Gate system:**

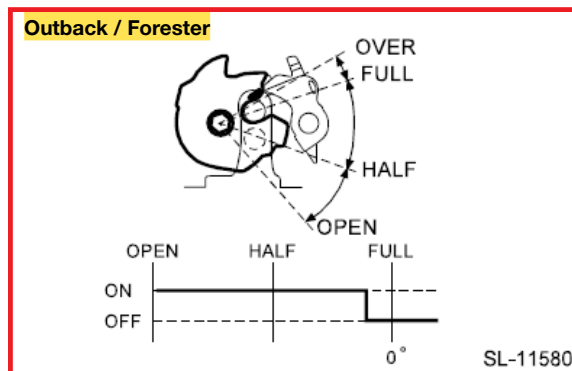
**NOTE 5) How to check resistance between terminals for Courtesy Switch.**

- Check the resistance between the terminals specified in the charts below.

Terminal No.	Inspection Conditions	Specification
7 to 8	Open	Less Than 1 Ω
7 to 8	Half	Less Than 1 Ω
7 to 8	Full	1MΩ or More

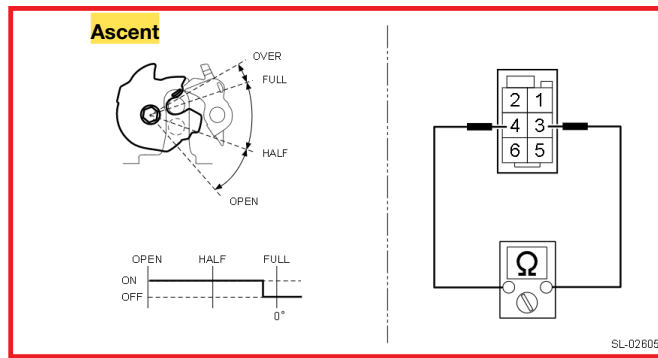
Terminal No.	Inspection Conditions	Specification
5 to 4	Open	Less Than 1 $\Omega$
	Half	Less Than 1 $\Omega$
	Full	10 k $\Omega$ or More
