SERVICE BULLETIN

APPLICABILITY: 2017-21MY WRX

NUMBER: 07-200-21

SUBJECT: Metallic Rattle Sound While Operating Horn

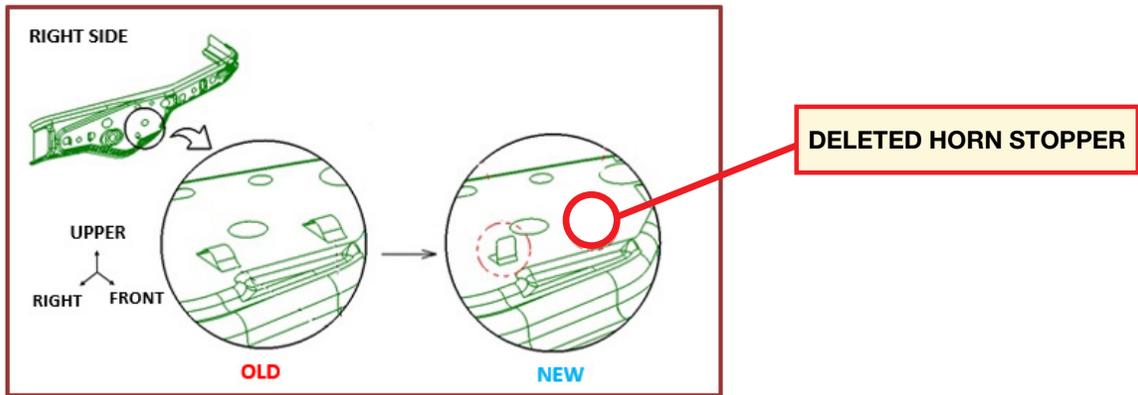
This bulletin announces the design changes to the right front wheel apron. A customer may experience a “metallic rattle” sound when operating the horn. This can be the passenger side horn mount making contact with the wheel apron creating a vibration/sound. The new apron has an added indentation to providing needed clearance for the horn. There has also been a horn stopper removed from the apron to allow additional clearance as well.

- Vehicles produced as of January 2020 will have the added indentation.
- Vehicles produced as of August 2021 will have the added indentation and the deleted horn stopper.
