SERVICE BULLETIN

APPLICABILITY: 2019-**22**MY Impreza
 2019-**22**MY Crosstrek (Including Hybrid Model)
 2019-**22**MY Forester
 2019MY Legacy/ Outback
 2019-**22**MY WRX
2019-22MY WRX STI
 2019-**22**MY BRZ- Navigation -equipped ONLY
 2019-**22**MY Ascent

NUMBER: 15-236-18R

SUBJECT: Reprogramming File Availability for Optimization of Harman Gen 3.1 and Gen 3.1α Audio and Navigation Head Units

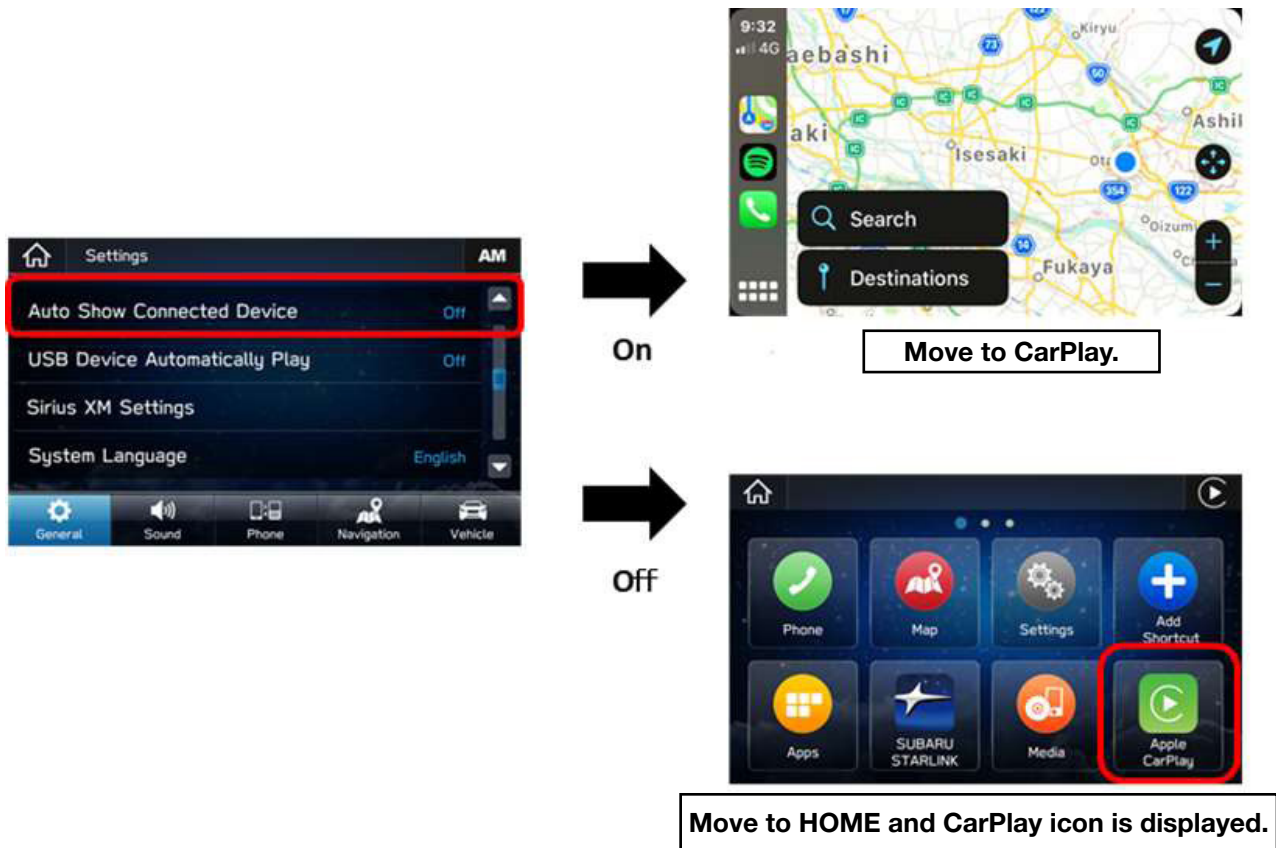
On Ver. 6.0 and before:

In a case where the iPhone was disconnected while playing music then reconnected while it is playing music, the system moves to CarPlay screen no matter what is set in <Auto Show Connected Device> in Setting (depending on iOS version of the iPhone.)

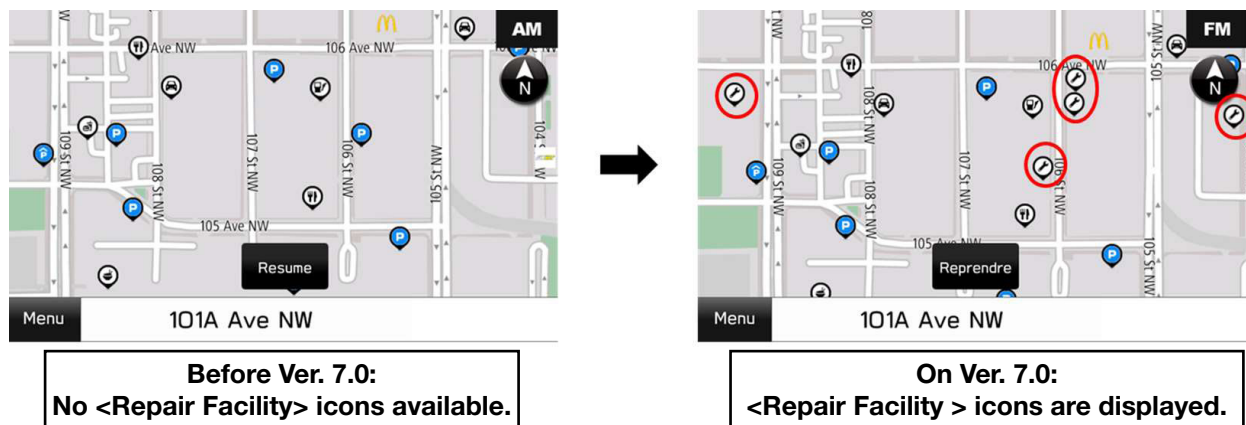
NOTE 4: Displaying Repair Facility POI icons:

<Repair Facility> Icons can be displayed in the NAVI Map.

<Repair Facility> Icons can be turned On or OFF by going to: Settings > Navigation > POI Icons.
