SERVICE INFORMATION

APPLICABILITY: All Models with STARLINK Telematics System **NUMBER:** 15-195-16R
SUBJECT: Servicing and Claim Submission Requirements for STARLINK Diagnosis and Repair Involving the Data Communication Module (DCM) **DATE:** 04/28/20
REVISED: 09/22/21

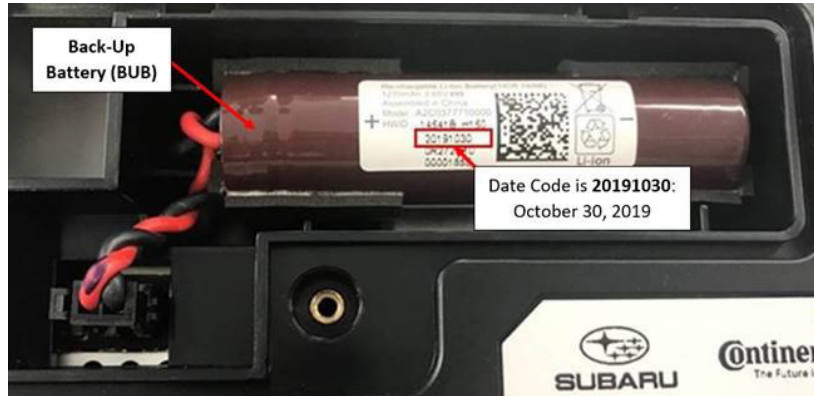
3. Techline contact may be required in some cases. Conditions may occur which cannot be resolved in the field solely by parts replacement and must coincide with additional vendor activity.
4. **NOTE:** A new replacement DCM does not come with a BUB installed. If the BUB requires replacement due to failure (B2A07) or the repair date is 5 years past the date stamp, (see image for decoding the BUB date stamp) the BUB must be ordered separately. There is also a related data collection requirement for anytime a DCM is replaced as outlined later in this bulletin.

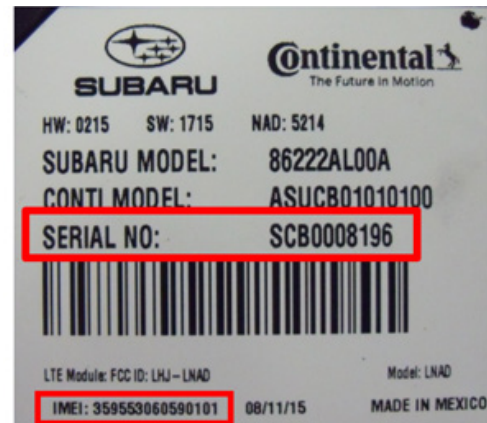
5) Effective Immediately, all claims for DCM replacement **MUST** include the 10-digit DCM Serial Number of the installed (new) DCM. This number is found on the DCM label shown here and **MUST** be entered in the Miscellaneous Detail field of the claim entry.
