SERVICE BULLETIN

APPLICABILITY: 2018-2021MY Crosstrek 2.0L DI & PHEV
2017-2021MY Impreza 2.0L DI

NUMBER: 09-81-21

SUBJECT: Fuel Injector- Design Change
Misfire DTC P030* / Engine Knocking / DTC P219C-D-E-F

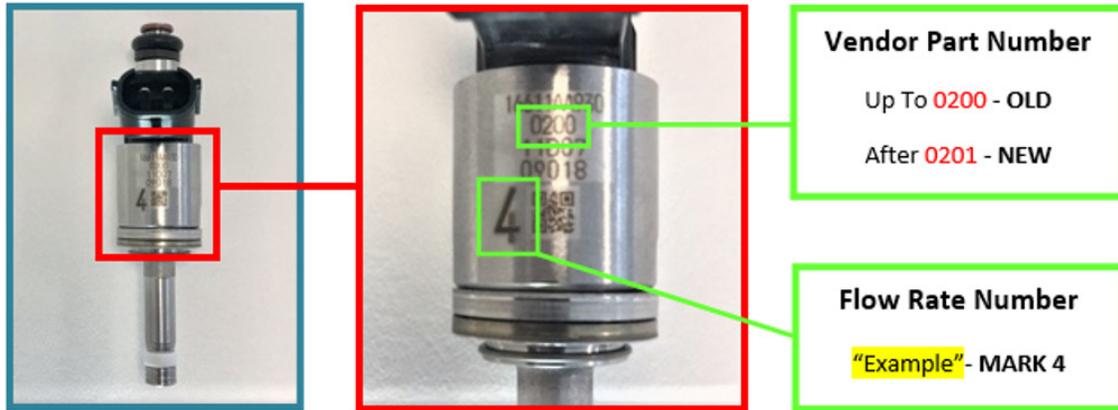
- Using the illustration below for identification reference, always replace an injector assembly with the same flow rate number as originally equipped.

STEP 8) Identify the injector assembly(s) by confirming the vendor part number and flow rate number engraved on the injector body as shown in the Parts Information section above. Replace the injector(s) as necessary with the **NEW** part(s) having the matching flow rate. Remove any carbon build-up found during replacement:
Engine > FUEL INJECTION (FUEL SYSTEMS) > Fuel Injector.
