FT5184 Safety Vision Camera system connection issues

# QJ 7621 - 2268

## Safety Vision Camera System Issues Solutions for LD82

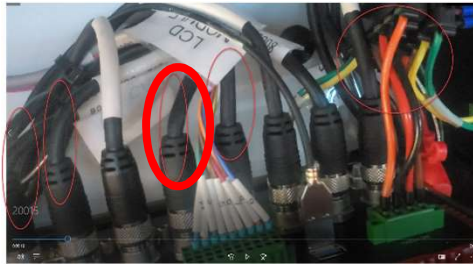
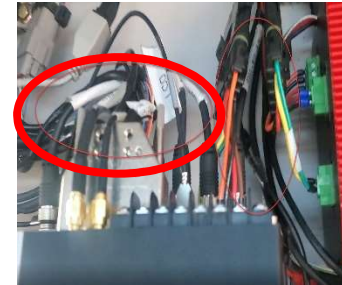
- The POE Cables connected to the NVR were too tight, stressed, and even 90° bending of the cables were observed.
- No agreed installation requirement provided by the vendor.

- 3"- 4" of slack at each end of the cables. (extra length loops vetted by PM Services)
- Avoidance of 90° bending
- Enabled free movements of the cables during Transit (Bad roads at Baltimore)

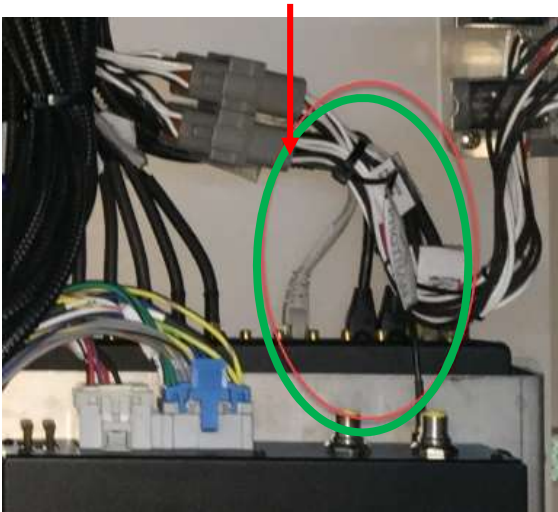
Example of Proper Routing
