Tips & Tricks – All Models

no.	Symptom	Subject	Photo	Notes and Indications - Corrective action
1	<p><u>ONLY</u> <u>Monster 821</u> <u>Monster 1200</u> <u>SuperSport</u></p> <p>Possible engine popping sound during deceleration and/or irregular idling</p>	Airbox

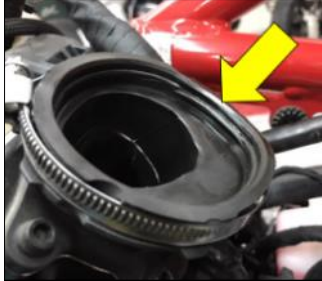
<p>We have received some complaints about a possible engine popping sound during deceleration. The performed analyses have shown that this symptom could be caused by an incorrect installation of the throttle bodies in the relevant intake manifolds (possible deformation of the rubber profile).</p> <p>Therefore, if you find any similar symptoms, we kindly ask you to check the correct installation of the Airbox on the motorcycle and that:</p> <ul style="list-style-type: none"> - throttle bodies are correctly inserted inside rubber intake manifolds, along the whole perimeter; - the rubber profile of the intake manifolds is not deformed. - the 2 fastening ties are correctly positioned in the seat on the intake manifolds. <p>Please be reminded that, to make throttle body insertion easier on rubber intake manifolds, the use of silicone lubricant or similar product is absolutely necessary.</p> <div style="display: flex; justify-content: space-around;">

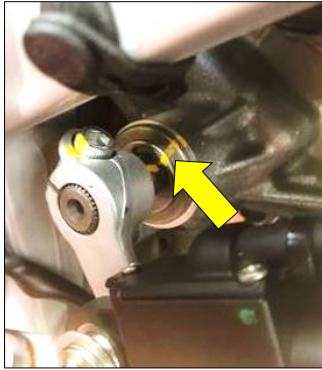
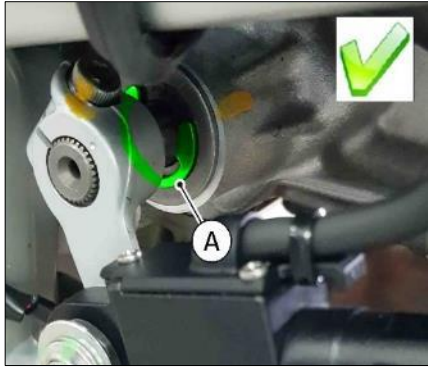
<p>We have received some isolated reports of a possible loss/absence of the snap ring (A) of the gear selector shaft. We would like to inform you that an additional certification on all Desmosedici Stradale engines between snap ring, washer, and crankcase at the outlet of the gear selector shaft has been added along the production line. The first engine serial number with this new certification is ZDM1100WC #001513#.</p> <p>Upon the first workshop service, you are thus invited to check for the presence of the snap ring (A) on all engine serial numbers preceding the one specified above.</p>

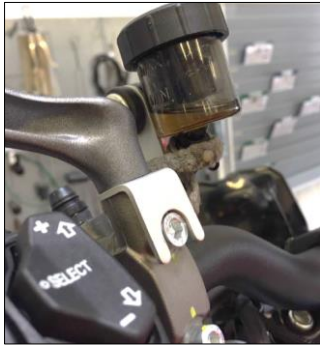
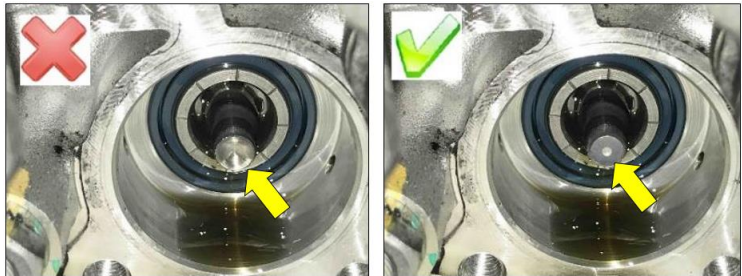
<p>We received a few claims concerning a reduction of the clutch fluid level inside its reservoir. We would like to inform you that it is not sufficient to carry out the bleeding procedure or top up the clutch fluid inside the reservoir. We suggest, at a preliminary stage, to check:</p> <ul style="list-style-type: none">• the play between the clutch master cylinder and the lever• if the clutch pushrod is worn or damaged in the area of contact with the clutch slave cylinder (ball)• the condition of the clutch slave cylinder protective diaphragm, which must not be torn. <p>According to our analyses, this phenomenon is due to a DOT4 leakage from the primary seal of the clutch slave cylinder (missing fluid in the reservoir builds up in-between the clutch slave cylinder diaphragms); in some cases, this phenomenon is also accompanied by wear of the clutch pushrod. We therefore ask you to replace the slave cylinder with a new part no. 19540091D featuring a new gasket in order to prevent the phenomenon described above.</p> <p>If the clutch pushrod is damaged as shown in the figure, replace it as well.</p> <div data-bbox="1256 727 1995 1003">

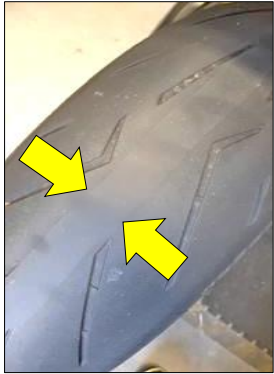
<p>We have received some isolated reports of the appearance of a "band" in correspondence with the central area of the Pirelli Diablo Rosso Corsa II rear tire.</p> <p>We would like to inform you that, since these are extremely sporty tires with 5 different compound zones at the rear, it can happen that, depending on the type of use of the motorcycle, they wear out in a different way causing the above mentioned phenomenon to occur; sometimes this occurs on the shoulder area, sometimes in the central area but, in general, it is a purely aesthetic phenomenon that does not affect the performance of the tire itself.</p>

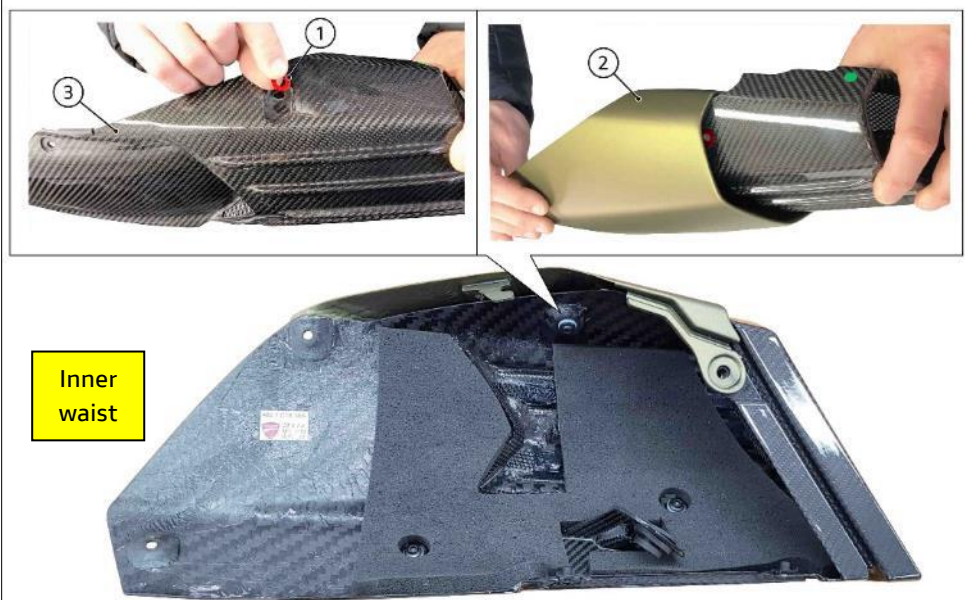
<p>We have received some isolated reports about a possible indentation of the RH and/or LH outer cover of the air conveyor.</p> <p>To avoid this phenomenon, it is necessary to position washer (1) 4x14x1 Part no. 85240171A between outer cover (2) and carbon air conveyor (3) in the upper fixing point, as shown in the figure.</p>

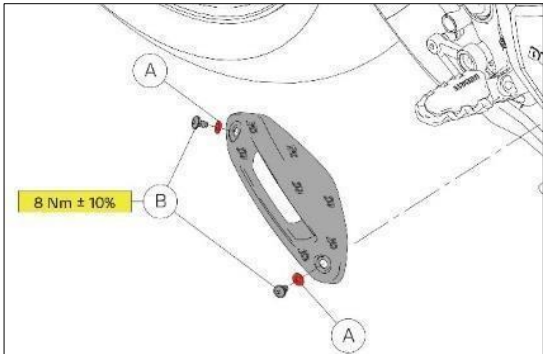
<p>We inform you that the assembly instructions for the carbon horizontal manifold heat guard kit by Ducati Performance part no. 96980251A have been updated. In particular, in order to install the part, <u>you must reuse the 2 washers (A) present on the original heat guard.</u></p> <p>Please always comply with the tightening torque of the 2 screws M6x12 (B) of 8 Nm ± 10%.</p>

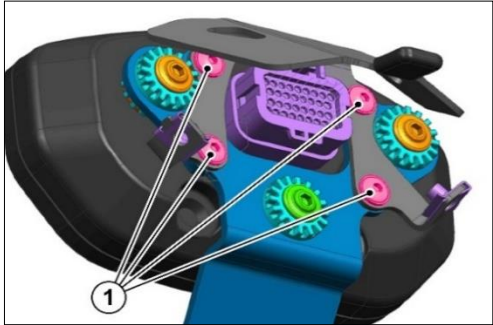
<p>We have received a few reports stating that 4 M5x8 screws (1) part no. 77240243C required to fix the headlight fairing support bracket to the instrument panel support bracket are missing from the kit supplied with the motorcycle.</p> <p>We would like to inform you that the kits available in stock have all been sorted out.</p> <p>For the headlight fairing assembly procedure and all Pre-delivery operations, please refer to the model introduction bulletin SRV-SRB-21-022.</p>

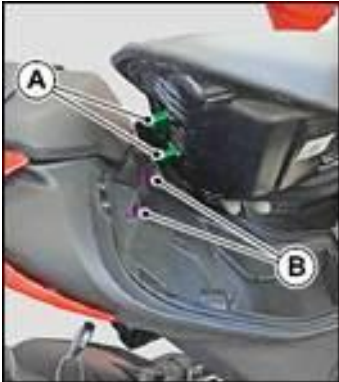
<p>We have received some reports about the possibility of unhooking the rear fasteners of the rider seat (the two pins (A) on the rear end of the underseat plate come out of from their seats (B) on the rear subframe).</p> <p>We would like to inform you that to avoid the phenomenon described above, the underseat plate has been updated by lengthening the rear fasteners; the new specific part numbers for each country version are indicated below:</p> <ul style="list-style-type: none"> • Part no. 595P6961BA: lowered rider seat (country versions Japan, South Korea and Taiwan) • Part no. 595P6801CA: rider seat <p>The new seats were introduced into production at the end of May and the spare parts warehouse has been rectified with the new part numbers.</p>

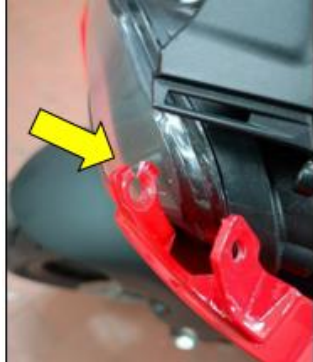
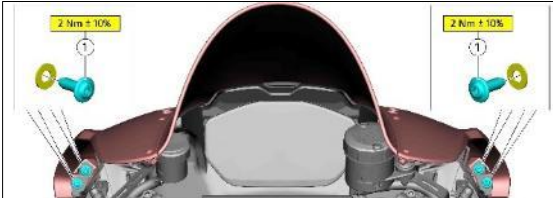
<p>We received some isolated claims about the possible breakage of the top fastener retaining the LH side half-fairing to the headlight fairing.</p> <p>During PDI and whenever removing the side half-fairings, we remind you to pay utmost attention to the tightening of the 2 screws M5x0.8 (1) retaining the upper LH and RH half-fairings to the headlight fairing; always comply with the specified tightening torque of 2 Nm ± 10%.</p>

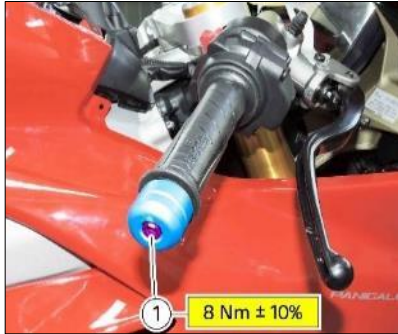
<p>We received some isolated claims about the possible triggering of a longitudinal crack on the handlebar, on balancing weight side. Our laboratory analyses found that said crack is due to an excessive tightening torque applied when installing the balancing weights.</p> <p>When installing balancing weights on the handlebar, please comply with the tightening torque specified for the M6x55 screw of 8 Nm ± 10%, as indicated on the bulletin introducing the model and on the Workshop Manual.</p>

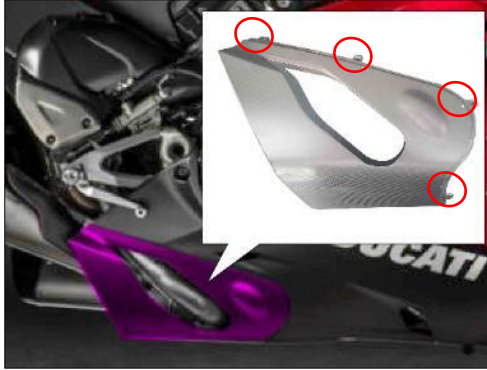
<p>We have received some isolated reports about an incorrect coupling between the silencer covers and the side half fairings in case the complete Akrapovic racing titanium exhaust system, supplied with the motorcycle, is installed. In fact, it is possible to find a misalignment between the mounting holes of the components.</p> <p>To improve this coupling, it is possible to slot-drill the 4 mounting holes of the silencer covers by using a column drill with a <u>6 mm drill bit</u> and setting a high rotation speed to prevent the fiber from flaking off.</p>

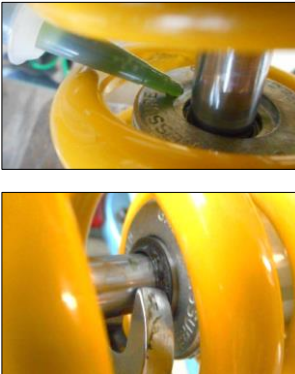
<p>We have received some isolated reports about the possible popping out of the dust seal on the rear shock absorber buffer support plug. <u>Do NOT replace the rear shock absorber.</u></p> <p>To avoid the phenomenon described above it is necessary to:</p> <ul style="list-style-type: none"> - apply a few drops of LOCTITE 638 on the plug, at the dust seal seat; - place the dust seal on the plug using an open-end wrench and hold it for a few seconds; - carefully clean any residues of LOCTITE 638 that may have fallen accidentally on the rod and on any other surface. <p>Please note that the supplier, Sachs, has introduced LOCTITE 638 during the assembly stage from <u>week 29-2020</u> (this information can be found on the sticker on the shock absorber body).</p>

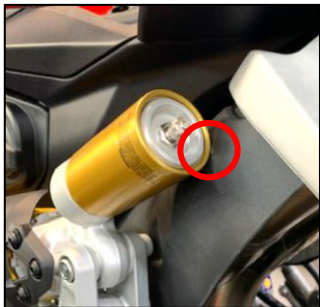
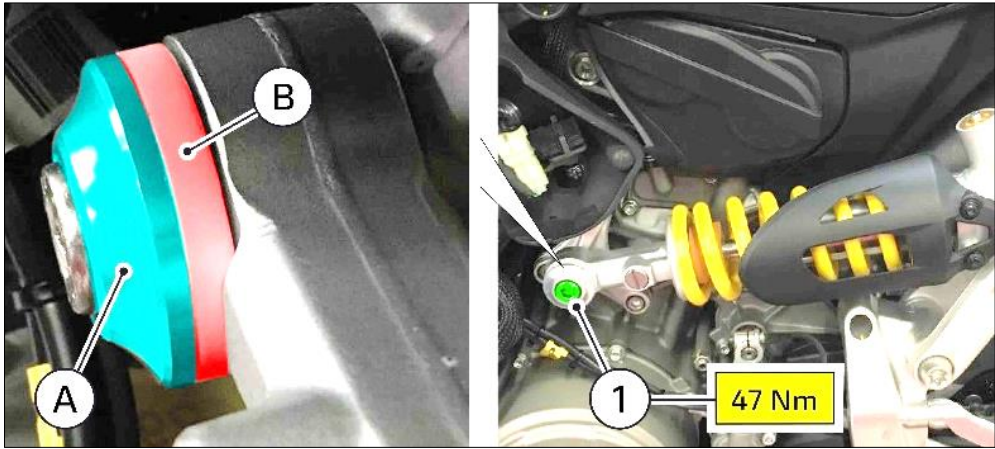
<p>We would like to inform you that starting from the frame number ZDMHAATW2MB003762, a spacer and a Teflon anti-rotation washer have been introduced at the front fixing screw of the shock absorber to prevent possible contact between the rear shock absorber reservoir and the vertical head manifold head guard. The contact results in a cosmetic defect only.</p> <p>In case of complaints from the Customer, it is possible to proceed with the installation of spacer part no. 7111D981AA (A) and washer part no. 7131E352A (B), as shown in the figure.</p> <p>We remind you to always apply the screw M10x45 (1) with Shell GADUS S2 V220 AD 2 grease and to tighten the screw to the new torque of 47 Nm (the previous tightening torque was 45 Nm).</p>

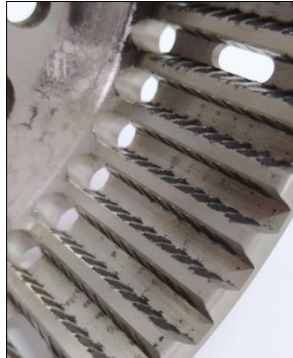
<p>We have received some isolated reports of possible clutch slipping, due to clutch housing indentation, which does not allow the drive and driven plates to come back into contact with each other correctly. This phenomenon depends on the use of the motorcycle and the user, therefore for racing use we suggest replacing the plates approximately every 5000km,.</p> <p>We would like to inform you that the new clutch housing with deep anodizing part no. 19810671C, replacing the natural grey one, is available as a spare part; this treatment improves the reliability of the clutch housing reducing the damaging of the drive plates on its contact surface.</p>
19	<p style="text-align: center;"><u>ONLY</u> Panigale V4 MY21</p> <p>Error “P0919 - Gear sensor plausibility” with MIL warning light turning on and/or failed display of the engaged gear on the instrument panel</p>	<p>Error “P0919 - Gear sensor plausibility”</p>	<p style="text-align: center;">-</p>	<p>If the error “P0919 - Gear sensor plausibility” occurs, <u>do NOT replace the gear sensor.</u></p> <p>It is necessary to check that the engine control unit software version is updated, then access the “Settings” section and activate the “<u>Reset of the final drive adaptive parameters</u>”.</p> <div style="background-color: black; color: white; padding: 5px;"> <p>CCP Enabling/Disabling</p> <p>DQS adaptives reset</p> <p>Idle control adaptives reset</p> <p>Idle speed engine operation mode</p> <p>Knock sensor adaptives reset</p> <p>Reset gears</p> <p style="border: 2px solid red; padding: 2px;">Reset of the transmission adaptive values</p> </div>

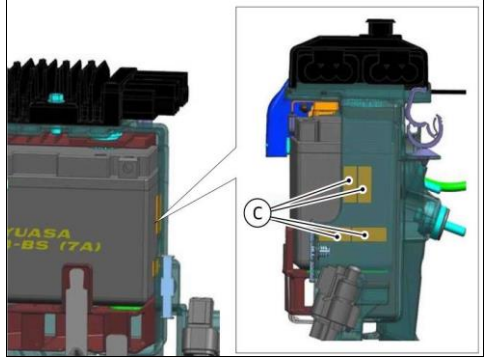
<p>The ongoing tests on the product have revealed the possibility of contact between the battery and its support, which causes marks on both surfaces due to vibration. These marks do NOT affect the correct operation of the electric system and therefore of the vehicle.</p> <p>In order to prevent such marks, 4 adhesive pads (C) in rubber 9X23X1.4 part no. 86612791A have been introduced in the production line to be applied inside the battery support.</p>
