Tips & Tricks –Multistrada V4 Model Year 2021

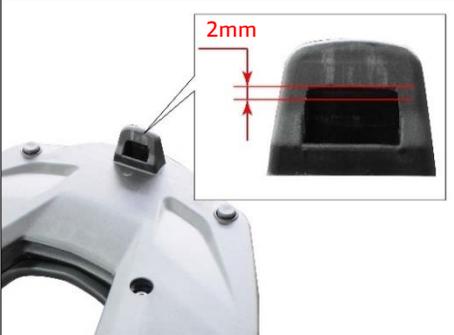
no.	Symptom	Subject	Photo	Notes and Indications - Corrective action
1	Issues during Top Case fixing to the plate	Top Case Kit Part no. 96781531AA

<p>We have received some reports concerning the difficulty in securing the Top Case (Kit Part no. 96781531AA) to the top plate Part no. 8291M033A due to a machining error of the supplier. In particular, the locking tooth on the upper plate Part no. 8291M033A shows a hole 2mm narrower than specified. To eliminate this defect, the locking tooth of the plate must be milled by <u>2mm in the upper area</u> using a flat file, as shown in the figure.</p>

<p>We inform you that the upper plates present inside the kits in stock have been restored.</p>
2	Anti-theft system kit Part no. 96681081AA malfunction	Anti-theft system kit Part no. 96681081AA

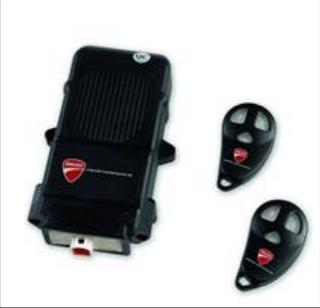
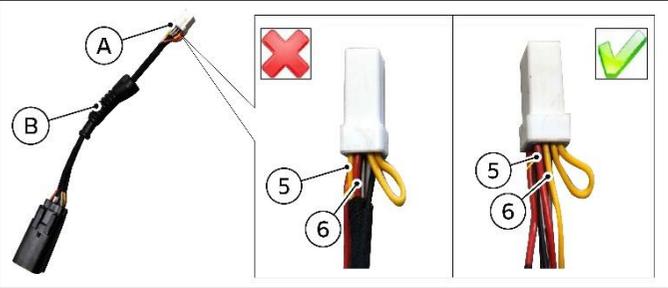
<p>After having installed the anti-theft system Kit Part no. 96681081AA and enabled it on the BBS control unit, some malfunctions may occur during activation due to a possible incorrect pin arrangement in the connector of the wiring branch supplied with the kit.</p>

<p>Follow the procedure described below:</p> <ol style="list-style-type: none"> 1) uncover connector (A) by moving sheath (B) backward; 2) uncover the wiring by removing a portion of insulating tape to make operations easier; 3) check the arrangement of Pins 5 and 6 and the relevant color on the 8-pin connector. If the pin arrangement is not correct, extract them working from the front side with a needle inside the groove so as to lift the retainer and invert them. 4) restore the cloth tape previously removed and the position of the protective sheath (B).

<p>The kits currently in stock have been restored.</p>

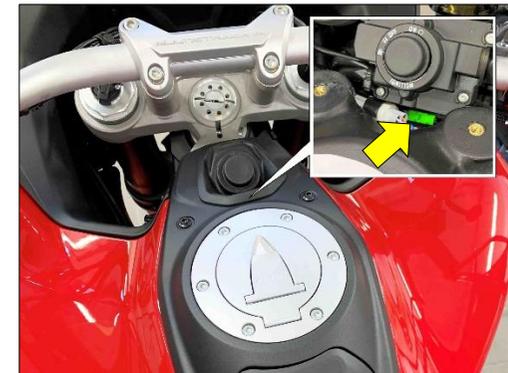
<p>We inform you that for the installation of the heated handgrip kit part no. 96680702A, the main wiring harness connectors where to connect the heated handgrips, are positioned below the ignition switch cover as shown in the figure.</p>

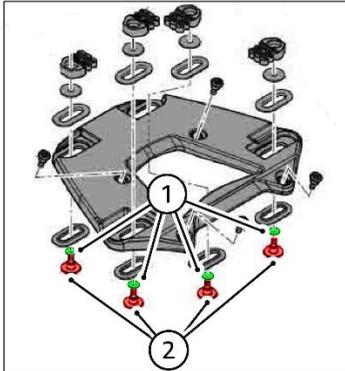
no.	Symptom	Subject	Photo	Notes and Indications - Corrective action
7	Possible incorrect operation of the swinging system - Top Case accessory kit part no. 96781531AA	Top Case Part no.96781531AA

<p>We inform you that the first Top Case accessory kits part no. 96781531AA delivered may not operate correctly with the swinging system, which may seem “too braked”. To improve this condition, it is possible to insert 4 copper washers (1) part no. 85250231A on the 4 screws (2) retaining the bottom plate to the top one.</p> <p>For a better understanding of the assembly procedure of the Top Case accessory kit, a video has been made which can be viewed at the following link: https://youtu.be/DVEHKVvdKQI.</p> <p>All Top Case kits in stock will be restored by February.</p>

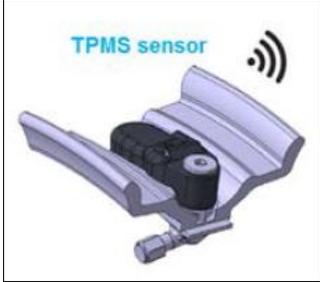
no.	Symptom	Subject	Photo	Notes and Indications - Corrective action
10	Activation procedure for TPMS tire pressure sensor	TPMS (Tire Pressure Monitoring System)

<p>The TPMS system (Tire Pressure Monitoring System) allows monitoring tire pressure value: if tire pressure deviates by 25% from the set reference value, the TPMS system displays a warning on the instrument panel. The sensor activates when speed exceeds 35 km/h and tire pressure is displayed on the instrument panel 1 minute later.</p> <p><u>We remind you that, before installing tire pressure sensors on front and rear wheel rims, they must be coded through DDS 3.0 diagnosis instrument.</u></p> <p>To activate TPMS system, follow the procedure indicated below:</p> <ol style="list-style-type: none"> 1) using DDS 3.0, access the "Special Features → Ducati Accessories Manager → Vehicle Configuration"; 2) select "Enable/Disable" TPMS; 3) access the "Self-diagnosis → Settings" section of Hands Free control unit and perform "TPMS code writing" for front and rear wheel sensors by entering the 8-digit code written above the Qr-Code; 4) access the instrument panel Settings menu and select "Tire Pressure" to set (and customize) the reference pressure values of the rear and front tires. The tire nominal pressure value specified inside the owner's manual can be used as a reference. <p><u>Explain to the Customer the use of the "Tire Pressure" function to edit the reference pressure value of the front and rear tires. The information about the current pressure value of front and rear tires is also available inside instrument panel main menu.</u></p>

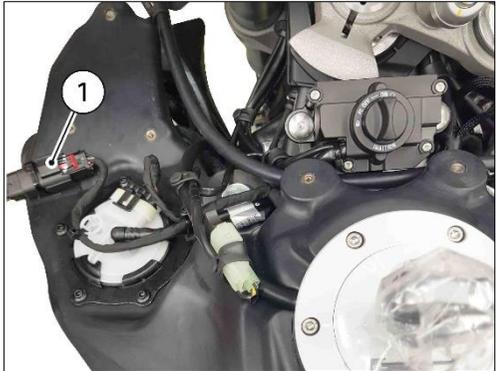
<p>We inform you that for the installation of the anti-theft system kit part no. 96681081AA, the main wiring connector (1) where to connect the anti-theft device, is positioned near the fuel pump flange, in the front left area of the fuel tank.</p>

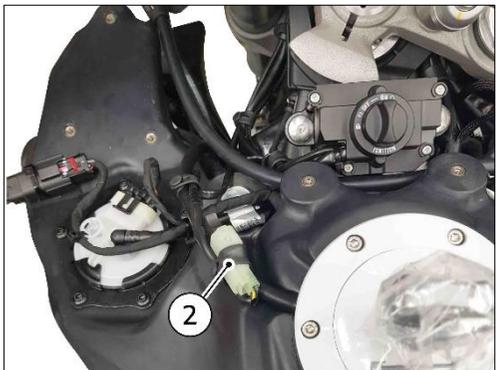
14	Assembly precaution for the fuel tank cap kit Hands Free part no. 96681021AA	Hands Free fuel tank cap kit part no. 96681021AA

<p>We inform you that for the installation of the Hands Free fuel tank cap kit part no. 96681021AA, the main wiring connector (2) where to connect the Hand Free fuel tank cap, is positioned near the fuel pump flange, in the front left area of the fuel tank.</p>

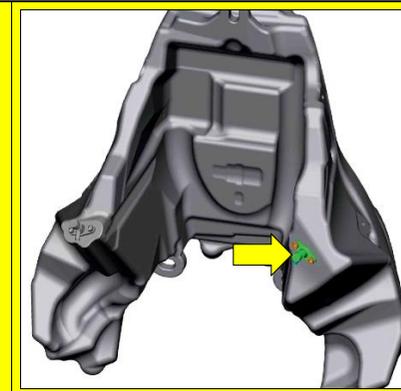
<p>NEW</p> <p>16</p>	Incorrect residual fuel in the tank	Fuel tank	-	<p>In some cases, we have found that the tap on the right-hand side of the fuel tank is completely closed instead of open; this leads to an incorrect remaining range when there are only a few liters of fuel in the tank (fuel reserve conditions).</p> <p>If the above-mentioned event occurs, we ask you to ensure that the tap on the right-hand side of the fuel tank is fully open.</p>

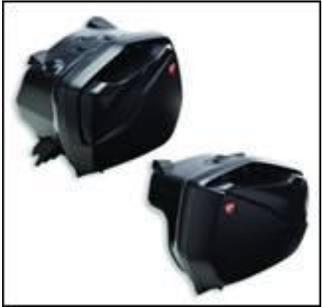
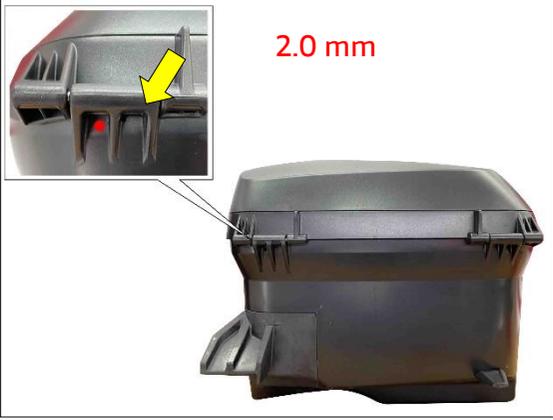
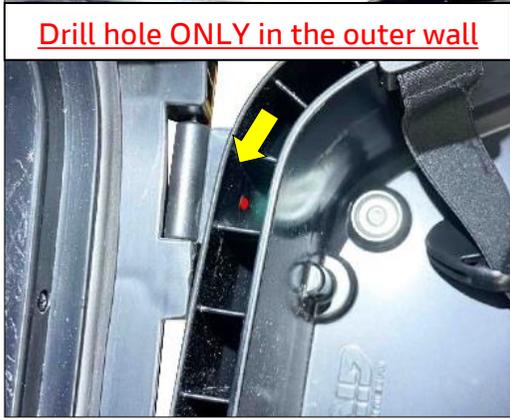
no.	Symptom	Subject	Photo	Notes and Indications - Corrective action
19	Difficulties in opening the side panniers part no. 96781551AA	Side panniers part no. 96781551AA

<p>We have received a few isolated reports of possible difficulties in opening the side panniers due to the “vacuum” effect that occurs when travelling with significant changes in altitude.</p> <p>To avoid this phenomenon, it is necessary to drill a venting hole with a maximum diameter of Ø 2 mm at the bottom of the bag, between the ribs near the rear hinge as shown in the figure.</p> <p style="text-align: center;"><u>DO NOT drill through the second internal wall of the bag.</u></p> <p>This modification has also been implemented by the supplier and does not affect the water tightness.</p> <div style="display: flex; justify-content: space-around;"> <div data-bbox="1055 595 1608 1015">

<p style="color: red; font-weight: bold;">2.0 mm</p> </div> <div data-bbox="1626 595 2136 1015">

<p style="color: red; font-weight: bold;">Drill hole ONLY in the outer wall</p> </div> </div>

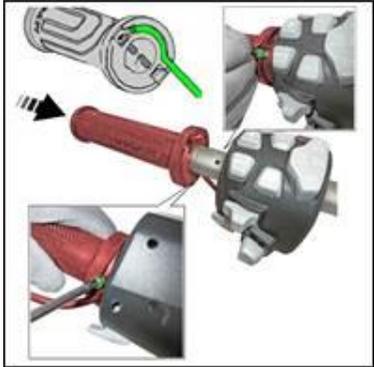
20	Precautions during PDI: installation of the heated handgrips part no. 96680702A	Heated handgrips Part no. 96680702A

<p>We have received some reports about heated handgrips that have not been installed correctly and so the cable between the handgrip and the switch may be pinched.</p> <p>We kindly ask you to always follow the instructions provided on the DCS under the “accessories catalogue” section or in the model presentation bulletin (SRV-SRB-20-049) and to <u>comply with the correct orientation of the cable and handgrip</u> as shown in the figure.</p> <div data-bbox="1756 1031 2130 1398">

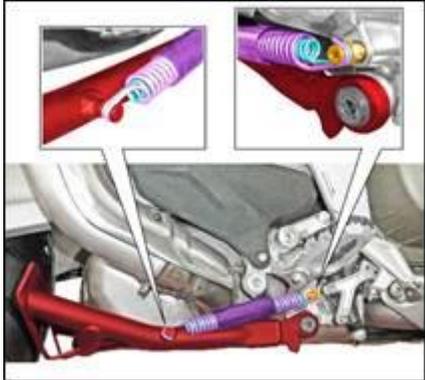
<p>We have received a few isolated reports of possible interference between the external central stand return spring and the footpeg holder plate when the central stand is closed.</p> <p>Check that the two side stand return springs are correctly installed and aimed as shown in the figure.</p>

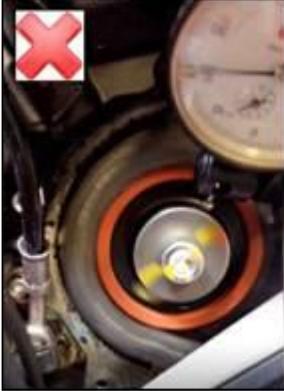
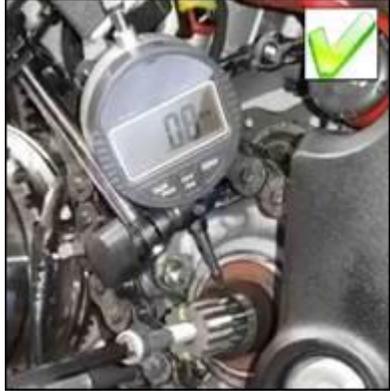
no.	Symptom	Subject	Photo	Notes and Indications - Corrective action
24	Possible oscillation of the final drive chain (non-uniform sliding)	Gearbox secondary shaft	-	<p>We have received some isolated reports about a possible oscillation of the final drive chain even if the chain is correctly tensioned. In these cases the customer may complain an uneven sliding of the chain at constant speed.</p> <p>In these cases, you are asked to check for a possible deformation of the gearbox secondary shaft by removing both the chain and the sprocket and taking the measurement with a dial gauge directly on spacer Part no. 713P0011C, as shown in the figure (the measurement should NOT be taken on the sprocket since an uneven wear of the rubber material may occur during the first few kilometers): by slowly rotating the shaft, the value taken with the dial gauge must be at most 0.1 mm.</p> <div style="display: flex; justify-content: space-around;">

</div> <p>a) If the measurement shows values below 0.1 mm, replace the sprocket only. a) If the measurement shows a value greater than 0.1mm, fill out a YouTech service request.</p>

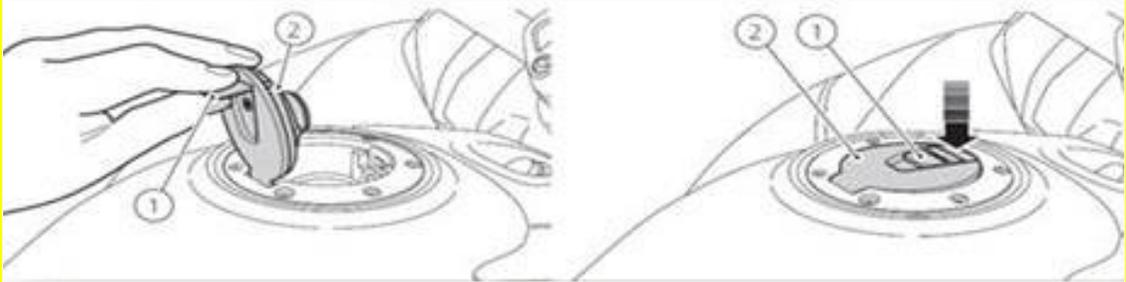
no.	Symptom	Subject	Photo	Notes and Indications - Corrective action
<p>26</p>	<p>ONLY Multistrada V4S, Multistrada V4S Sport</p> <p>Precautions for the use of the Hands Free fuel tank cap part no. 96681021AA</p>	<p>Hands Free fuel tank cap part no. 96681021AA</p>

<p>We have received a few isolated reports concerning the hands free fuel cap part no. 96681021AA that proves difficult to open and/or close. DO NOT REPLACE THE FUEL TANK CAP.</p> <p>Hands-free tank filler plug</p> <p>The hands-free tank filler plug allows the cap to be opened during refuelling without using a key.</p> <p>Opening</p> <p>To open the cap, the suitable flap must be lifted within 50 seconds of turning the vehicle off (key off). During those 50 seconds, the cap can be opened a maximum of 5 times. If a new opening is desired, the key must be turned on and then back off (key-on >> key-off).</p> <p><u>Caution: the opening flap must be operated gently. Excessively fast movements may impair the cap opening, even though the attempt will still be counted among the 5 available.</u></p> <p>Information on instrument panel</p> <p>The instrument panel has an icon indicating “fuel cap open”. If the instrument panel is turned on (key-on) while the cap is open, the icon will be active.</p> <p>Closing</p> <p>To close the cap, use your fingers to push it in fully home.</p> <p><u>Caution: After refuelling, always ensure that the cap is correctly positioned and closed and that the corresponding icon on the instrument panel is off.</u></p>
