Subject: TELEMATICS COMMUNICATION UNIT (TCU) ACTIVATION PROCEDURE	Service Alert No.: SA-004/21
	Last Issued : 09/13/2021

2019-2021 Mazda3
2020-2021 CX-30
2021 CX-5
2021 CX-9

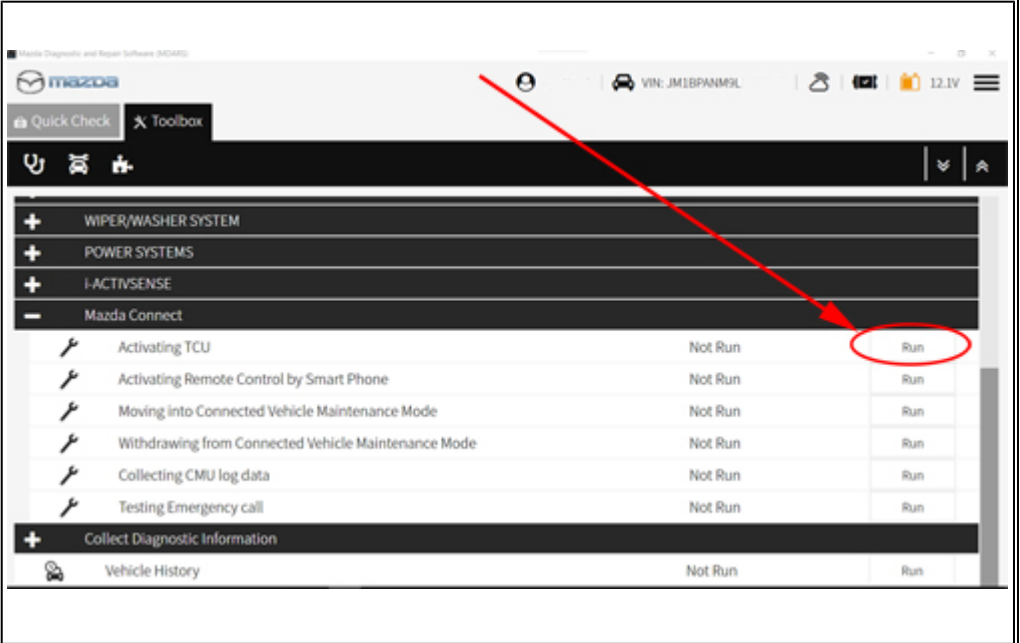
NOTE: MDARS may show "Incomplete". This may be caused by:

- Advanced key is not in the vehicle.
- Connected vehicle maintenance mode is enabled.
- Pacemaker radio wave interference prevention is enabled.
- key transmitter power saving function is enabled. See SA-040/20.

9. Select Activating TCU (links TCU to server) -> "Run". Wait for "initialization complete" message.

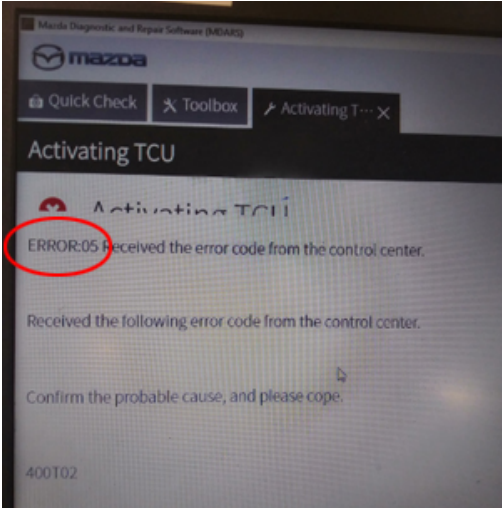
ERROR:05	Error code 400t02

- If DTC U2050:55-TCU (Activation of remote control not implemented) is stored, go to TSB [09-013/20 - DTC U2050:55 STORED AFTER REPLACING OR REPROGRAMMING TCU](#).
- If the TCU was not replaced and MDARS shows error code 400t02 and/or ERROR:05, TCU activation was previously completed. Ignore these errors as TCU activation is not required.
