# Service Alert

| <b>Subject:</b><br><br><b>CONNECTED VEHICLE SYMPTOM TROUBLESHOOTING</b> | <b>Service Alert No.: SA-013/21</b> |

2019-2021 Mazda3  
2020-2021 CX-30  
2021 CX-5  
2021 CX-9

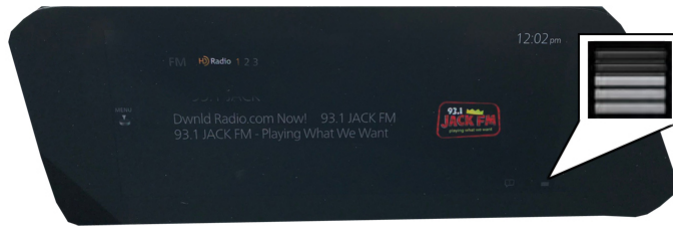
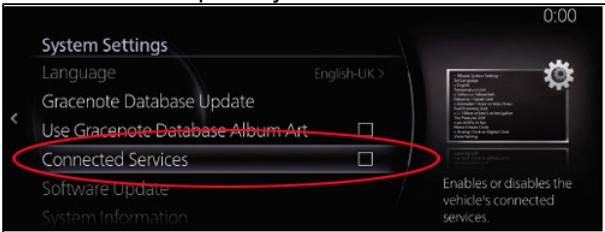
- Infotainment Center Display does not provide the Authorization Code during the MyMazda App Connected Vehicle enrollment.
- Remote function(s) inoperative.
  - Engine Start / Stop
  - Door Lock / Unlock
  - Lights ON / OFF
- MAZDA CONNECT connected vehicle reception strength icon shows "X" or "\".

Confirm the customer's phone and vehicle have good to strong reception during the concern as shown in the table below.

- If the reception is weak, move the vehicle to a location where the reception is good to strong as shown in the table, then try to get the Authorization Code and/or operate the remote functions before proceeding to the Repair Procedure if there is still an issue.
- If the reception is good to strong, proceed to the Repair Procedure.

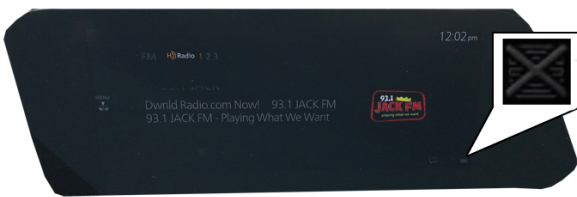
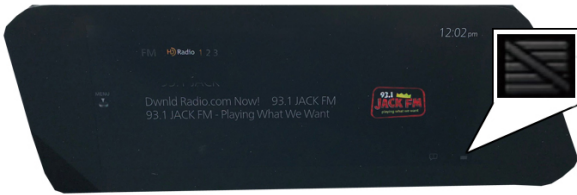
MAZDA CONNECT connected vehicle reception strength icon shows "X" or "\".

1. Did the customer deactivate Connected Services (Opt-Out)?

- **Yes:** No repair needed.
- **No:** Go to next step.

2. Check for DTCs.

- **Yes:** Go to MGSS for normal DTC diagnosis.
- **No:** Go to next step.

3. Disconnect battery terminal for 30 seconds, then move the vehicle. **Is the reception strength signal normal?**

- **Yes:** Repair complete.
- **No:** Go to next step.

4. Perform TCU activation. Go to [SA-004/21](#). **Is the reception strength signal normal?**

5. Compare Tel antenna No. 1 signal strength with good known vehicle near by.

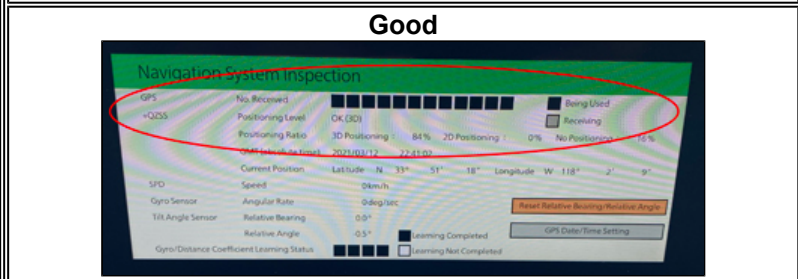
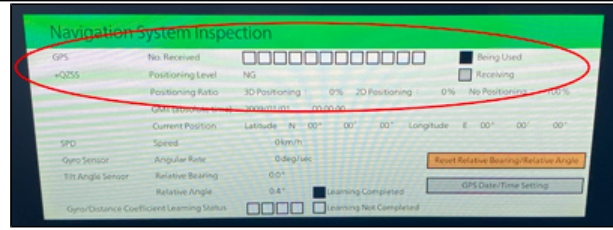
**No Good**

- **Good:** Contact Hotline for technical support.
- **No Good:** Swap Tel antenna No. 1 with known good vehicle.

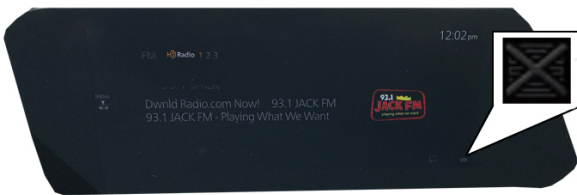
- The customer is not able to activate Connected Services via the MyMazda app after CSP06 completion.
- MAZDA CONNECT connected vehicle reception strength icon is missing or shows unsubscribed after CSP06 completion.

Go to [CSP07 Repair instructions](#).

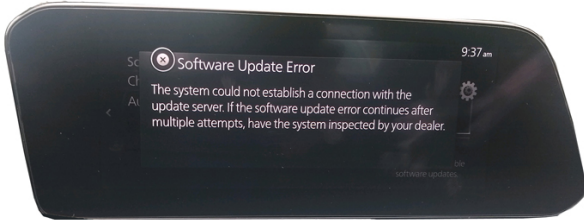
- Infotainment center display does not provide Authorization Code during the MyMazda App Connected Vehicle enrollment and infotainment Software Update Error message.

Go to [SSPC1](#).
