Service Alert

Subject: WATER LEAK FROM ROOF CAUSING ELECTRICAL AND MECHANICAL CONCERNS	Service Alert No.: SA-035/21
	Last Issued : 09/03/2021

2020-2021 CX-30

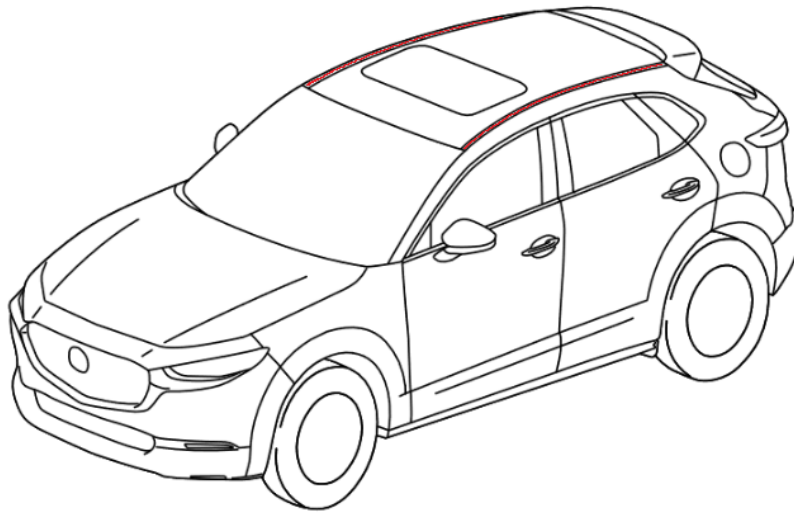
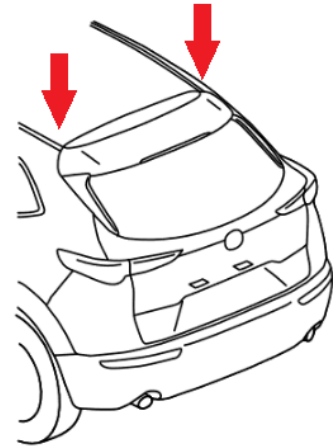
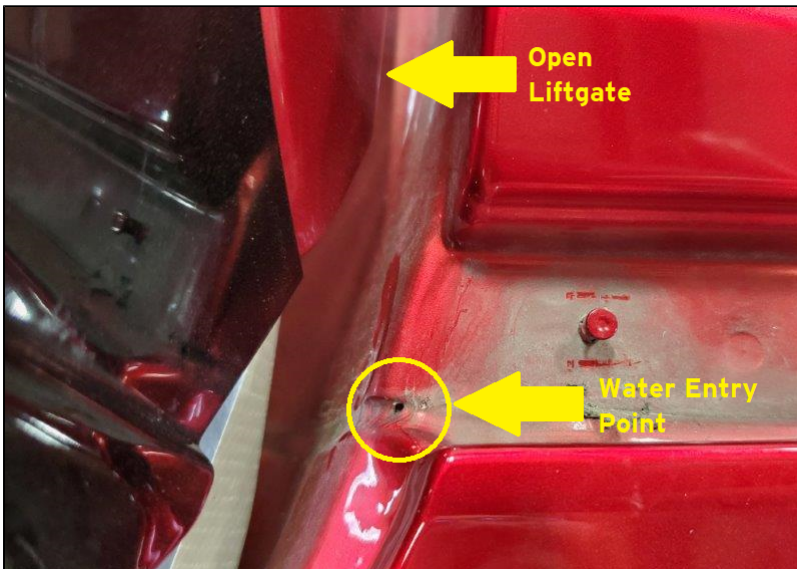
The source of the leak may be pinhole anywhere along the roof seams under the 2 trim strips (where the roof rails attach). Depending on the location of the leak, the headliner may or may not be visibly affected.

1. Document the following information on the RO:
 - Document all concerns caused by the leak (e.g. radio not working because Remote Tuner got wet).
 - Check for and document any stored DTCs.
 - Take photos of the area where the leak was found. These will be needed for the warranty claim or pre-authorization (if needed).
2. Check these locations on both sides of the vehicle for a small hole. If a leak is found at this location, sublet to a body shop for repairs.
