Technical product information

Topic	Accessory valve caps - Difficult to remove
Market area	Bentley: worldwide (2WBE)
Brand	Bentley
Transaction No.	2033864/6
Level	EH
Status	Approval
Release date

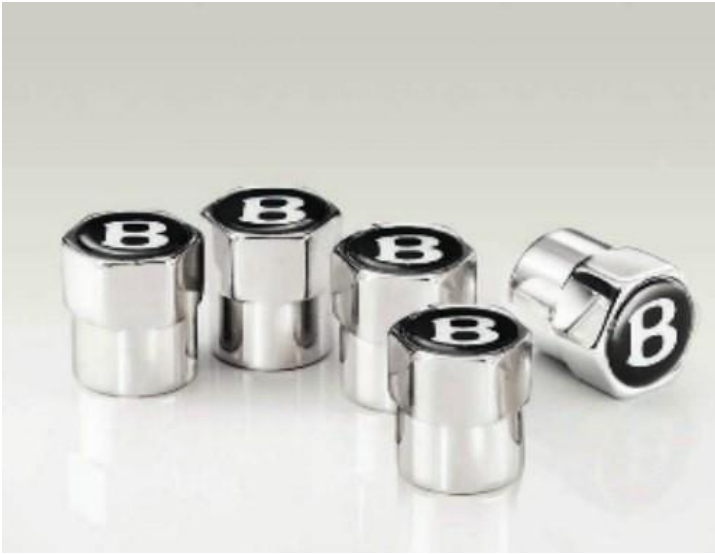
Unable to remove Accessory valve caps, Figure 1 shows an example of the caps

We have observed instances where the caps have been difficult to remove once fitted, the issue is caused by corrosion.

The valve stem itself is made from aluminium and the accessory valve caps are chromium plated brass, it is possible under certain environmental conditions, particularly winter road salt, for corrosion to take place between these dissimilar metals.

The solution is to apply a thin smear of silicon-based grease, such as Dow Corning high vacuum grease, to the external threads of the valve stem prior to fitting the accessory valve cap. Grease should be applied any time the cap is removed and grease is not evident
