CR221 – Check and Possible Re-Route of Instrument Panel Wiring

Monster (937cc) MY 21-22 (all versions)
Technical Service Bulletin SRV-TSB-21-009

Date: September 16, 2021
To: Dealer Principal, General Manager, Service Manager, North American Dealer Network
From: Richard Kenton, Technical Director
Eric Bradley, Technical Training and Publications Manager

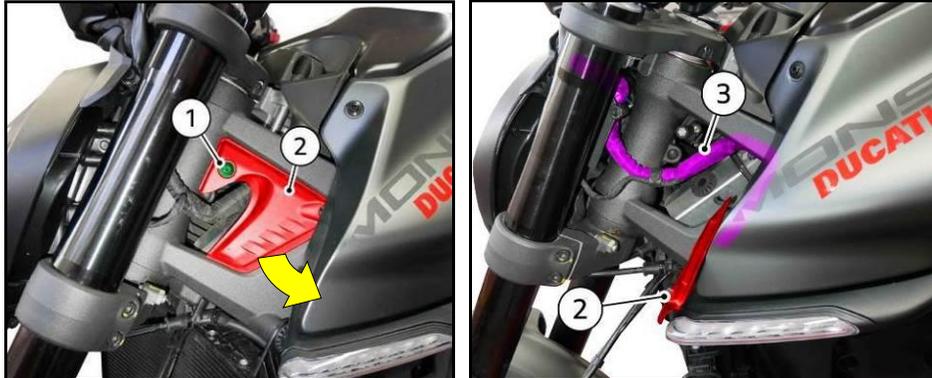
1. Working on vehicle LH side: Remove screw with collar M5x9 (1) retaining the RH cover (2) to check the routing of headlight branch (3).

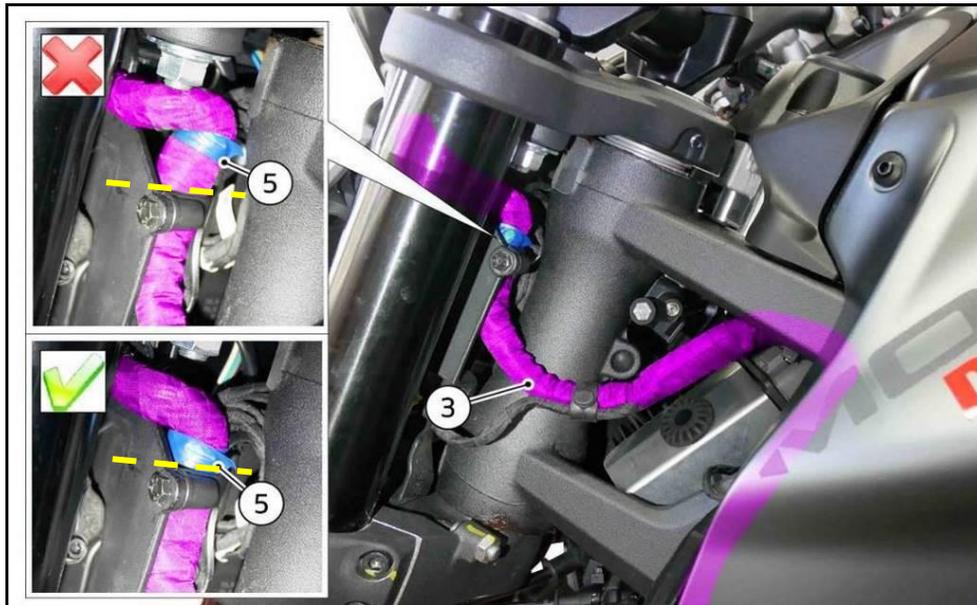
2. The blue taping (5) present on instrument panel wiring (3) must be positioned on the front wiring guide, as shown in the figure (taping must slightly protrude over the special guide).

- If the taping IS in the correct position, reinstall the LH cover by tightening the 2 screws with collar M5x9 to 3 Nm ± 10%
- If the taping IS NOT in the correct position, proceed to Part 2 **Instrument Panel Harness Re-routing**

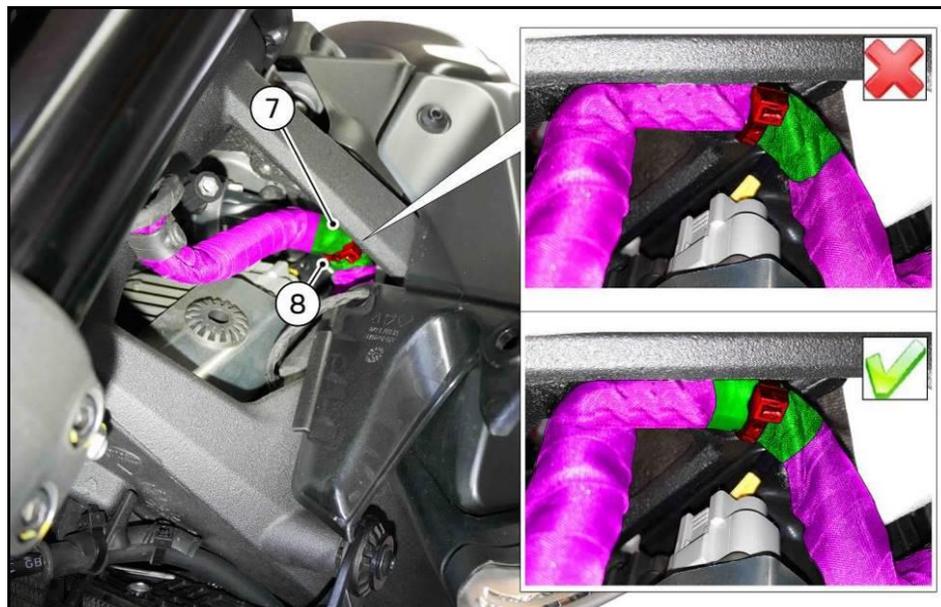
2. The black heat-shrink sheath (7) (highlighted in green in the figure) must be positioned at the center of the large self-locking tie (8), as shown in the figure. (NEVER to the right or left of tie).
