Technical product information

Topic	Bentayga - Auxiliary tail lights in bumper operating instead of main tail lights when not intended
Market area	Russische Föderation (5RU),Australia E04 Bentley rest Asia and Australia (6E04),China 796 VW Import Comp. Ltd (Vico), Beijing (6796),Germany E02 Bentley rest Europe (6E02),Japan E03 Bentley Japan (6E03),Korea, (South) E08 Bentley South Korea (6E08),United Arab Emirates E06 Bentley Middle East and Africa (6E06),United Kingdom E01 Bentley UK (6E01),United States E05 Bentley USA and rest America (6E05)
Brand	Bentley
Transaction No.	2063070/2
Level	EH
Status	Approval
Release date

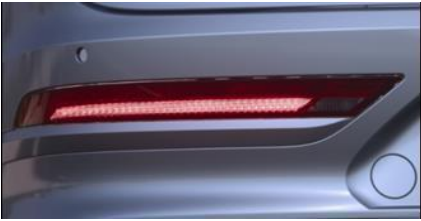
Figure 1

The auxiliary tail lamps in the rear bumper are illuminated instead of the main tail lamps with the tailgate closed, there is no fault with the main tail lamps (Figure 1)

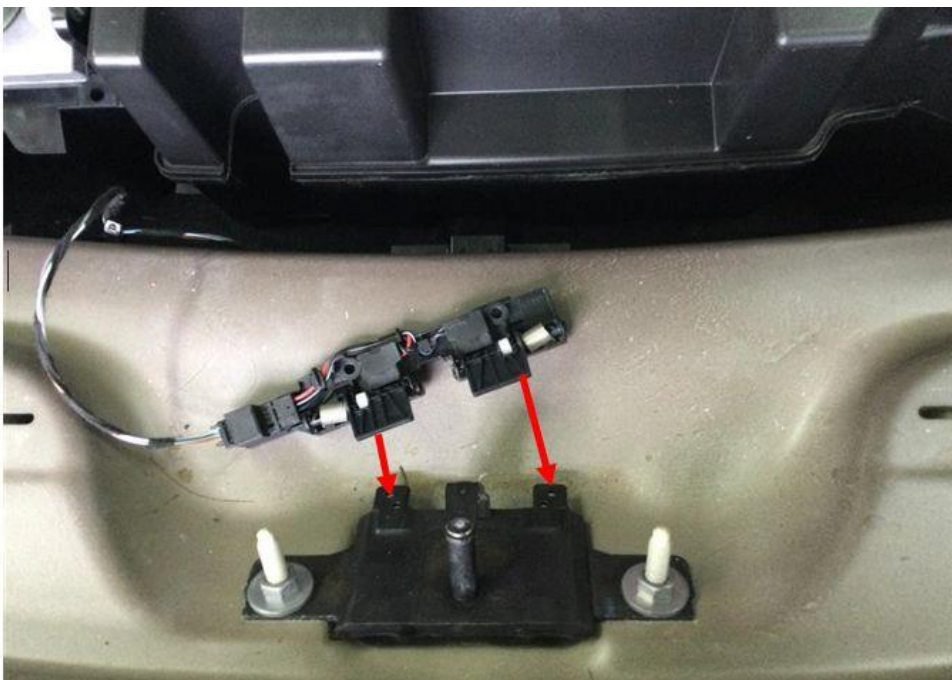
If the tailgate is closed and diagnosis has proven, by way of no DTC's, that the main tail lamps are not faulty, then the Rear lid closed sensor (G525) switch must be checked for locational and electrical integrity

- Figure 2 - Shows a sensor which is not fixed correctly

In this case, fit the sensor to the latch as shown by the arrows

- Use (x2) screws to secure the sensor into position
