Technical product information

Topic	Bang & Olufsen - BeoSonic sound settings reset after ignition cycle
Market area	Bentley: worldwide (2WBE),Hongkong-Macau (5HK)
Brand	Bentley
Transaction No.	2056276/3
Level	EH
Status	Approval
Release date

New Continental GTC

Bang & Olufsen - BeoSonic sound settings reset after ignition cycle

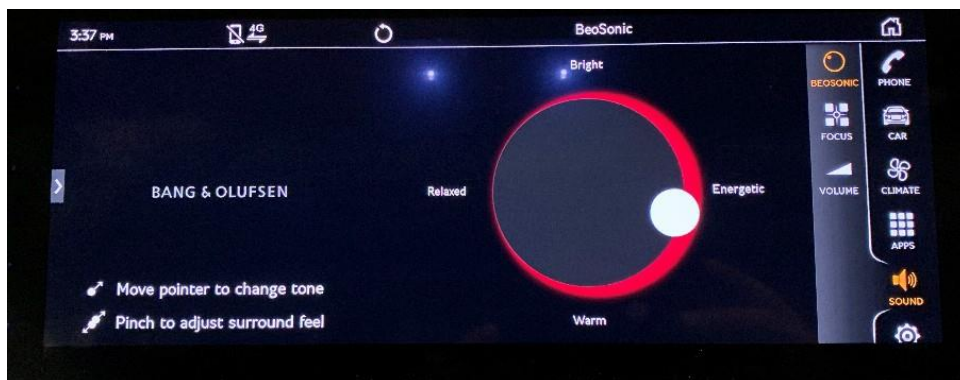
The BeoSonic sound settings are lost when the ignition is turned off.

Incorrect software in the Sound system control module.
