Technical product information

Topic	Windscreen replacement criteria whilst under manufacturers warranty
Market area	Bentley: worldwide (2WBE),Hongkong-Macau (5HK)
Brand	Bentley
Transaction No.	2057841/3
Level	EH
Status	Released for publishing
Release date	27-Aug-2021

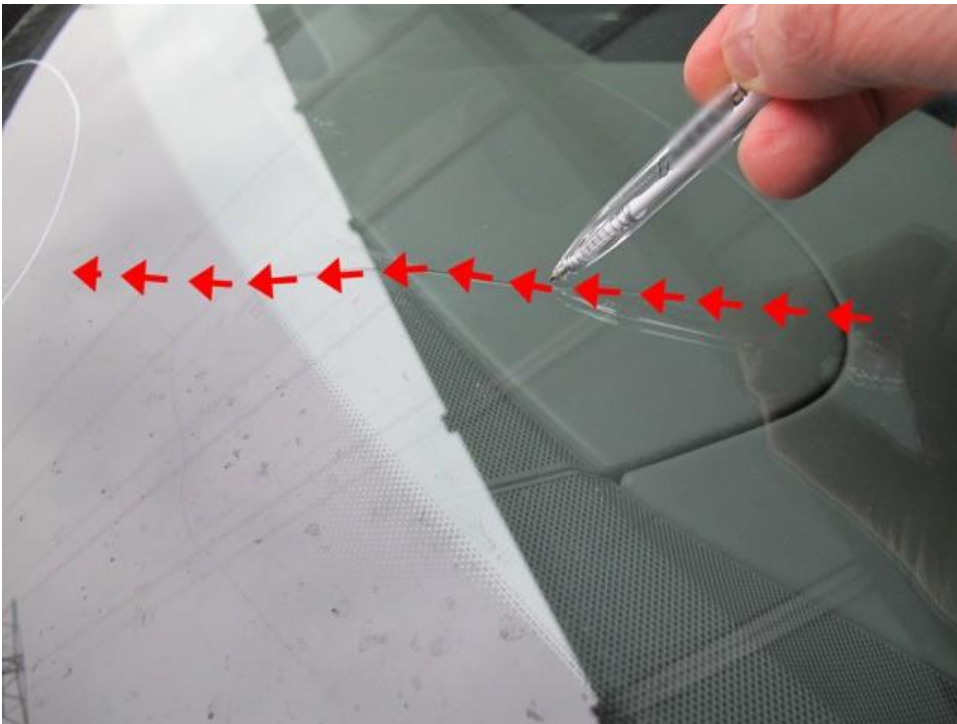
Figure 1

TIP: A "pen test" can be used to determine if there is a stress crack evident, a ballpoint pen tip is run along the crack (Figure 1), in the event the tip of the pen dips at any point along the crack this MUST be classed as damage from external influences

Should the pen not dip this can possibly be considered as a stress crack

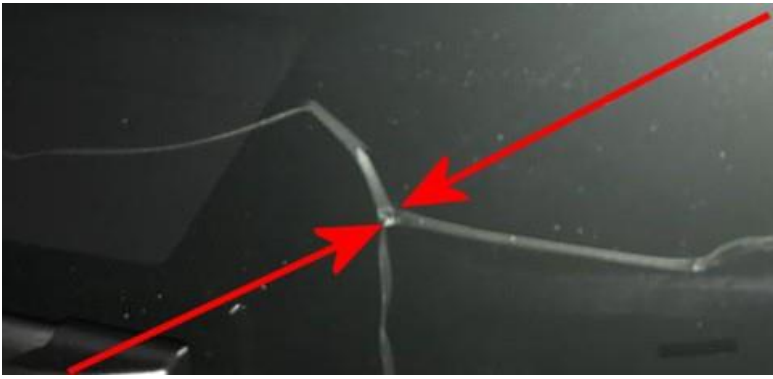
In the event that the windscreen has been identified as cracked/damaged through impact (See Figure 2 as an example), this would NOT be covered under the Bentley Motors Warranty policy, therefore the windscreen MUST be replaced, the cost of replacement would not be covered by Warranty

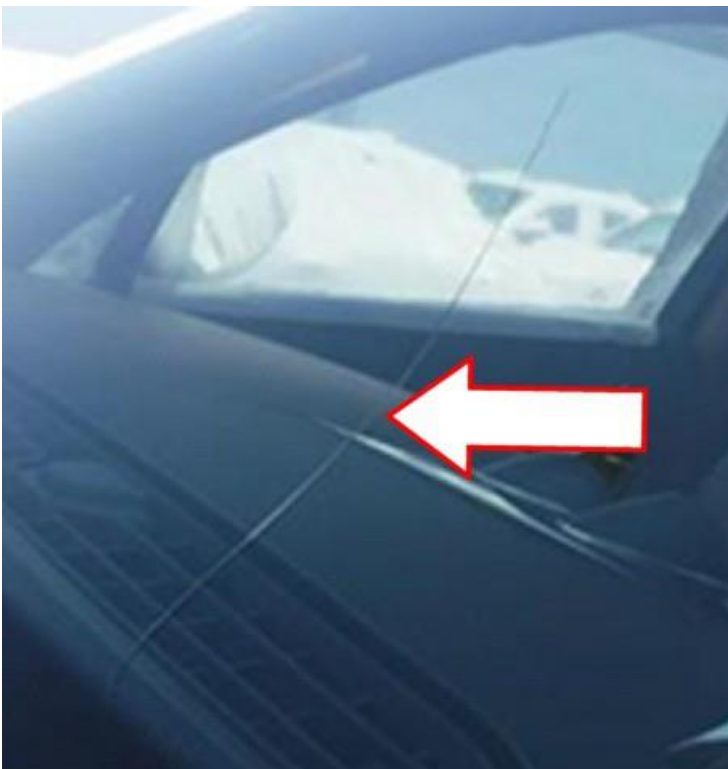
In the event the screen has been identified as cracked/damaged through a stress fracture (See Figure 4 as an example) and the vehicle is covered by manufacturers/extended warranty the retailer MUST carry out the following instructions

- Damaged windscreens MUST be reported as per the Mandatory DISS reporting policy
- A DISS query must be raised, the retailer MUST not carry out windscreen replacement or removal until permission has been granted through the open DISS query *NOTE: Product Support may request the screen is removed for further diagnosis*
- The retailer must ensure that the following information is attached within the query
- Clear photographs of the crack/damage
- Clear description of the location in which the crack/damage is emitting from for example: Right hand front corner
- Video to be attached to the DISS query clearly showing the tip of a ball point pen being run along the length of the suspected crack
