Technical product information

Topic	Engine warning light illuminated within the DIP during acceleration - DTC P029900 evident - W12 TSI only
Market area	Russische Föderation (5RU),Australia E04 Bentley rest Asia and Australia (6E04),China 796 VW Import Comp. Ltd (Vico), Beijing (6796),Germany E02 Bentley rest Europe (6E02),Japan E03 Bentley Japan (6E03),Korea, (South) E08 Bentley South Korea (6E08),United Arab Emirates E06 Bentley Middle East and Africa (6E06),United Kingdom E01 Bentley UK (6E01),United States E05 Bentley USA and rest America (6E05)
Brand	Bentley
Transaction No.	2063954/3
Level	EH
Status	Approval
Release date

New Continental GT/GTC - New Flying Spur, Bentayga - W12 TSI

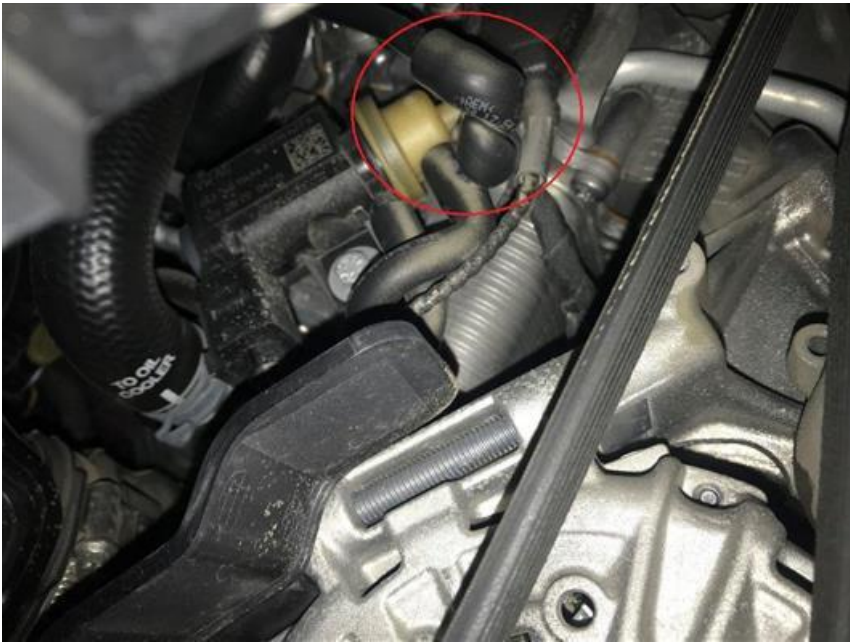
A kinked/damaged hose within the engine vacuum system

3) Carry out a visual inspection of the engine vacuum system TIP: Referring to the example shown in Figure 2, Check there are no kinks or damaged vacuum hoses

NOTE: The issue shown in Figure 2 is an example of a kinked vacuum hose which is fitted to the Boost pressure valve vacuum solenoid

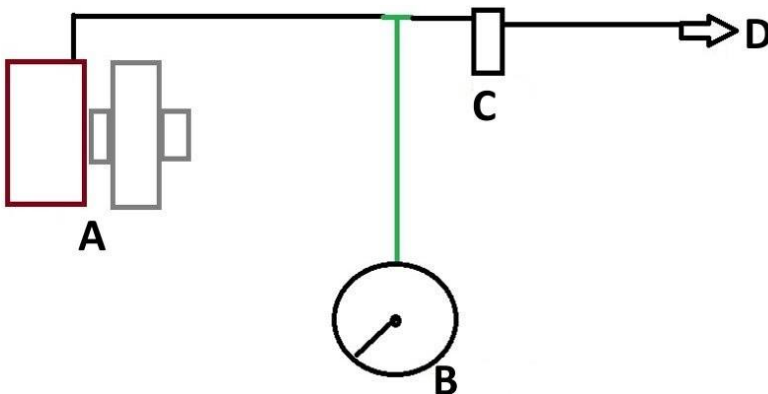
4) Referring to Figure 3 - Attach a manual vacuum gauge (B) between the following components: (Depending on the bank which is suspected to be at fault)

- Turbocharger wastegate (A) and (C) Boost pressure valve vacuum solenoid

N249 (Bank1)

N547 (Bank 2)

NOTE: Point (D) refers to the engine vacuum system

The manual vacuum gauge must be connected as shown, the hose must be long enough to allow the gauge/readings to be viewed from inside the cabin

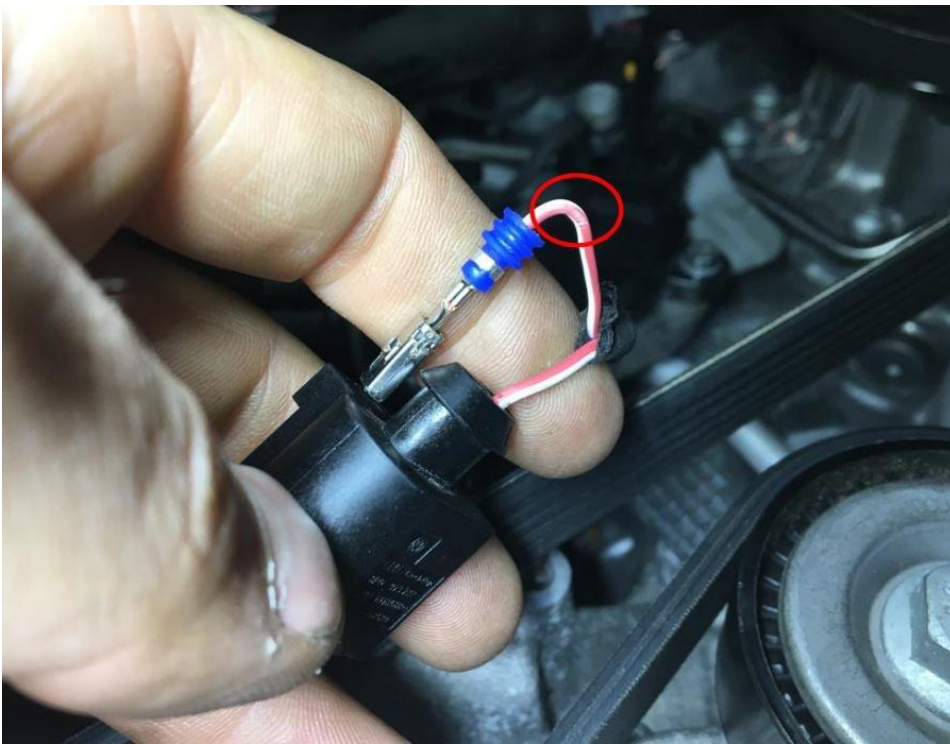
One of the turbochargers may not be achieving full boost, the issue can be related to a poor connection between the applicable boost pressure valve vacuum solenoid and the signal wire to the applicable Engine Control Module (ECM) leading to a lack of vacuum supplied to the waste-gate when under load

- Figure 4 shows a location which should also be checked for damage/kinks NOTE: The disconnected pin is shown for photographic purposes only

7) In the event an issue is suspected, for test purposes the operative should overlay the suspected wiring as follows:

- Make and temporarily fit an overlay wire between the applicable boost pressure valve vacuum solenoid and the signal wire to the applicable Engine Control Module (ECM)
- Attempt to erase the DTC and carry out a road test to confirm the issue has been successfully diagnosed
- The overlay **MUST** not be left in place under any circumstances, the operative should repair the wiring as per Rep.Gr 97
