Technical product information

Topic	New Continental GTC - Wind noise between 50 - 70 mph - Above the driver/front passengers head
Market area	Bentley: worldwide (2WBE)
Brand	Bentley
Transaction No.	2063992/2
Level	EH
Status	Approval
Release date

New Continental GTC

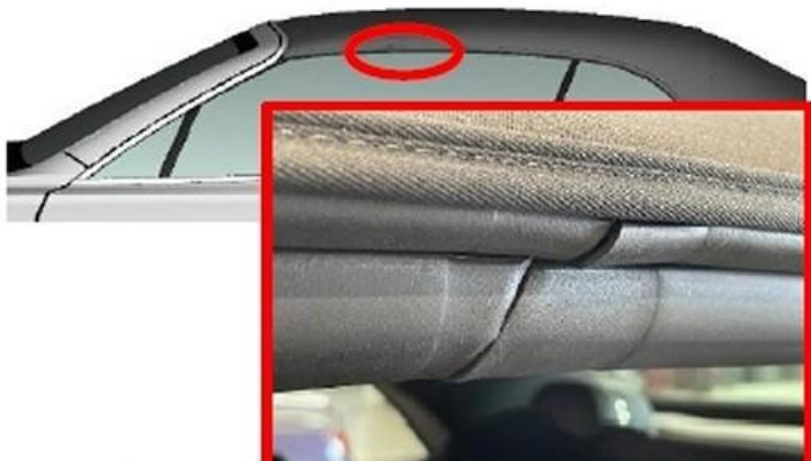
The issue in some cases can be related to the roof frame seal (Figure 1)

IMPORTANT: The operative should not assume the poor fitment of the seal as Figure 1 is the issue, should the symptom be as described the instructions within the Measure section should be adhered to

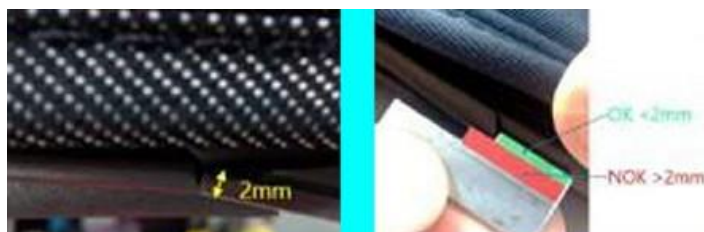
- The glass set is confirmed as within specification as per the "Side glass - to check" procedure on Elsa Pro. A completed measurement table must be saved as this will be requested as evidence if a DISS query is raised
- Battery health condition must be confirmed as within specification, as per the applicable Elsa Pro Rep.Gr guidelines. Save an image of the battery printout should a DISS query be raised
- Window seals are confirmed as not damaged, split or torn, see the examples shown in Figure 2 regarding the OK and NOK condition of the roof frame seal as regards the expected measurement results

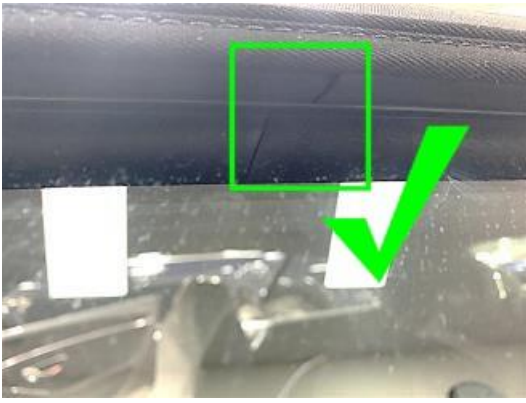
Figure 3

- Figure3-Roofframe seal OK- roofframe seal <2mm

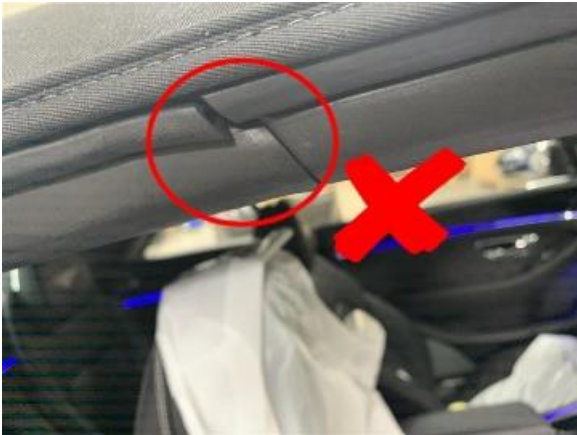
- Figure 4 - Roof frame seal NOK - roof frame seal > 2mm

NOTE: Should the side glass check and window seals be within specification and the wind noise issue is as described and/or the roof frame seal is > 2mm, please continue with the onward instructions

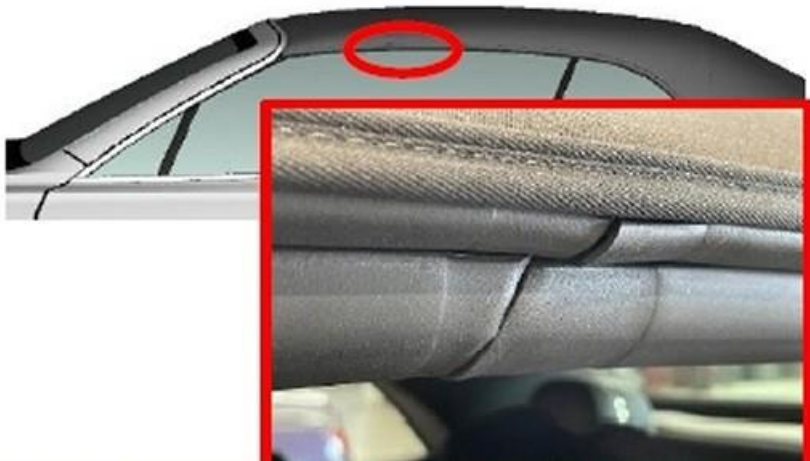
1) Referring to Figure 5 - Check the driver and passenger side outer roof section in the location shown

IMPORTANT: Should the seal be as (Inset) the operative should continue with the remaining instructions:

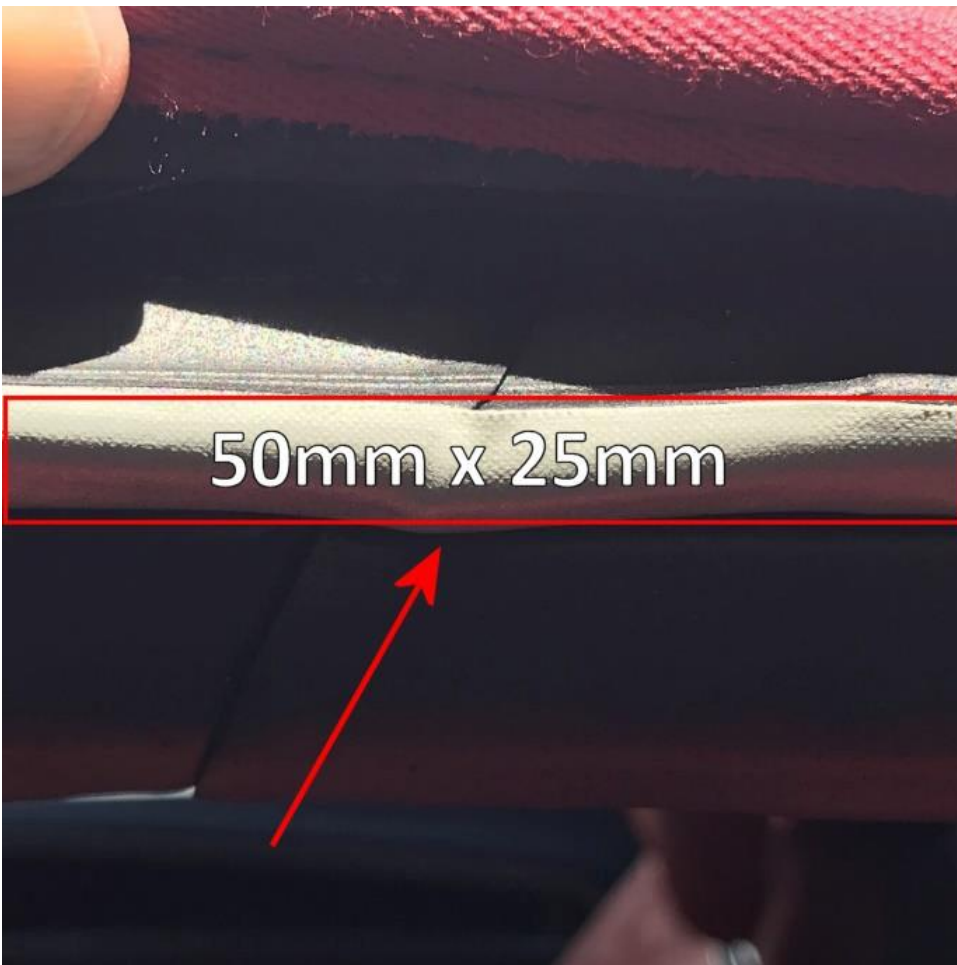
- Figure 7 shows the tape applied

3) Conduct a road test to confirm the noise is no longer evident
