Technical product information

| Topic | New Continental GT 48V anti-roll bar cable routing |

New Continental GT

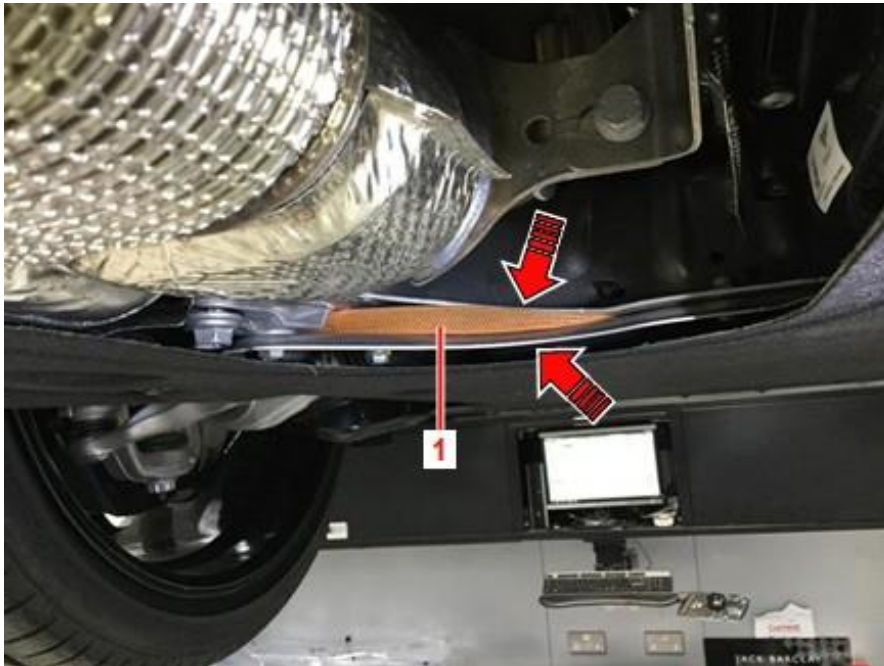
Figure 1

The 48 volt electrical supply cable looks as if it is trapped between the cross brace and transmission heat shield but is the correct condition.

The 48 volt supply cable (1) to the anti-roll bar may appear to be trapped between the front subframe and the engine undersheet (arrows). See Figure 1.

This would be visible on the LH underside of the vehicle and is the normal condition for this routing of cable.

Do NOT raise a DISS technical query for this concern.
