Technical product information

Topic	During PDI - Steering wheel vibration and/or steering wheel out of alignment is evident
Market area	Russische Föderation (5RU),Australia E04 Bentley rest Asia and Australia (6E04),China 796 VW Import Comp. Ltd (Vico), Beijing (6796),Germany E02 Bentley rest Europe (6E02),Japan E03 Bentley Japan (6E03),Korea, (South) E08 Bentley South Korea (6E08),United Arab Emirates E06 Bentley Middle East and Africa (6E06),United Kingdom E01 Bentley UK (6E01),United States E05 Bentley USA and rest America (6E05)
Brand	Bentley
Transaction No.	2060223/4
Level	EH
Status	Approval
Release date

New Continental GT/C - New Flying Spur - Bentayga

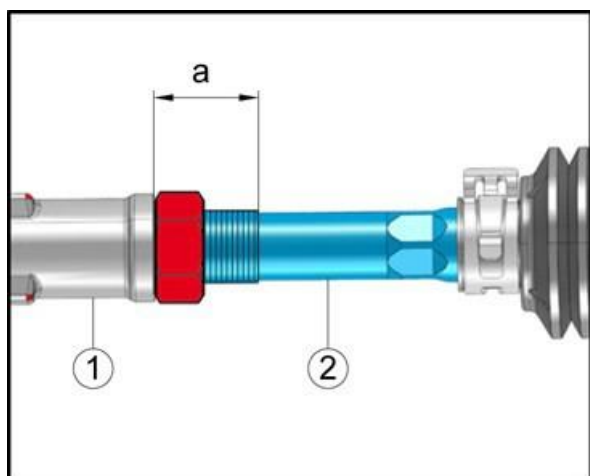
- Tyre Pressures to be recorded and checked against the correct specification – Actual results should be requested and attached to the DISS query
- Referring to Figure 1 - Images of the track rod end threads before and after alignment from both sides should be requested and attached to the open DISS query
- *Measure and note down dimension -a- between the track rod ball joint -1- and the track rod -2- on both sides.*

- Geometry results before and after alignment should be requested and attached to the open DISS query
- Vehicle ride heights before and after alignment should be requested and attached to the open DISS query
