Technical product information

Topic	Engine overheating - Warning on the DIP - V8 Kovomo
Market area	Bentley: worldwide (2WBE)
Brand	Bentley
Transaction No.	2061369/3
Level	EH
Status	Approval
Release date

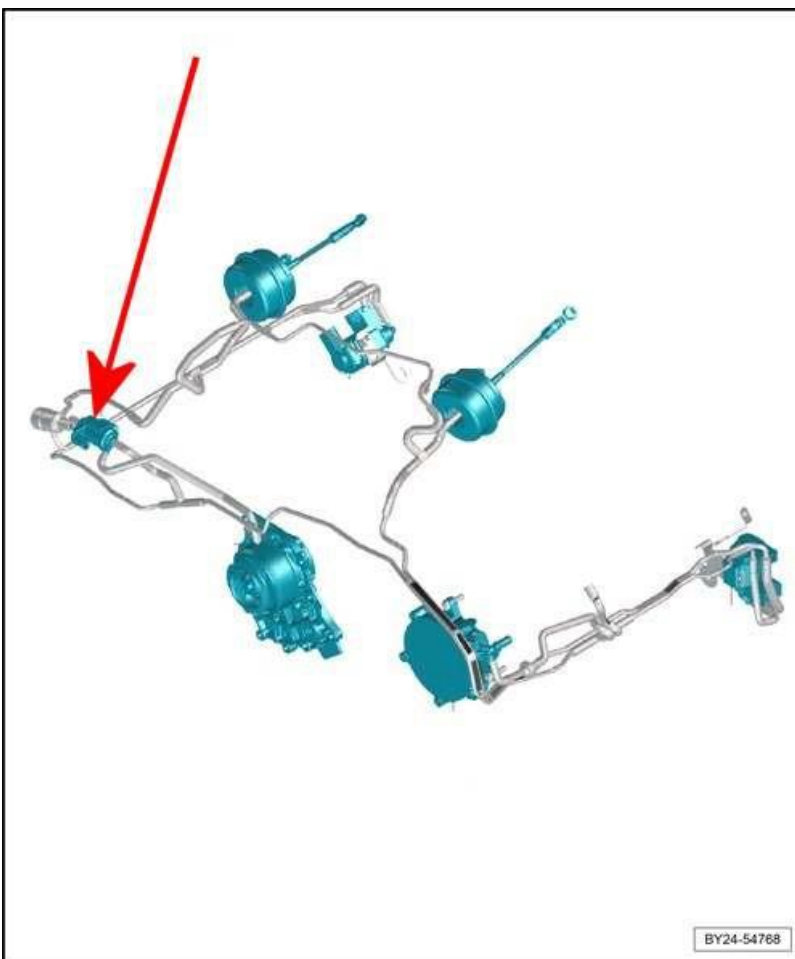
Figure 1 Shows the Bentayga Solenoid (Arrow)

When the solenoid is at fault (sticking open) the vacuum supply is constant, this allows the sleeve to stay in position around the impeller which leads to the symptoms described within the Customer statement/Workshop findings section of this TPI

1) Check and confirm the solenoid valve is sticking open and supplying a constant vacuum

- Disconnect the vacuum hoses and electrical connection
- Replace the solenoid
- Reconnect the vacuum hoses and electrical connection
- Refit the right hand engine cover

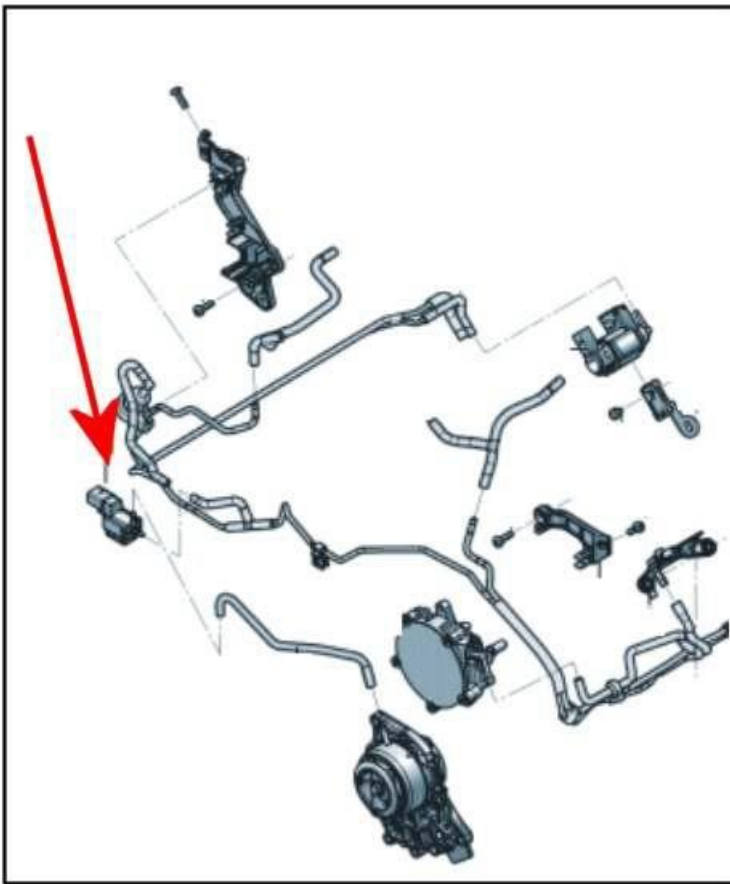
Figure 2 Shows the New Continental GT/ GTC and Flying Spur solenoid (Arrow)
