## Campaign Update CA#9992

Subject: The Dinette Flipdown Support & Footrest  
Affects certain 2022 Unity U24TB motorhomes

# SOP05830

## QAAR 9992 Reinforce the U241B/TB PS/DS dinette flip down

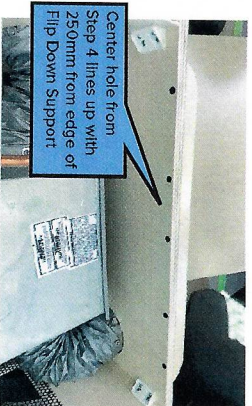
The dinette flipdown support & footrest assembly does not have adequate support when in the sleep position.

Remove the Passenger Side seat cushions and flip the Footrest into the sleep position.  
i.e. backrest becomes foot support
