Technical product information

Topic	New Continental GTC - Heated Armrest - De-activates
Market area	Bentley: worldwide (2WBE)
Brand	Bentley
Transaction No.	2059651/4
Level	EH
Status	Approval
Release date

New Continental GTC - Heated Armrest - De-activates

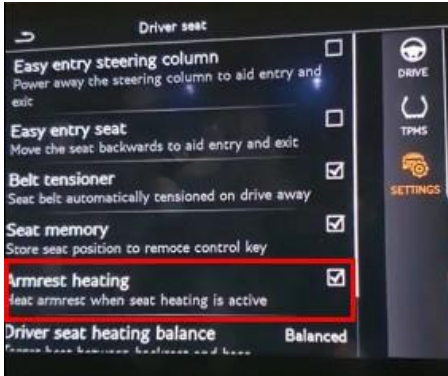
Figure 1

If "Armrest Heating" is selected on the Infotainment Touch Screen it should remain configured as a preference - Figure 1.

NOTE: A software update for address 08 – Air conditioning control unit is now available – Refer to the Measure section of this TPI

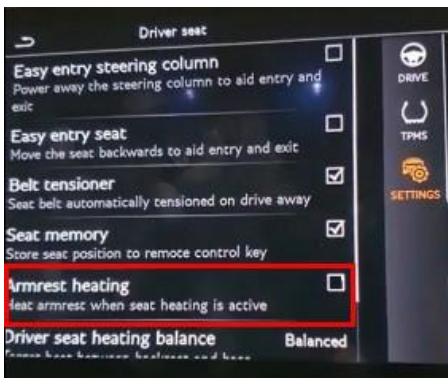
Figure 2

When a Controller Area Network (CAN) shutdown occurs the "Armrest Heating" selection box becomes "unticked" and has to be manually re-selected to enable "Armrest Heating" functionality - Figure 2.

"Armrest Heating" selection box becomes "unticked" every time a CAN shutdown occurs.
