N595NAS1

# TECHNICAL BULLETIN

Service Action - Incorrect Emissions Label Installed

MODEL:	MODEL YEAR:	VIN:
Range Rover Sport (LW)	2021	790620-796378

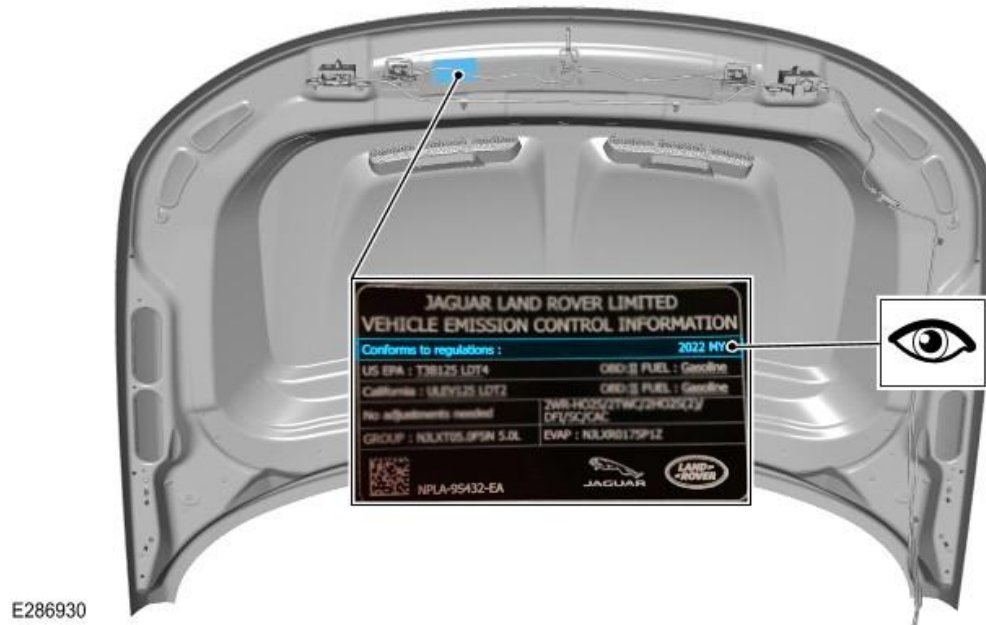
E286930

Inspect the model year number displayed on the emissions label.

- If the model year shown on the emissions label is **incorrect**, continue to the Service Instruction.
- If the model year shown on the emissions label is **correct**, close the hood and release the vehicle.
