Complaint – Average Consumption Value Display Resets Automatically: Re-Programming Instrument Cluster Control Unit (104/21)

Model Line: **Taycan (Y1A)**

Model Year: **As of 2020 up to 2021**

Concerns: **Instrument cluster control unit**

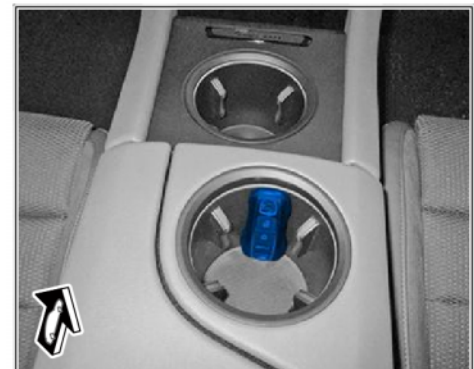
Emergency start tray

- Work Procedure: 1 Place the driver's key with the back facing down into the front left storage compartment in the center console (emergency start tray) to guarantee a continuous radio link between the vehicle and the driver's key ⇒ *Emergency start tray*.
- 2 Carry out general preliminary work for control unit programming as described in ⇒ *Workshop Manual '9X00IN Basic instructions and procedure for control unit programming - section on "Preliminary work"*.
