**Taycan with 22kW OBC: Charging Start Error at Electrify America DC Chargers**

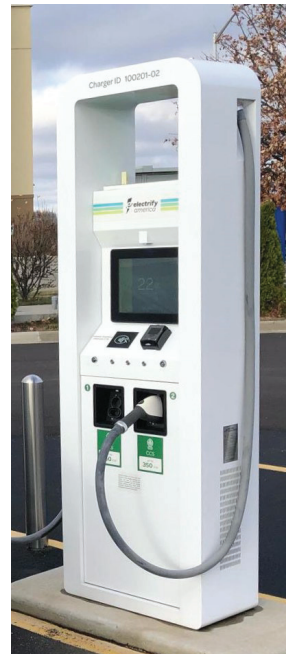
Figure 1

The customer may see the charging kiosk displays "Charging start error", and may note error code "42\_00H\_00". Further discussion with the customer should confirm the error only occurs at select Electrify America sites, that use DC chargers from hardware supplier Signet (see Figures 1 and 2).

Charging hardware and plug-in hybrid & electric vehicles initiate communication through a pulse-width modulation (PWM) signal on the control pilot (CP) line. The PWM signal of Signet charging kiosks may intermittently fall outside the signal range defined in certain 22kW OBC software versions.

Revised OBC software (version 1256) is available in PIWIS Tester III v40.475.060 (or higher), released on August 27, 2021. The campaign code and work procedure to re-program and update the OBC is available through PCNA AfterSales on a case-by-case basis.
