# Technical product information

| Topic | Convertible hood cannot close - Header trim flap eyelet broken |
| Brand | Bentley |
| Transaction No. | 2060120/5 |

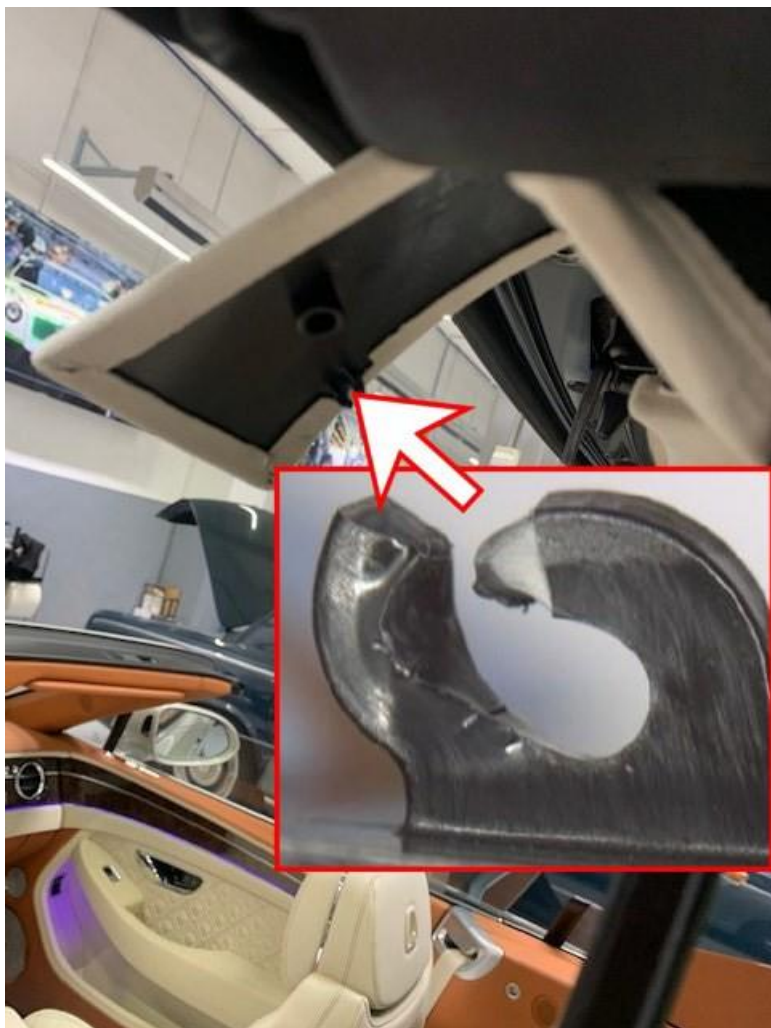
Figure 1

Convertible hood cannot close/latch due to a broken eyelet. The eyelet is part of the trim flap assembly (Figure 1)

1) Replace the right and left hand trim flaps - Rep.Gr 61

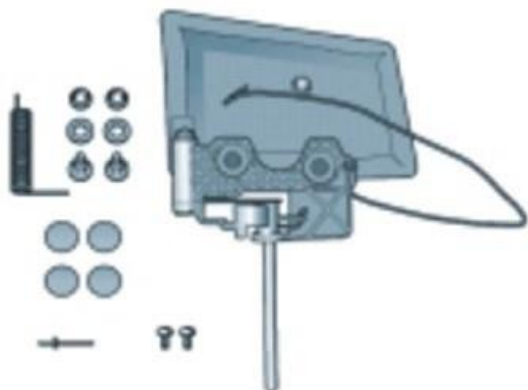
Figure 2

A kit of parts to replace the right and left hand trim flaps is now available (Figure 2)

NOTE: The trim flaps should be replaced in pairs
