Technical product information

Topic	Vibration noise from the powertrain when park or neutral is selected
Market area	Bentley: worldwide (2WBE),Hongkong-Macau (5HK)
Brand	Bentley
Transaction No.	2053428/5
Level	EH
Status	Approval
Release date

New Continental GT and New Continental GTC - W12

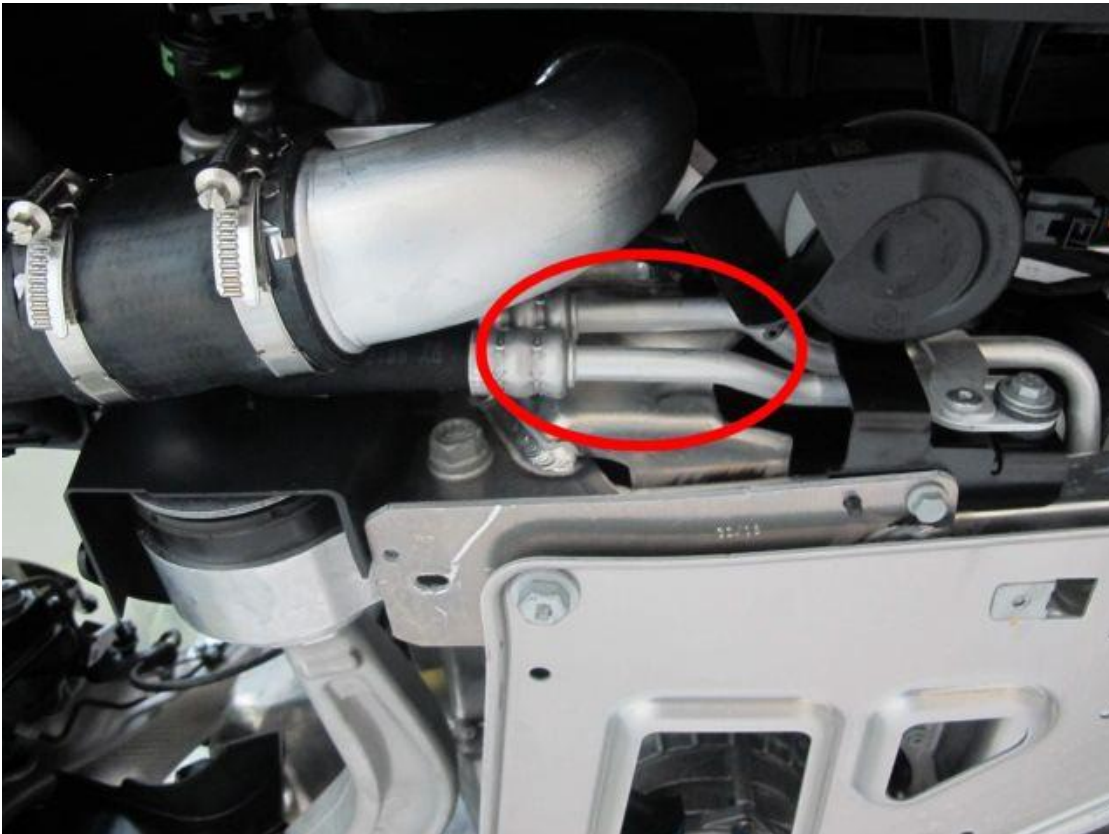
The noise is caused by contact between the transmission cooler pipes and the front subframe

- 1) Referring to Repair manual Rep.Gr 66 – Remove the front undersheet
- 2) Referring to Figure 1 - Locate the area (circled) at the front right hand side of the front subframe

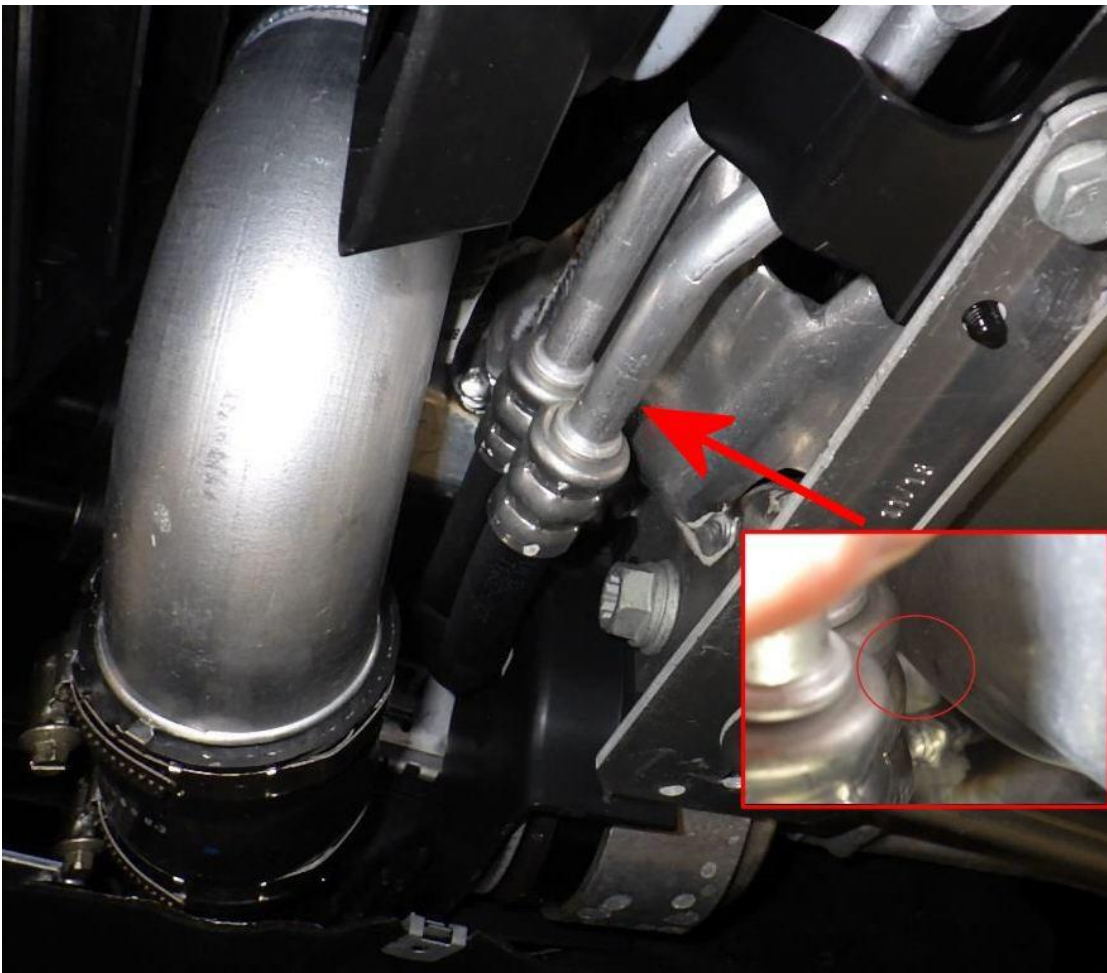
Figure 2

- Referring to Figure 2, Carry out a visual check of the transmission pipes to confirm the pipes are contacting the front subframe at the location shown

3) Should contact be confirmed – Taking care not to damage the pipes or securing points/brackets reposition the pipes ensuring clearance is maintained between the pipes and the subframe
