Technical product information

| Topic | Emission control system lamp illuminated - DTC P044100 evident |
| Brand | Bentley |
| Transaction No. | 2053429/4 |

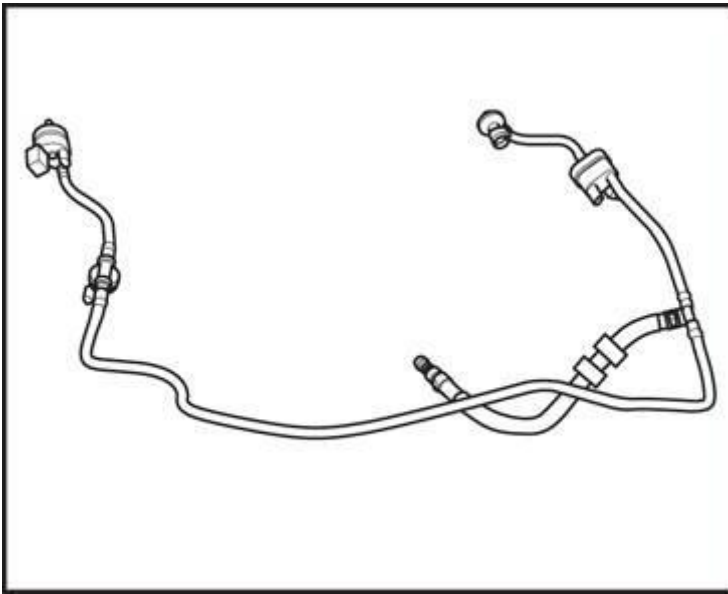
Figure 1

NOTE: The solenoid valves are connected together with a hose, and have to be replaced as a unit as these solenoid valves and hoses are not supplied separately

- 5) Replace the evaporative emission purge valve assembly (Figure 1) - Refer to repair manual Rep.Gr 20 - Evaporative emission purge valve - To remove and fit - pay attention to any debris/contamination falling from the ends of the line during disconnection, If contamination is found in the ends of the line or the engine ports please raise a DISS query
