Technical product information

Topic	Knock/clunk noise from the rear of the vehicle (Rear axle)
Market area	Russische Föderation (5RU),Australia E04 Bentley rest Asia and Australia (6E04),China 796 VW Import Comp. Ltd (Vico), Beijing (6796),Germany E02 Bentley rest Europe (6E02),Japan E03 Bentley Japan (6E03),Korea, (South) E08 Bentley South Korea (6E08),United Arab Emirates E06 Bentley Middle East and Africa (6E06),United Kingdom E01 Bentley UK (6E01),United States E05 Bentley USA and rest America (6E05)
Brand	Bentley
Transaction No.	2064477/1
Level	EH
Status	Approval
Release date

Knock/clunk noise from the rear of the vehicle (Rear axle)

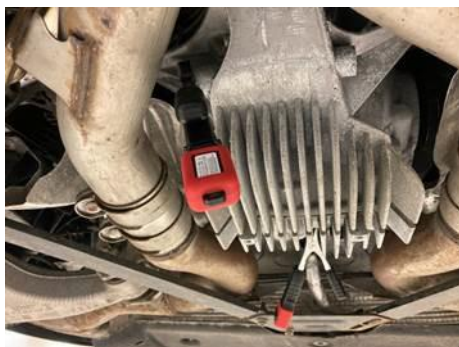
Figure 1

- Use WT 10437 (Chassis Ear Tool) to identify the source of problem by attaching the clamp and module assemblies to the areas of concern. For example, front and rear of the differential casing, as well as the upper control arms on the suspension (see Figures 1 to 3 for examples)

IMPORTANT: Ensure secure fitment of the clamp and module assemblies, ensuring there is no clash with exhaust system
