**Location:** Body Exterior & Electrical

**Topic:** Electrochromatic (EC) Roof Glass diagnosis

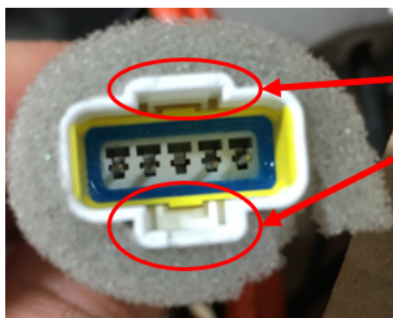
Image 1.2 - EC system connect orientation

There is a key to prevent the connector Engaging in wrong way but it has been noticed with a bit of extra force it is possible to have it connected wrong way  
There is two off this connector on the EC roof loop  
One next to switch another one next to control unit.

- Check fuses for cigarette lighter and EC roof glass fuse (EC roof fuse is located above the fuse box on a separate bracket above electric city)
- Check all connectors are fully engaged in the correct orientation. Take extra care as connectors and be forcefully connected in reverse. See image 1.2.

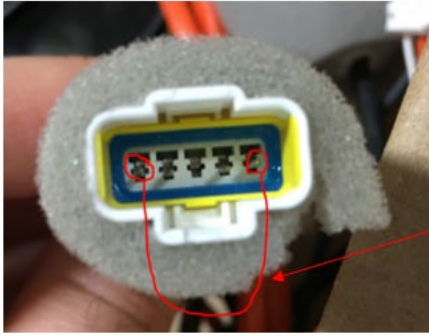
Figure 1.3 - EC glass basic system

- Check the electrical continuity between the outer 2 pins for the loop to the EC glass. If there is no continuity between the outer 2 pins of the glass, the loop within the glass may be damaged. See Image 1.3.

This can be tested in two connectors:

- first with glass connected check the connector by the EC roof control unit (under interior trim behind RH seat)
- Secondly at glass connector next to switch by head liner
