## Document Information

**Topic:** Additional check points to be aware of during PDI completion of all McLaren Vehicles

**Condition:** During PDI completion

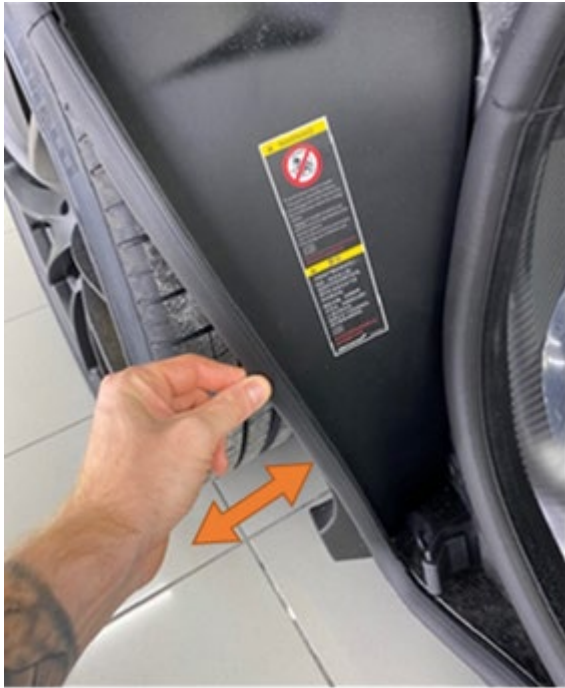
### Door and Bonnet Seal Condition and Operation

During vehicle PDI special attention should be used to ensure there has been no degradation of the seal fitment. To check adhesion, the seal should be lightly pulled using minimal force only.

Any sign of adhesion failure should be rectified through the normal Warranty process.

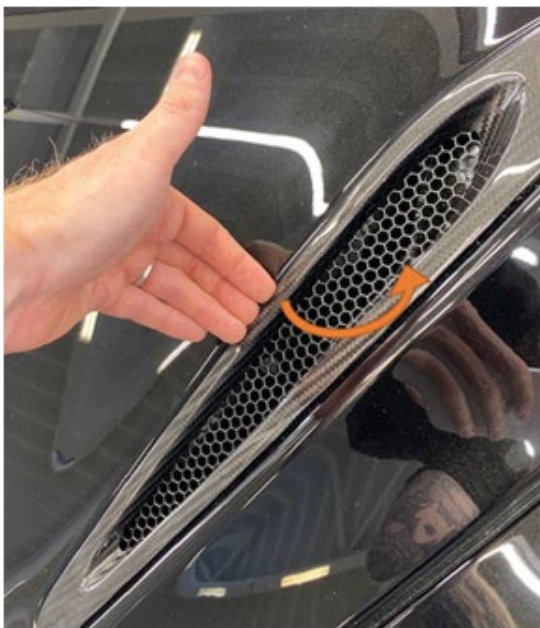
All bonded trims should be assessed for correct adhesion to the vehicle using a light pull test with only minimal force.

720S bonnet vent trims

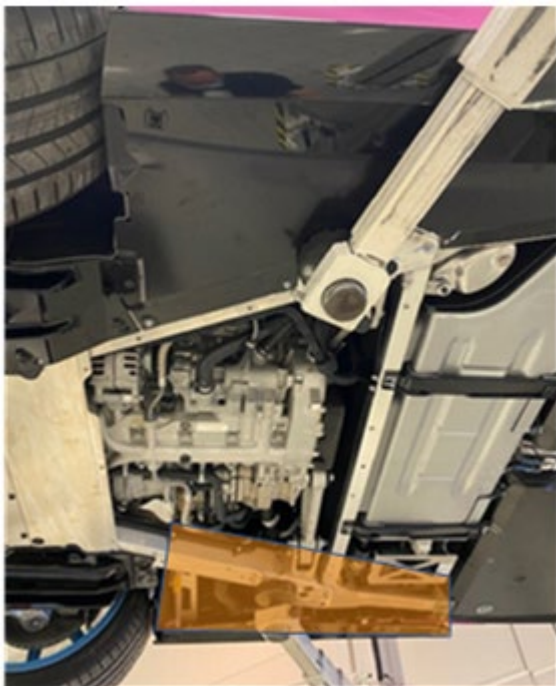
Underfloor extensions can be removed on left hand side for access

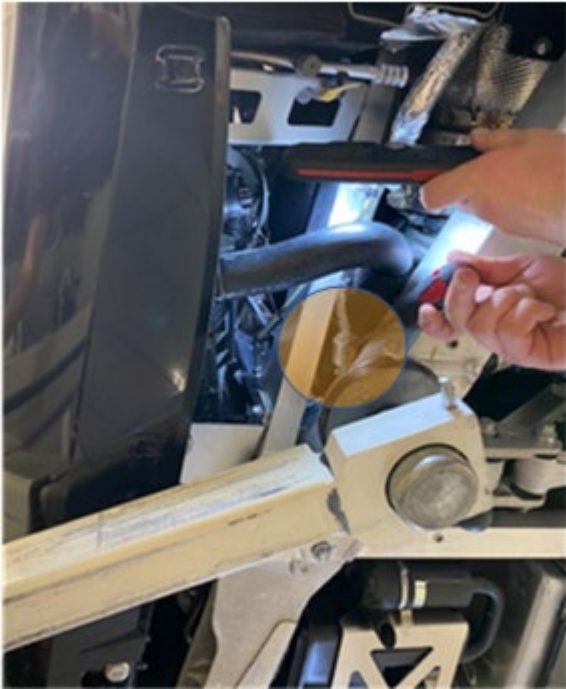
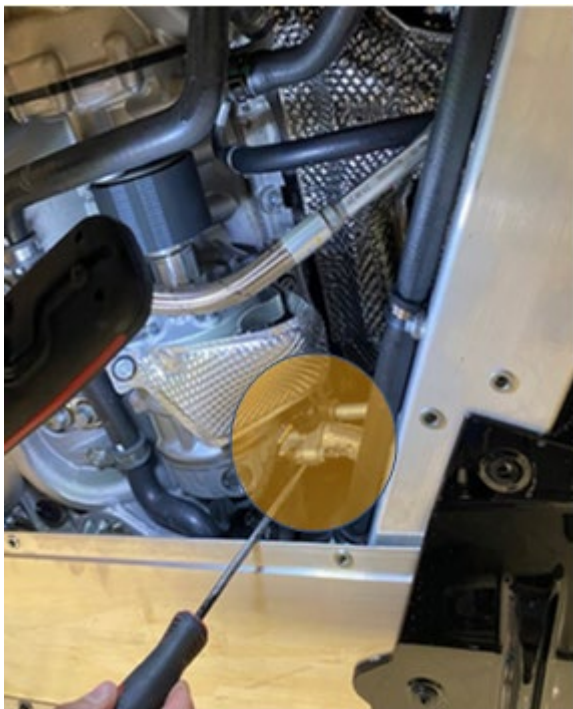
Compressor HVAC pipe union

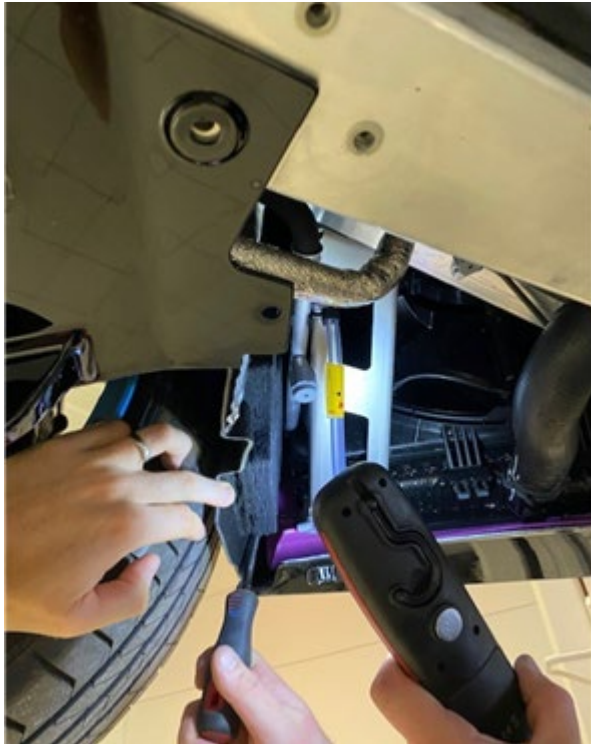
HVAC pipes and unions behind left hand wheel arch liner

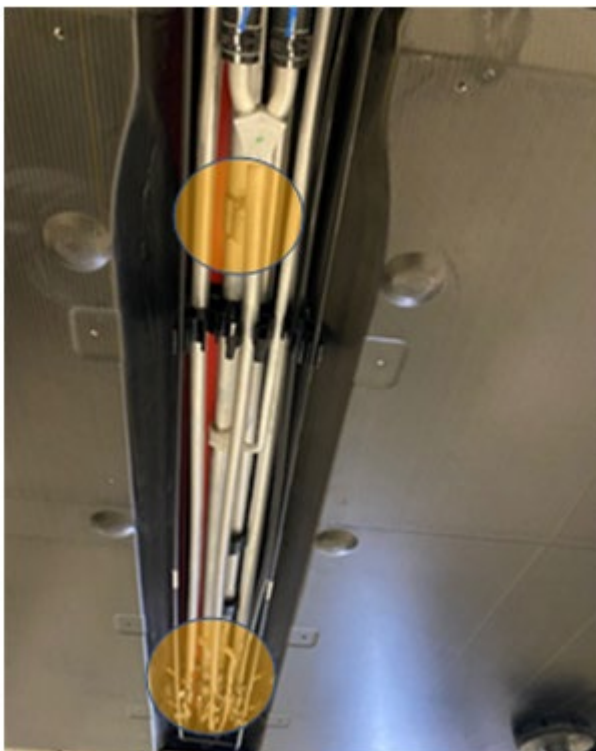
HVAC pipes along centre of vehicle tunnel

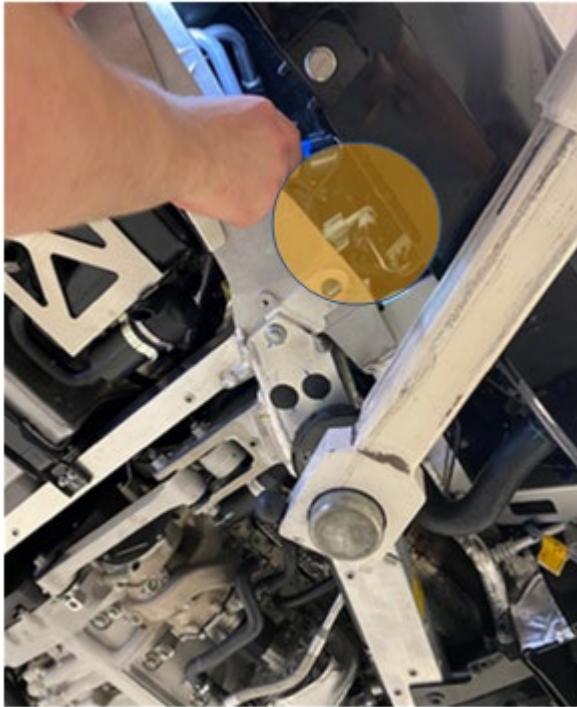
HVAC union above the left hand sub-frame (black in to silver pipe)
