QUALITY ACTION

CAMPAIGN BULLETIN Brake Tube Dealer Inventory

Reference: PC826

PC826 - 2021 MURANO BRAKE TUBE INSPECTION

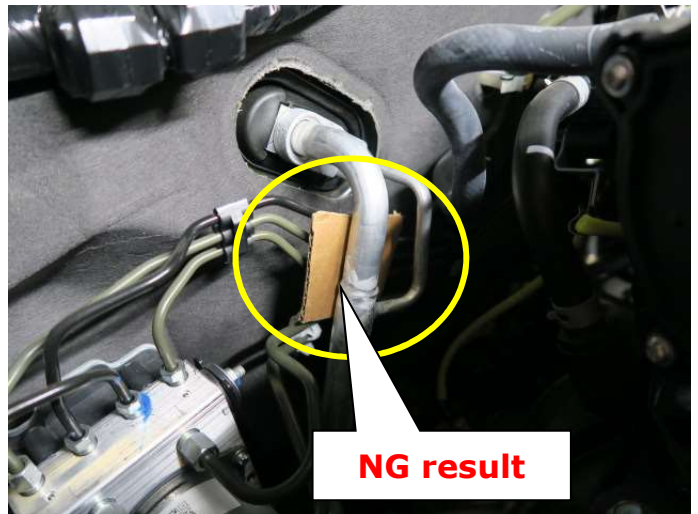
Figure 7

5. Check the gap between the brake tube and the internal heat exchanger. (Figure 7)

- Cutout a 2"x2" square of single wall corrugated cardboard that is approximately 3mm thick as shown in Figure 6
- Insert cardboard cutout between internal heat exchanger tube and brake tube
 - If cardboard moves freely, move to **Step 12** for reassembly and release
 - If cardboard cannot be inserted or if the cardboard makes contact on both sides, move to **Step 6** for further inspection of brake TUBE

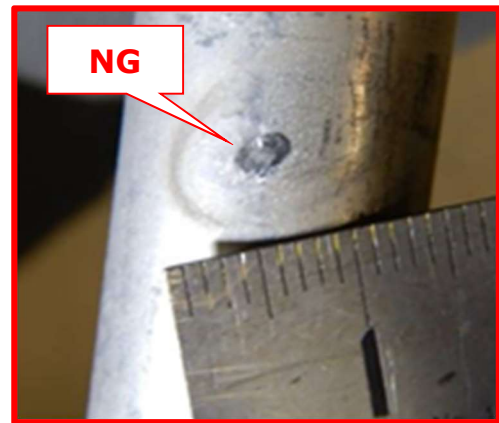
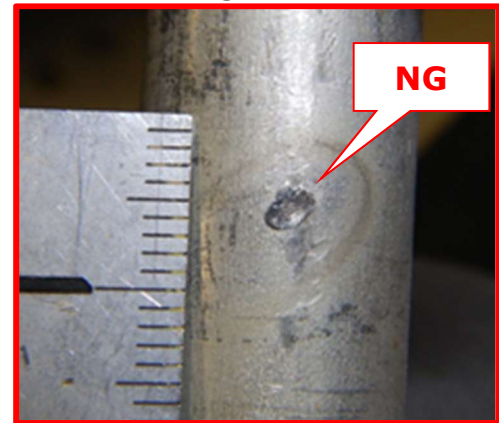
7. Inspect brake tube for wear damage.

Note: Do not remove the brake tube. Inspect the brake tube while the part is in the vehicle. Figure 9 was taken with the part out of the vehicle as a reference only.

- Move brake tube toward the rear of the vehicle and visually inspect the brake tube
- If brake tube has any wear (Figure 9 & 10), move to **Step 8** for replacement
- If brake tube does not have wear, adjust the brake tube to heat exchanger tube clearance to a minimum of 3mm and torque the nut to **16.2 N·m (1.7 kg·m, 12 ft-lb)** and repeat **Step 5** to verify 3mm gap minimum clearance and move to **Step 11**
