HYUNDAI

Technical Service Bulletin

GROUP Campaign	NUMBER 21-01-038H-1
DATE September, 2021	MODEL(S) Accent (HC)

SUBJECT: TCU UPDATE AND / OR IVT REPLACEMENT
(SERVICE CAMPAIGN T6J)

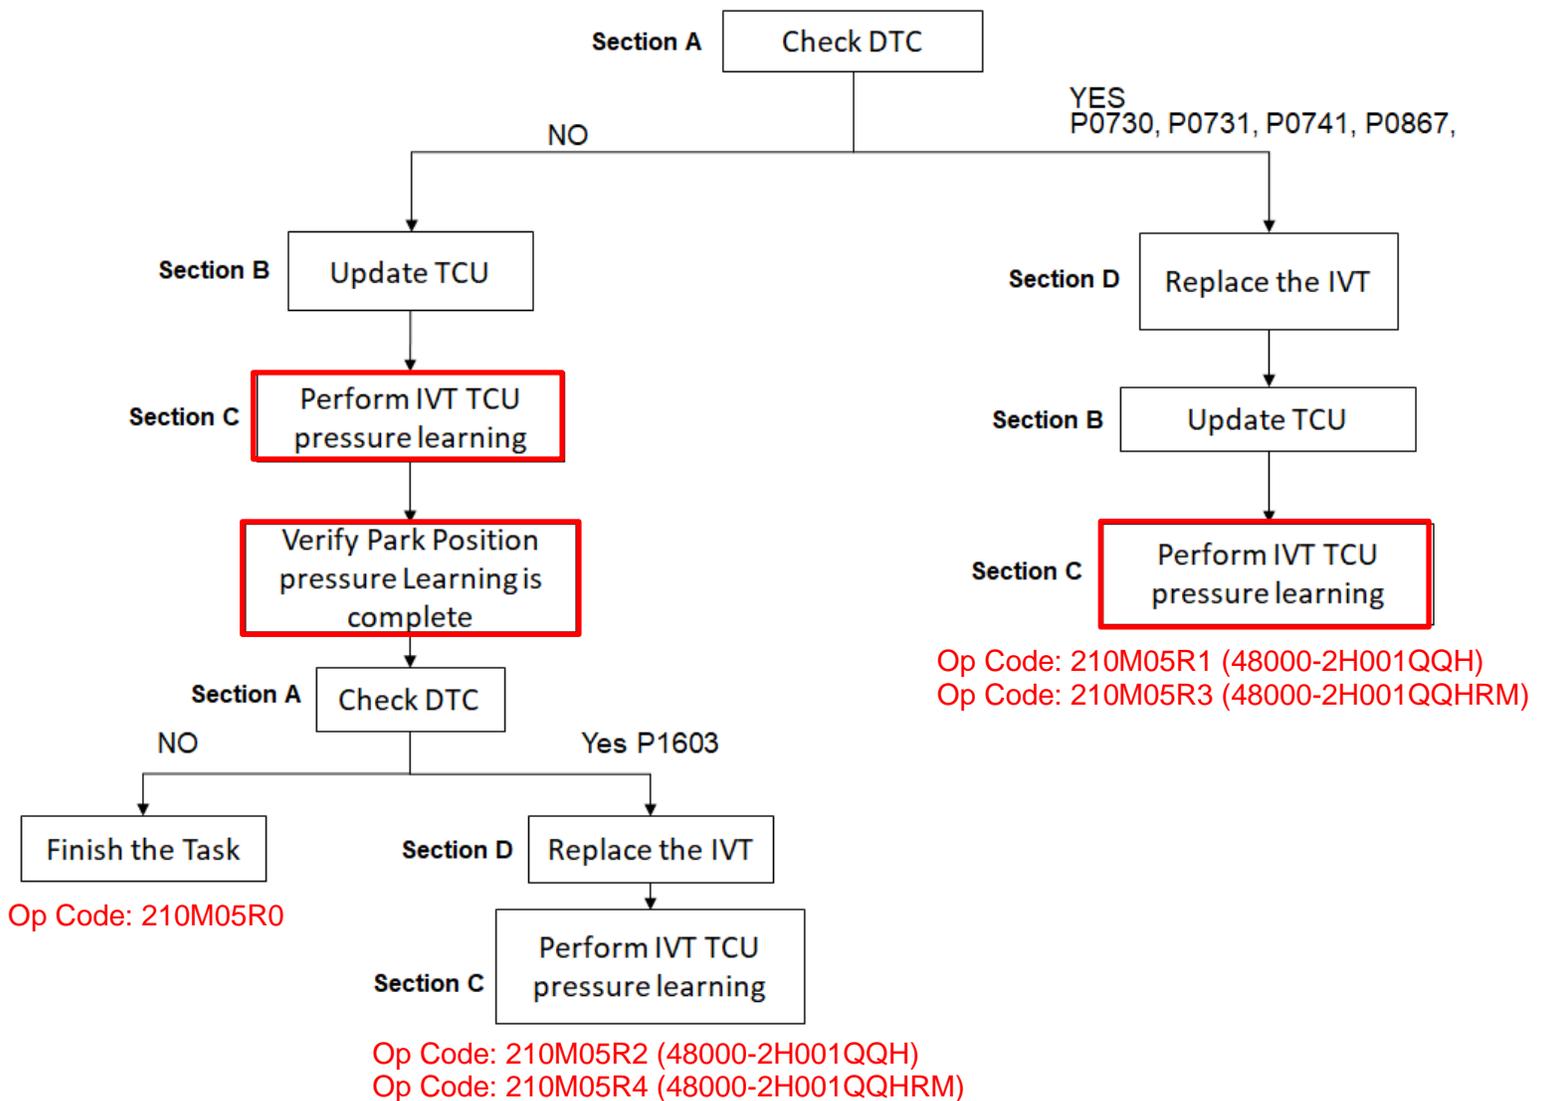
TCU Update Flow (HC with IVT)

1. Use the GDS-M to check the TCU DTC.
2. If one of the DTC(s) P0730, P0731, P0741, P0867, P1603 applies (History, Current, or Pending), replace the IVT.
3. Replace the IVT according to the applicable vehicle shop manual.
4. After IVT replacement, perform TCU update first, then perform the IVT resetting auto T/A values, TCU adaptive values learning procedure.

1. Refer to the flowchart below to update the procedure.

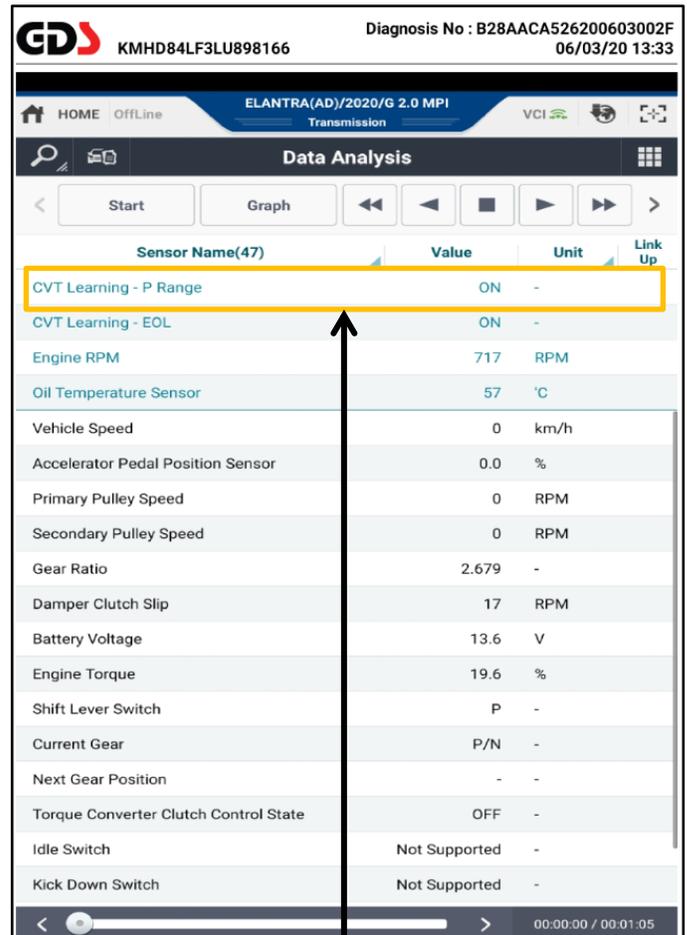
Use the GDS-M to verify the IVT P-Range learning is complete, and check TCU for DTC P1603 (EOL P-Range Pressure Learning Failed).

(1) If IVT- P Range learning is not complete, and P1603 is present, Replace the IVT (Refer to **Section D.**)

(2) If IVT-P Range is not complete, and P1603 is not present, the learning condition has not been met. Re-perform **Section C - IVT, TCU Learning.**
