GROUP	MODEL
Body	2021MY~ K5 (DL3a)
NUMBER	DATE
PS710	October 2021

APPEARANCE OF WATER LEAK AND/OR CONDENSATION IN REAR CENTER COMBINATION LAMP

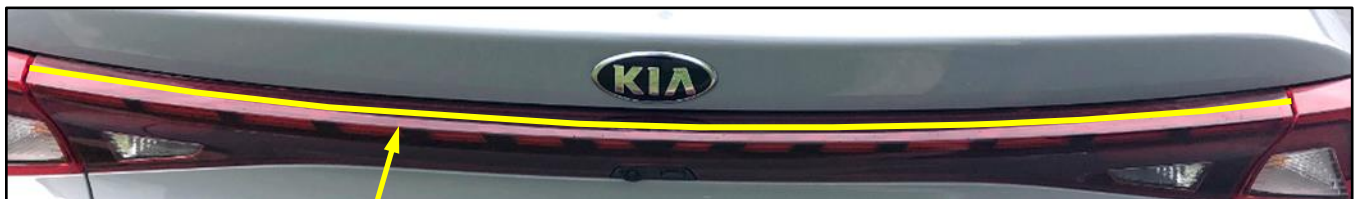
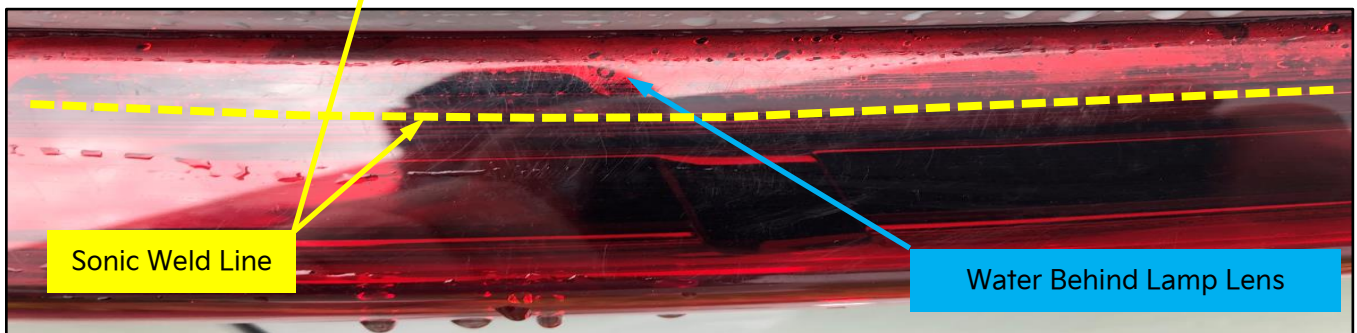
This Pitstop provides clarification on what appears to be a water leak and/or condensation in the rear center combination lamp assembly on some 2021MY~ K5 (DL3a) vehicles. The top area of the rear center combination lamp assembly can have the appearance of condensation behind the lens. This is a normal condition for water and/or condensation to be present above the sonic weld line. As the weld forms a lip along the top of the rear combination lamp, water may enter the back side of the lens but does not actually enter the inside of the lamp housing. Replacement of the rear center combination lamp is not necessary.

In case of customer concerns, water leak and/or condensation may be cleared from the area by:

1. Giving it some time to dry (about one hour outside on a dry, warm day)
2. Lightly blowing shop air between the trunk lid and the lamp housing.
