October 1, 2021

# Popping/Crackling from the Speaker; Display Blank

## AFFECTED VEHICLES

Year	Model	Trim	VIN Range
2021	TLX	ALL	ALL

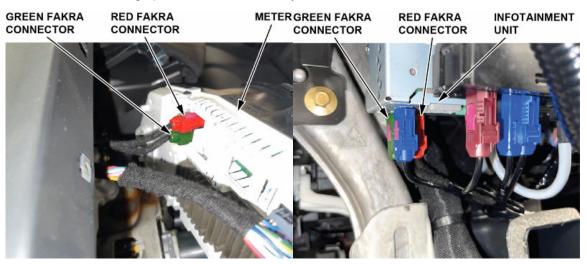
STEREO AMPLIFIER RED FAKRA CONNECTOR GREEN FAKRA TUNER UNIT CONNECTOR

4. Disconnect the red and green MOST connectors at the meter, infotainment, stereo amplifier, and tuner units using the straight FAKRA puller.

NOTE: To avoid mixing up the wires, remove only one FAKRA connector at a time.
