## Popping/Crackling from the Speakers; Display Blank

Supersedes 21-032, dated October 01,2021, to revise the information highlighted in **yellow**.

Year	Model	Trim	VIN Range
2021	TLX	ALL	ALL

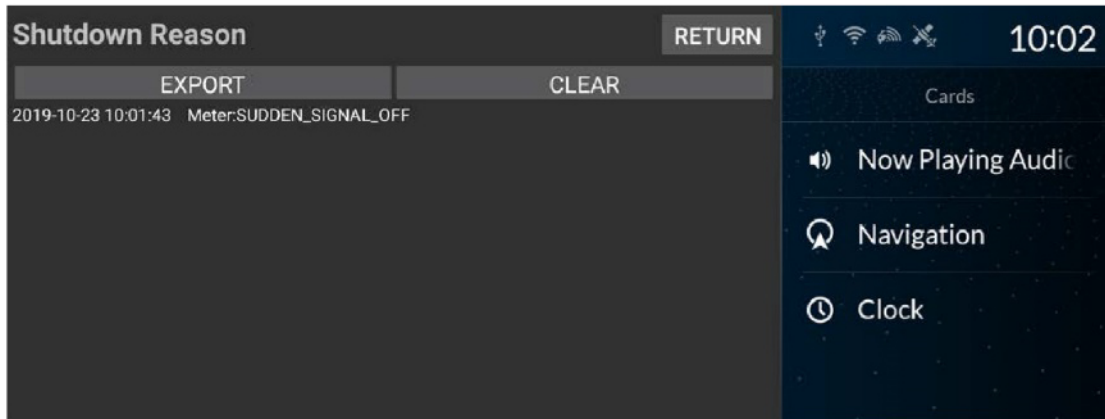
In this example, the cause of the failure can be identified as **Meter:SUDDEN\_SIGNAL\_OFF**

4. Write down any failures as they will be collected on the warranty claim. Then, clear the data.

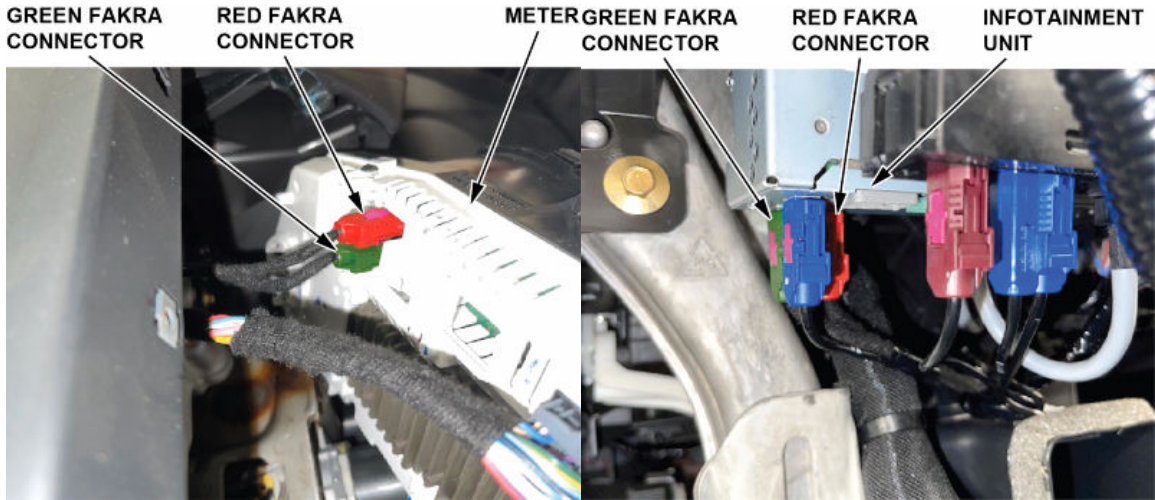
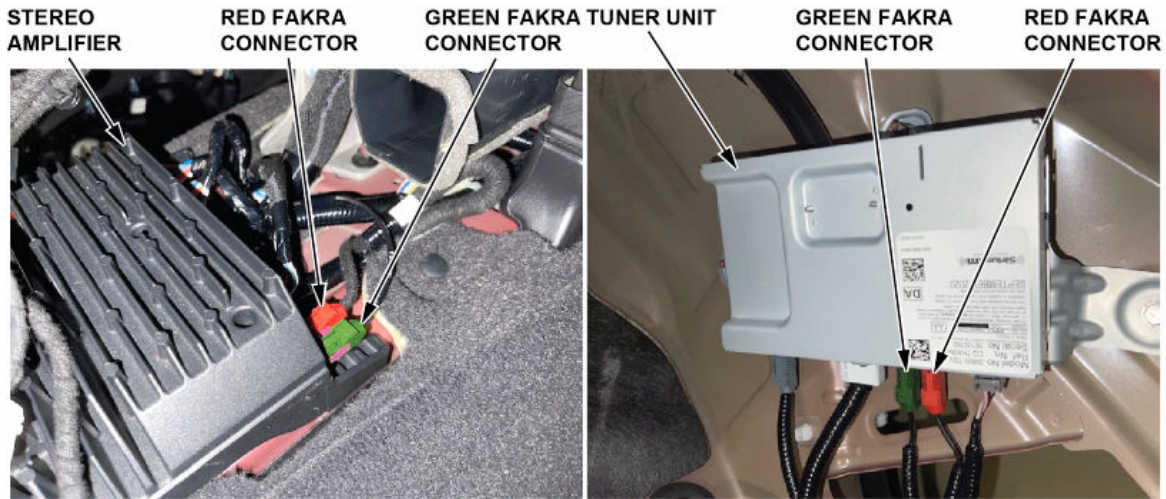
There is a loose connection in the MOST bus network.

4. Disconnect the red and green MOST connectors at the meter, infotainment, stereo amplifier, and tuner units using the straight FAKRA puller.

NOTE: To avoid mixing up the wires, remove only one FAKRA connector at a time.

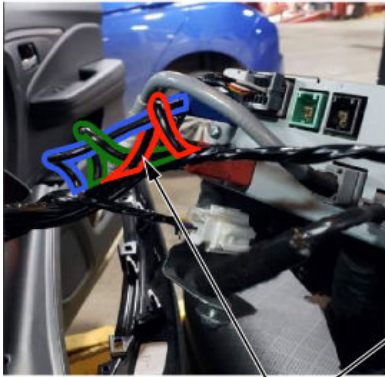
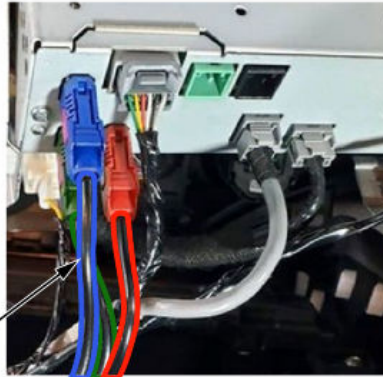
10. Install all the removed parts in the reverse order of removal. When installing units, make sure the harness is routed correctly because a misrouted harness can put pressure on the connectors, which can cause a connection issue. Do not pull on the units or MOST feeders while the FAKRA connectors are connected.

**HARNESS  
Reroute.**
