Technical Service Bulletin: TSB180032	Released Date: 03-Aug-2021
Navistar® Air Compressor Hose Rupture: Fault Codes 125, 1866, 3361, 3382, 3389, and 4729

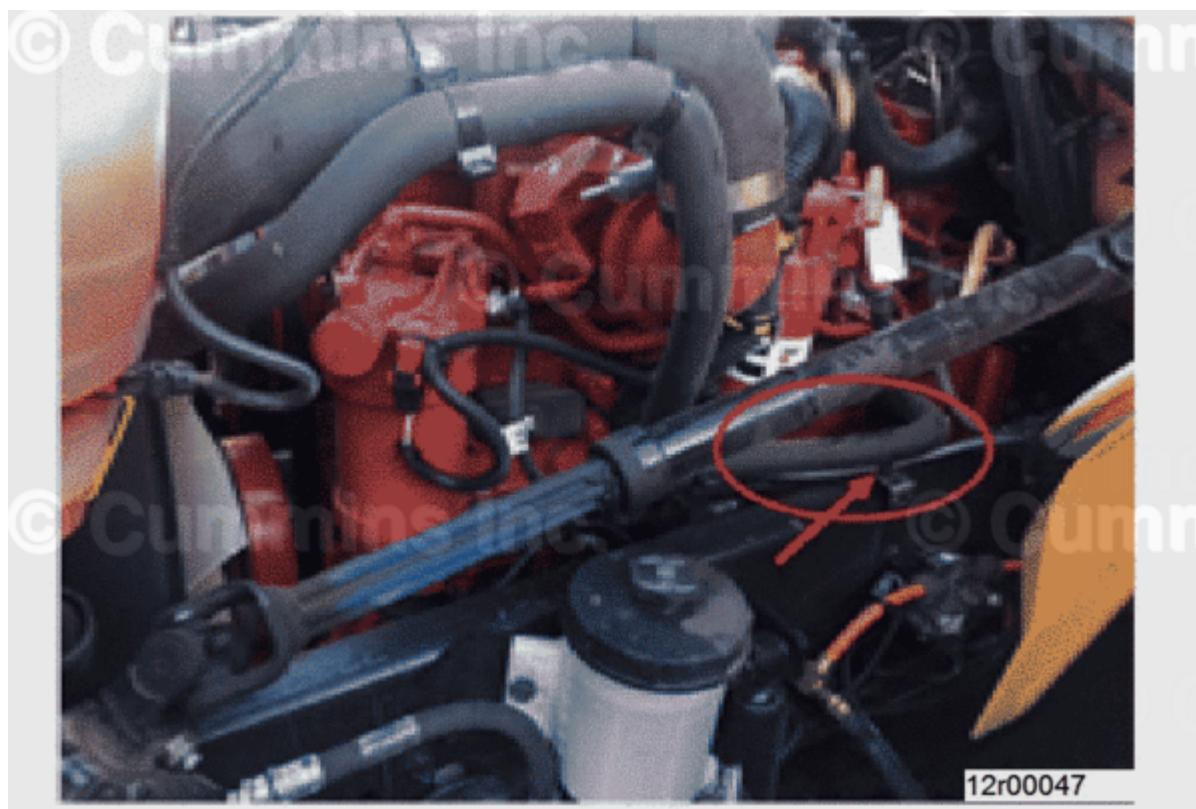
Figure 1, Air Compressor Hose Location.

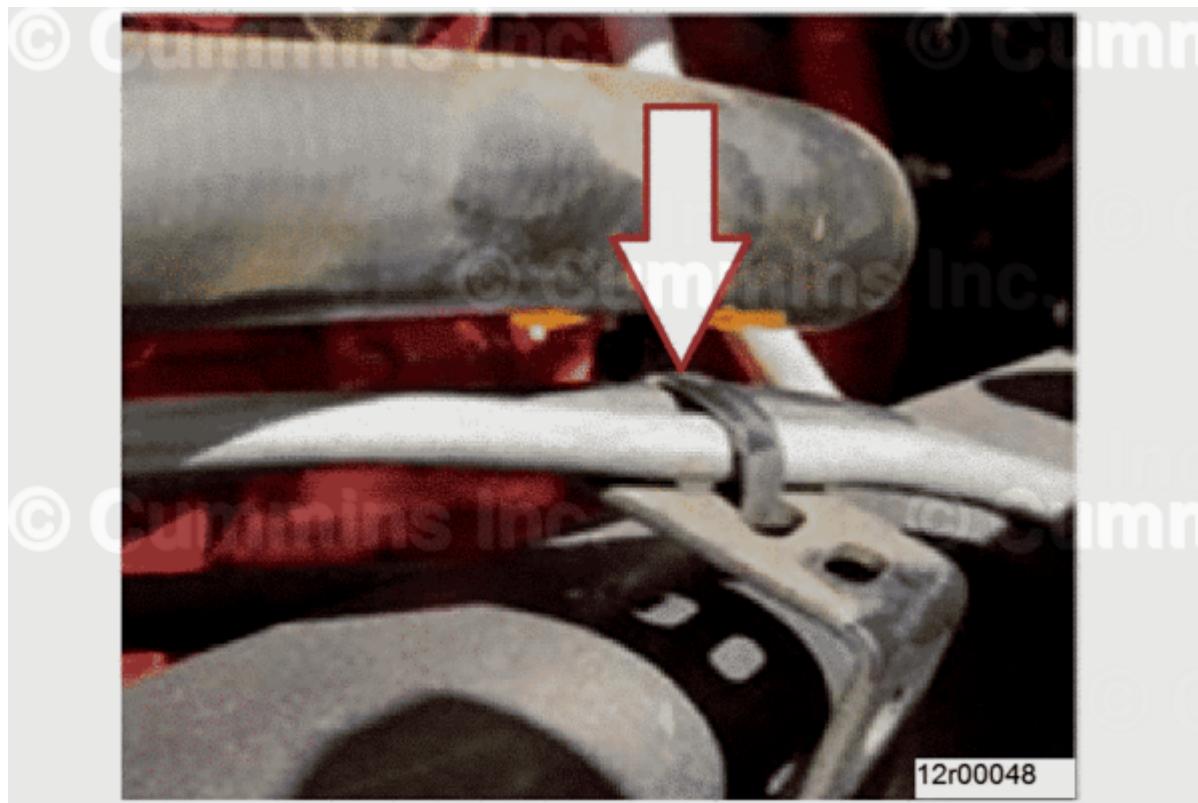
- Zip tie retaining air governor lines is rupturing inlet hose of air compressor. (Navistar® Part Number 6132813c1 or 6132813c2)

Figure 2, Ziptie Location.

- Reference Navistar iKnow article IK0900141 and IK1201362 for further instructions. Any malfunctions, consequential to air compressor hose leak, are **not** covered under Cummins Inc. Warranty. Repair locations are to contact Navistar® for further repair direction.
