### PIT5291F Wind Whistle Noise at Highway Speeds from Left or Right Rear Quarter Glass Area

#### Models

Brand:	Model:	Model Years:	VIN:		Engine:	Transmissions:
			from	to		
Chevrolet	Suburban	2015 - 2020	All	All	All	All
Chevrolet	Tahoe	2015 - 2020	All	All	All	All
GMC	Yukon Models	2015 - 2020	All	All	All	All

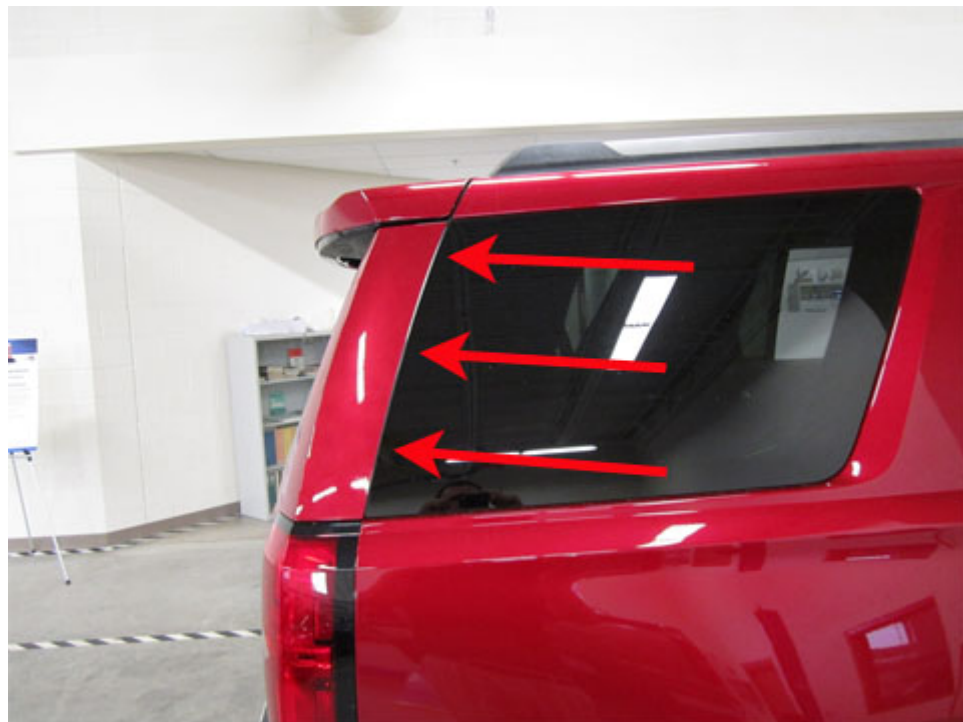
**1. The fit between the exterior "D" pillar trim and the rear quarter glass in the area shown below.**

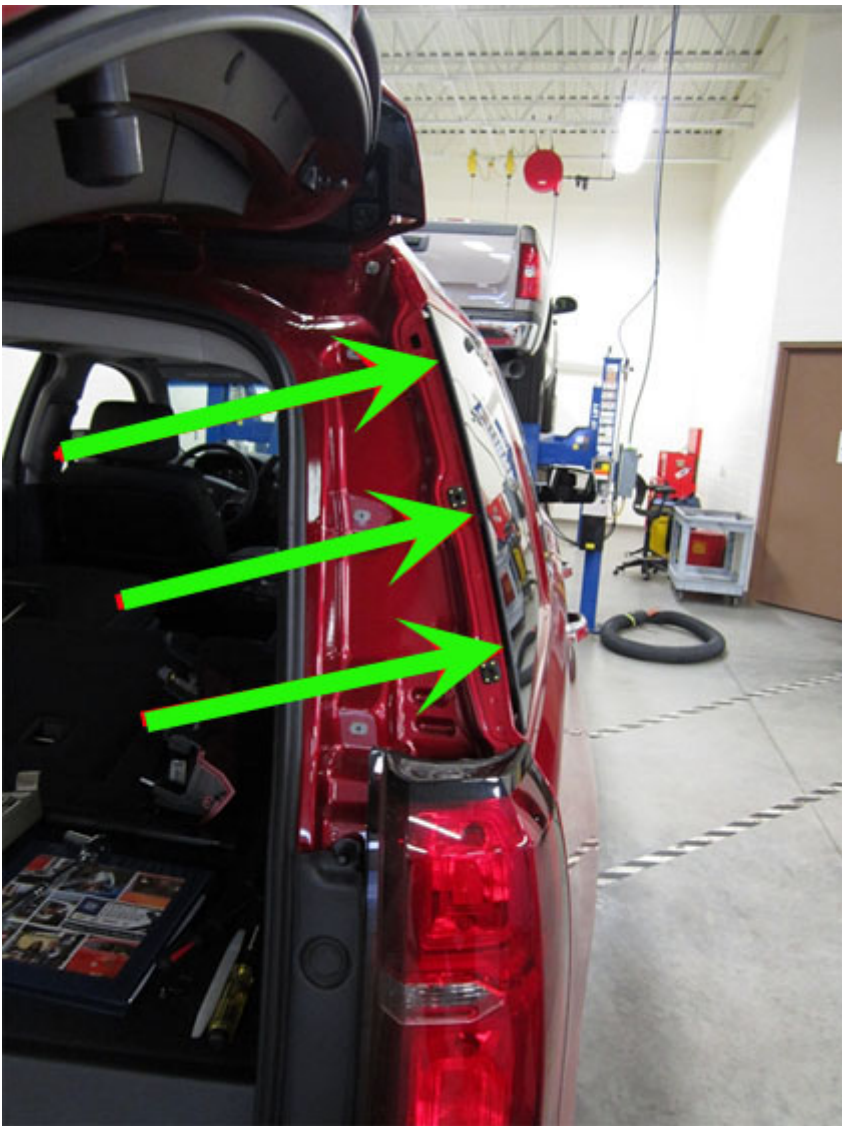
**Excessive urethane from the quarter glass installation may not allow the exterior "D" pillar trim to fit properly against the rear quarter glass, as shown below.**

1. Use a sharp knife and cut off the excessive urethane, as shown below. In most cases the urethane will need to be cut sub-flush to the sheet metal. This will allow the exterior "D" pillar trim to fit correctly against the rear quarter glass.

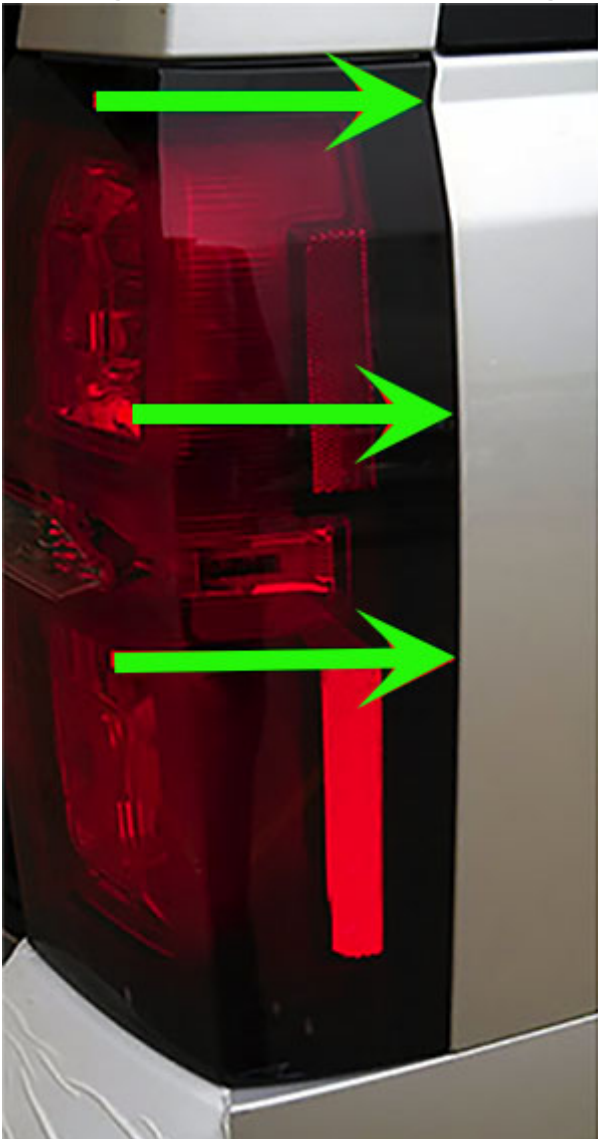
2. The gap between the rear tail light assembly and the quarter panel, as shown below.

**2. Install a 5mm X 5mm (3/16 X 3/16) piece of closed cell foam tape along the entire length of the tail light assembly, as shown below.**
